Appendix B

Manhole Inspection Summary

MANHOLE INSPECTION FORM

Client: Enfield, NH
 Date: 5/9/2019
 Time: 8:13
 Staff Initials: TH

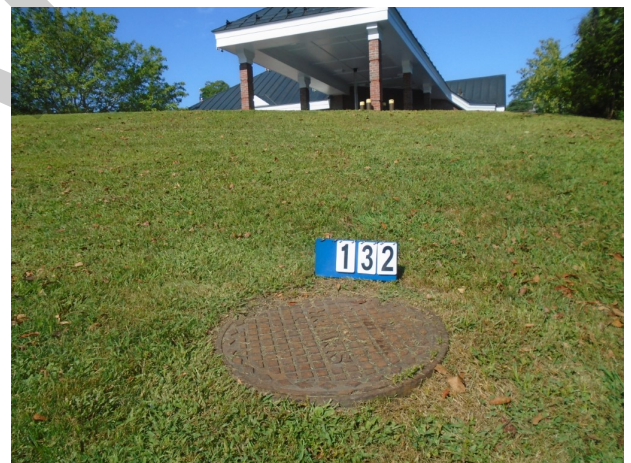
Exterior Manhole Photo

Type? Brick
 Condition? Poor
 I/I? Past Inactive
 Comments? Loose/Missing Bricks from Riser

Loose/Missing Bricks from Riser

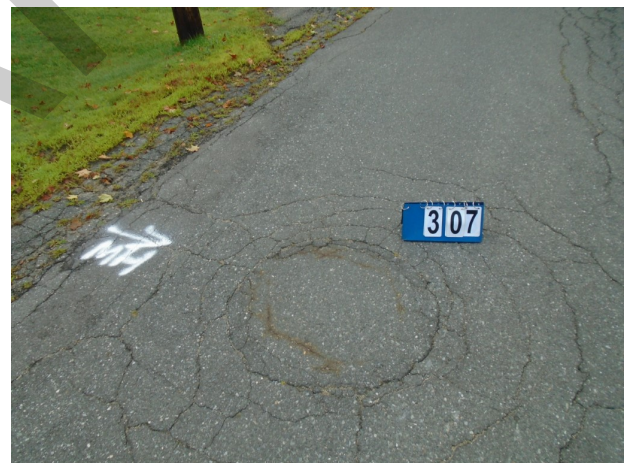
Exterior Manhole Photo

Paved Over

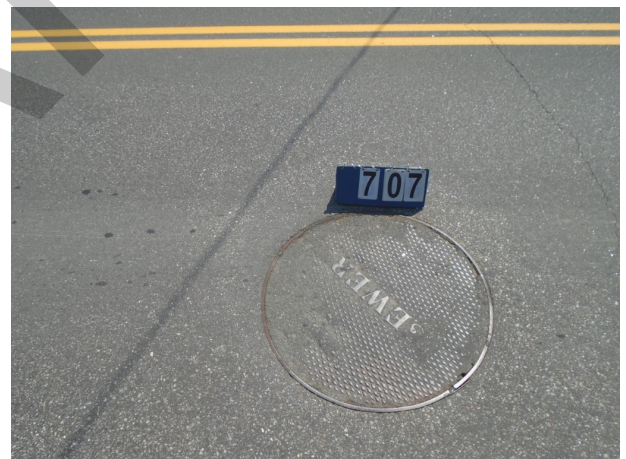
Exterior Manhole Photo

Loose/Missing Bricks from Riser

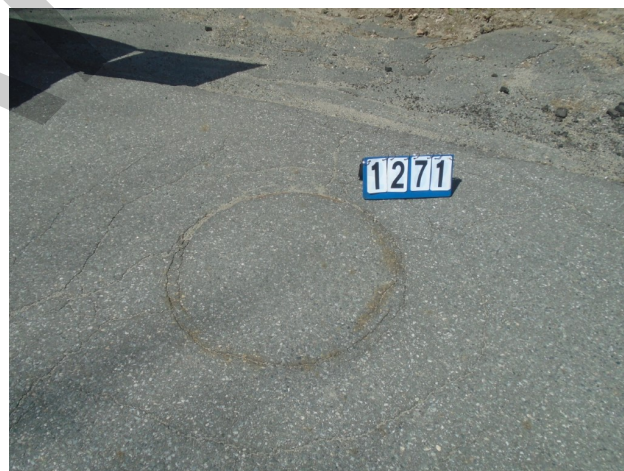
Exterior Manhole Photo

Paved Over

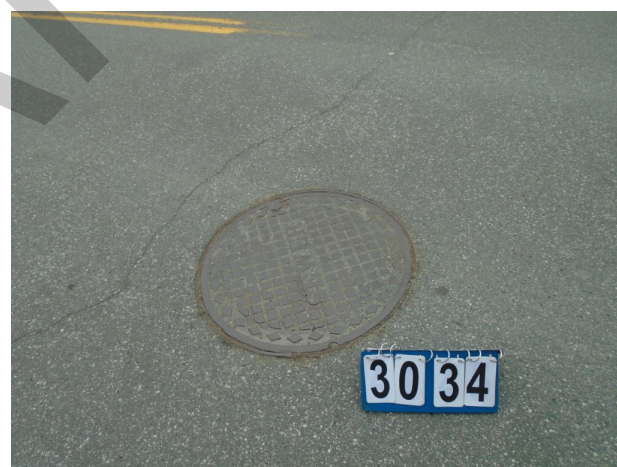
Exterior Manhole Photo

Loose/Missing Bricks from Riser

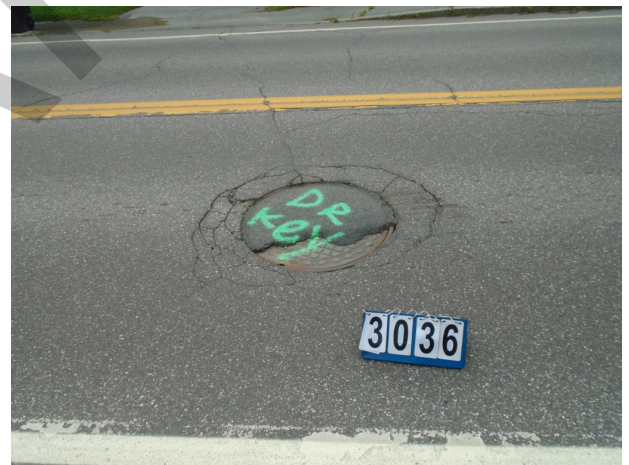
Exterior Manhole Photo

Paved Over

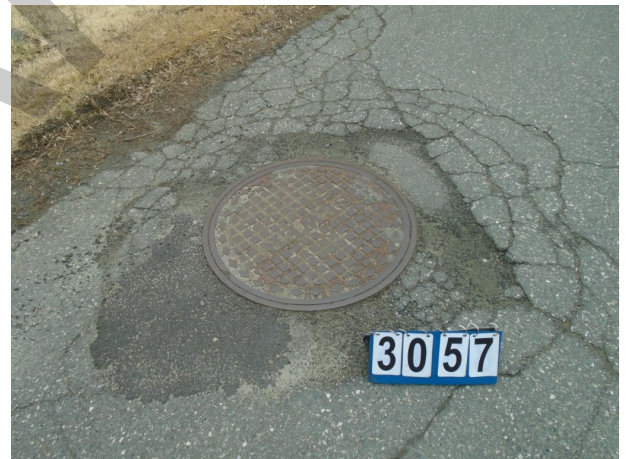
Exterior Manhole Photo

Active Light I/I, Loose/Missing Bricks from Riser

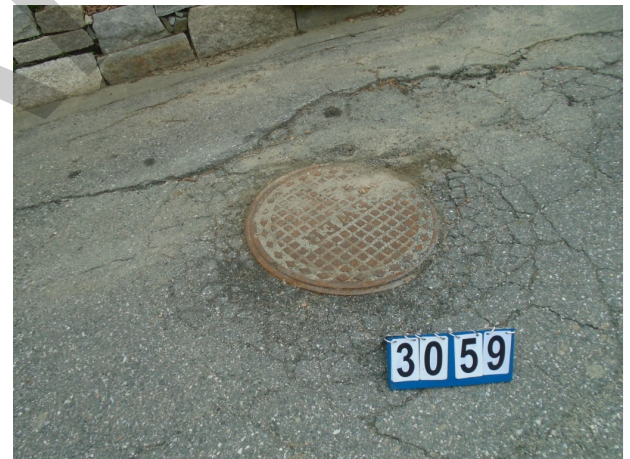
Exterior Manhole Photo

Loose/Missing Bricks from Riser
