Whitney Hall

Enfield's Union Street Fire Station

Enfield's Police Station

Enfield's Ambulance Building

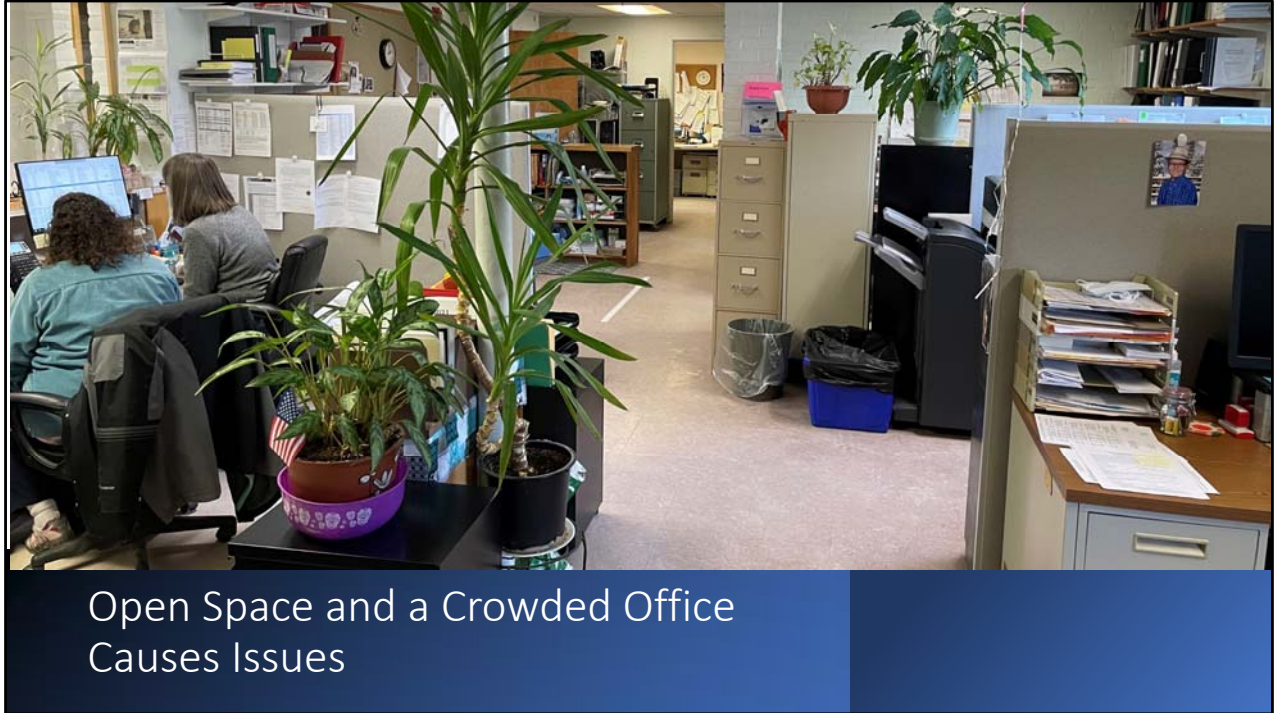
Open Space and a Crowded Office Causes Issues

This main area houses six desk spaces with four people often working in the area. Off this main space is Assessing and the Assistant Town Manager's Office.

With the public coming to the Clerk's window there are constant communications, which often makes it difficult to hold a phone conversation or concentrate on a detail-oriented job.

The open, crowded space has been a cause for concern during COVID-19.

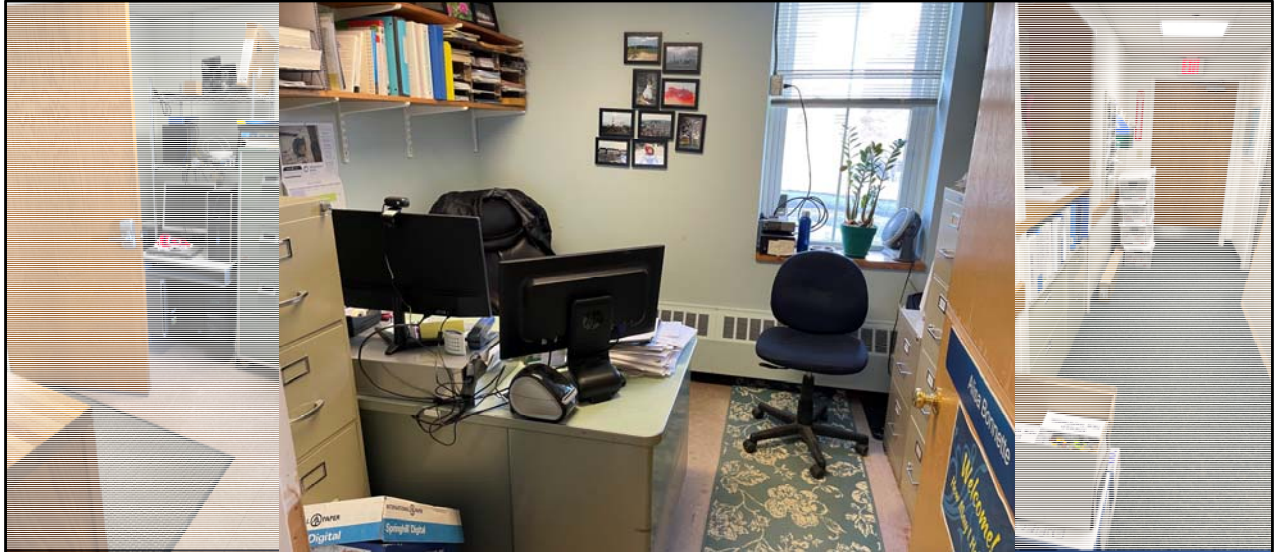
Lack of Storage Space Causes Cramped Quarters

As with other facilities, lack of space is an issue, and storage is at a premium.

Server unprotected in an open space.

Assistant Town Manager's office is more storage than office.

Some documents end up in the hall.

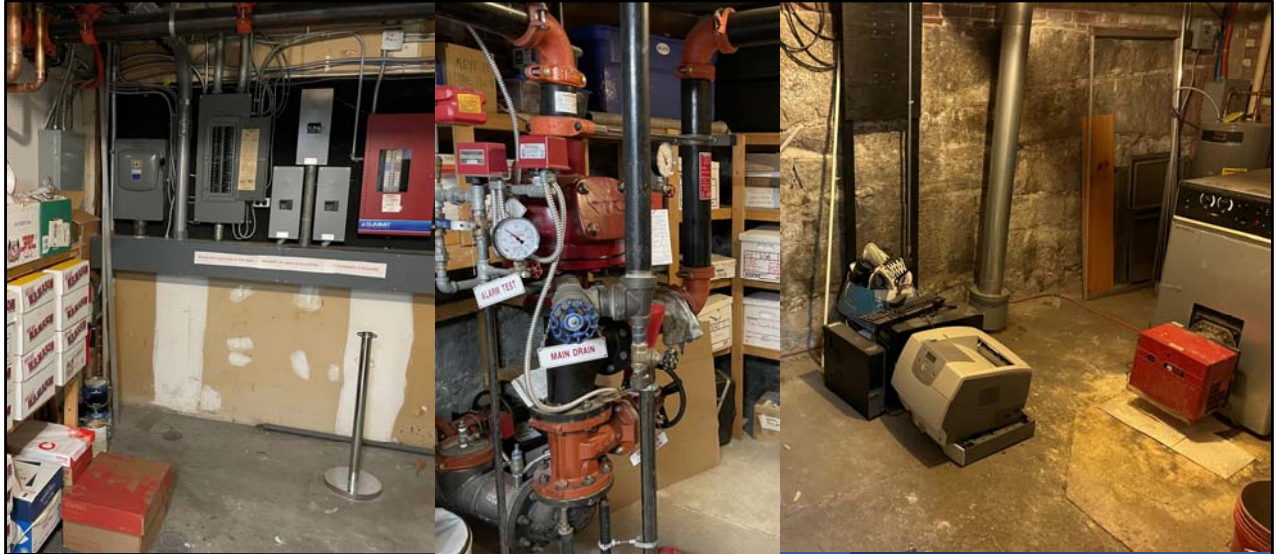
Storage in Utility Spaces is a Fire Hazard

Electrical equipment and the boiler should not have storage around them, especially paper.

The middle picture shows important documents being stored in and around the fire sprinkler system. With activation or issues these documents could be destroyed.

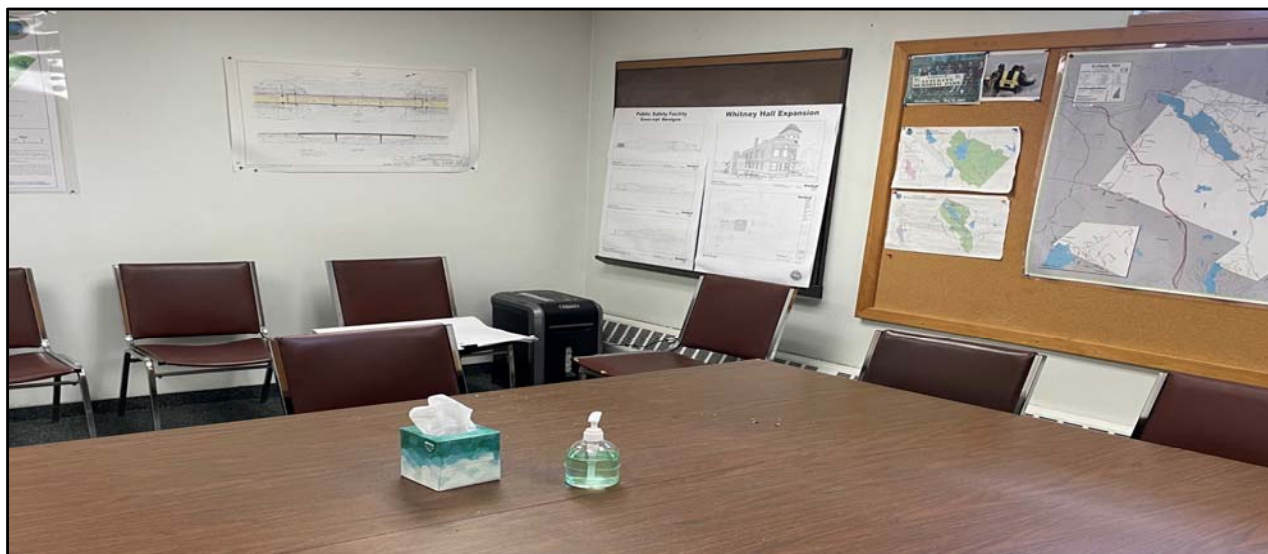
Inadequate Meeting Space

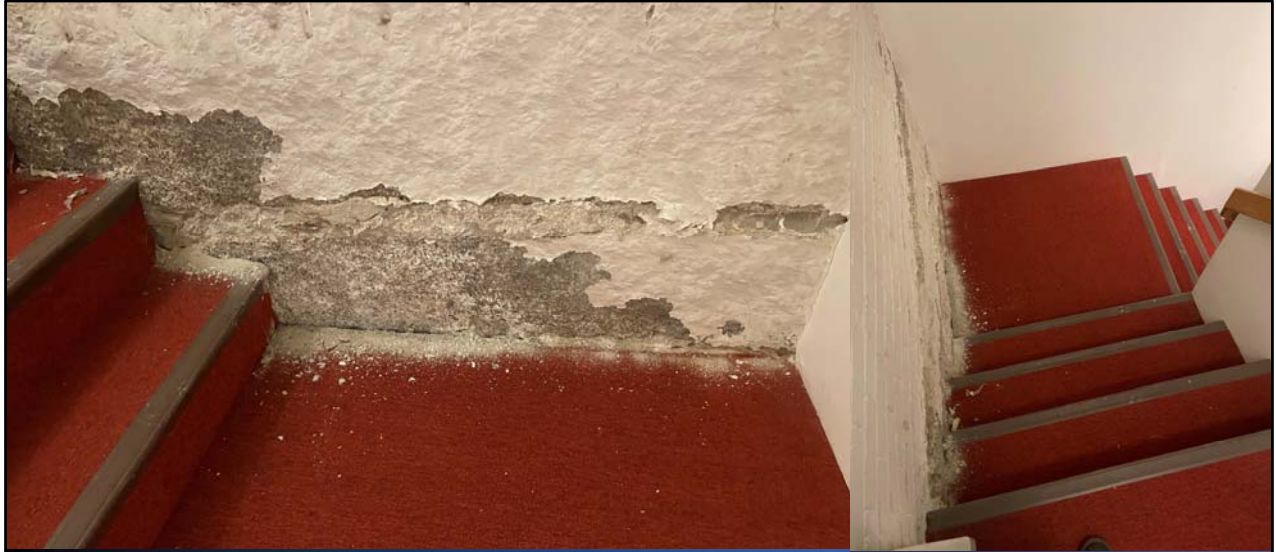
Water Infiltration Causing Mortar to Crumble

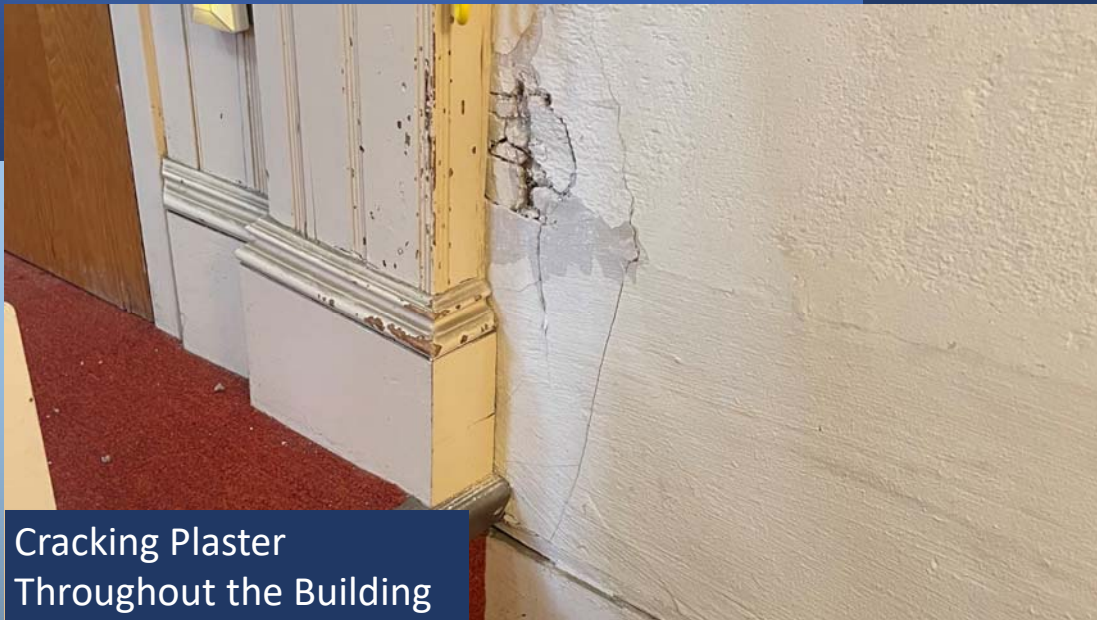
Cracking Plaster
Throughout the Building

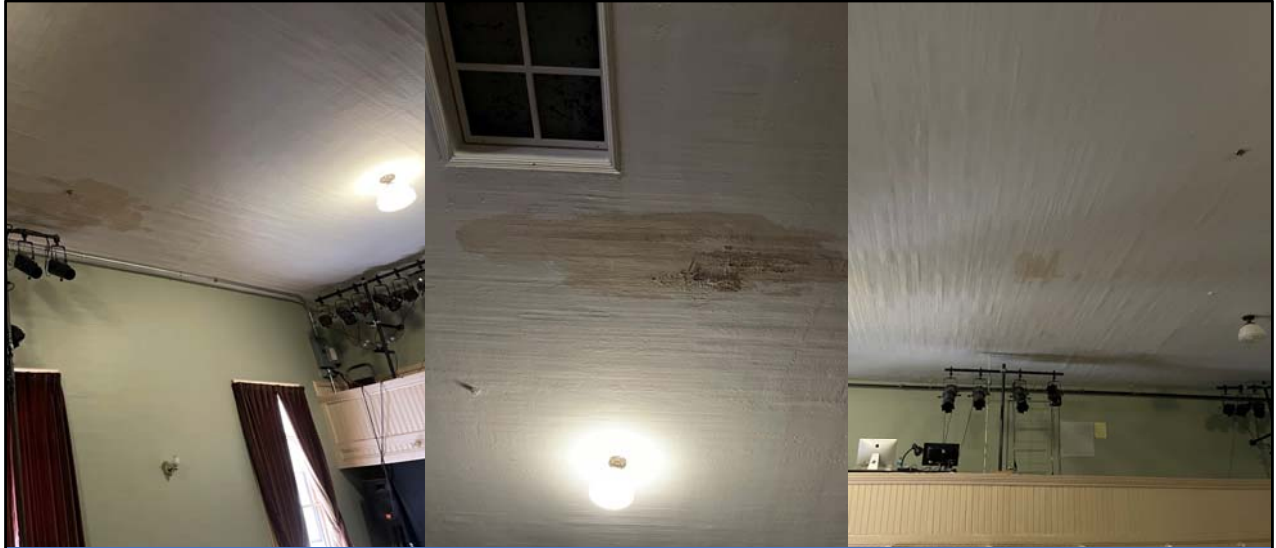
Signs of Water Staining in the Hall

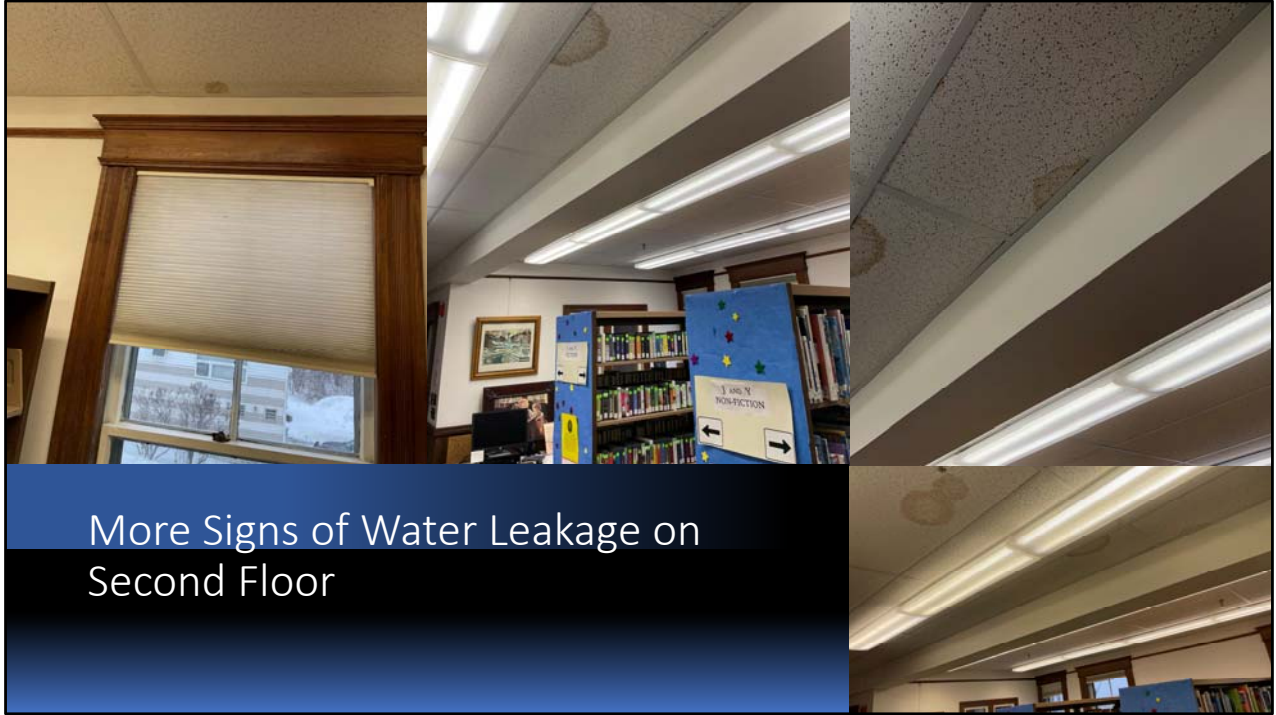
More Signs of Water Leakage on
Second Floor

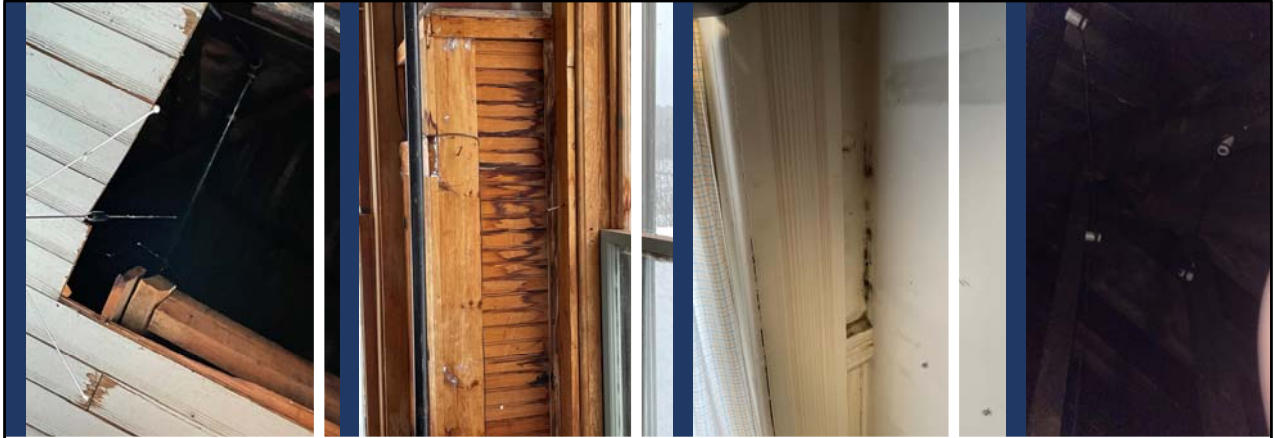
Dangerous Conditions:
Knob and Tube Wiring, Signs of Mold, Cut Open Spaces.

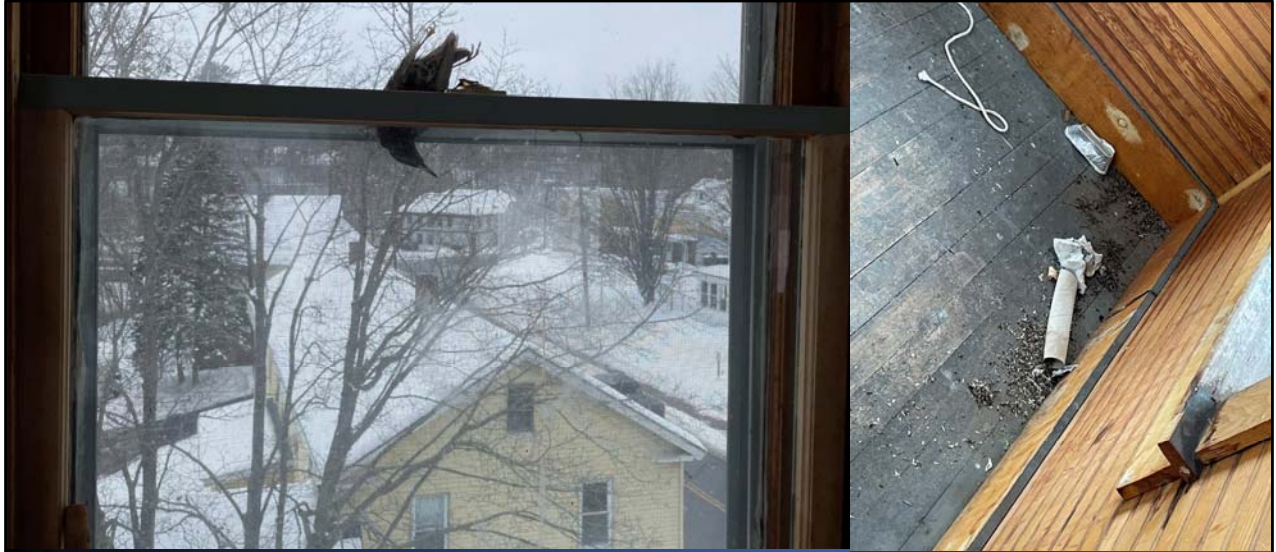
Bird, Rodents and Pest Infiltration

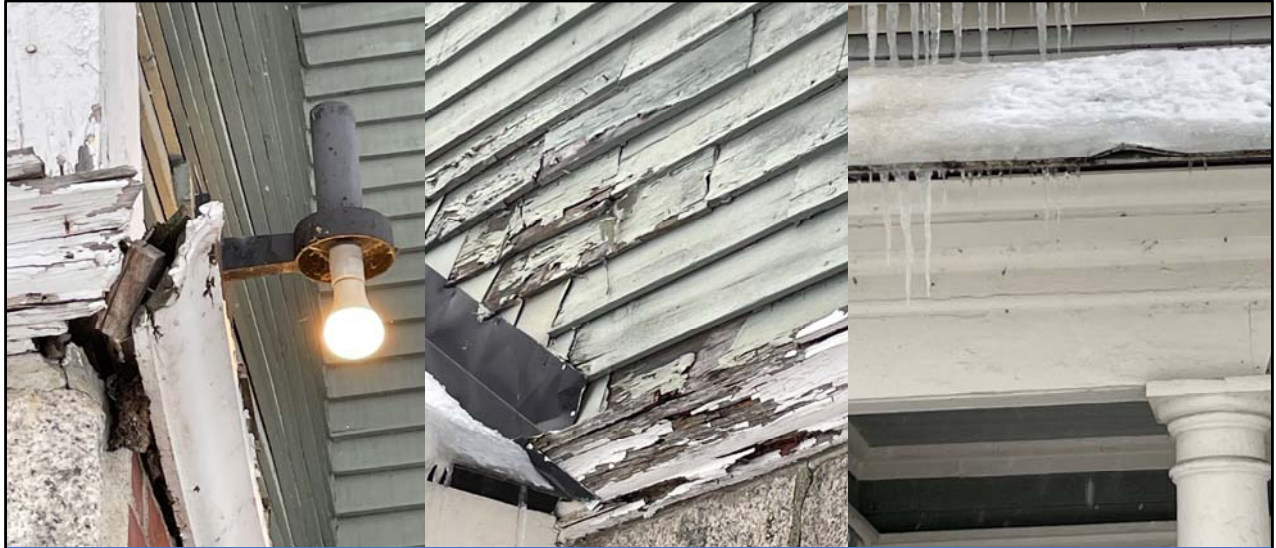
Rotting and Buckling Wood

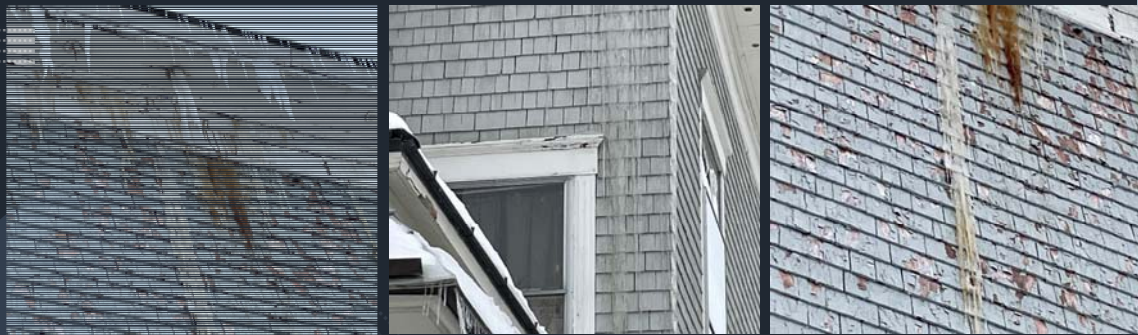
Water Coming Through Siding and Soffits

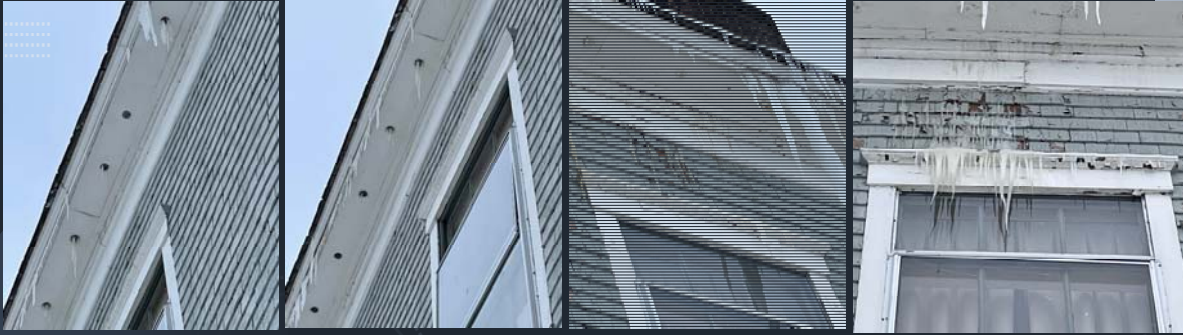
More Water Coming Through
Siding and Soffits

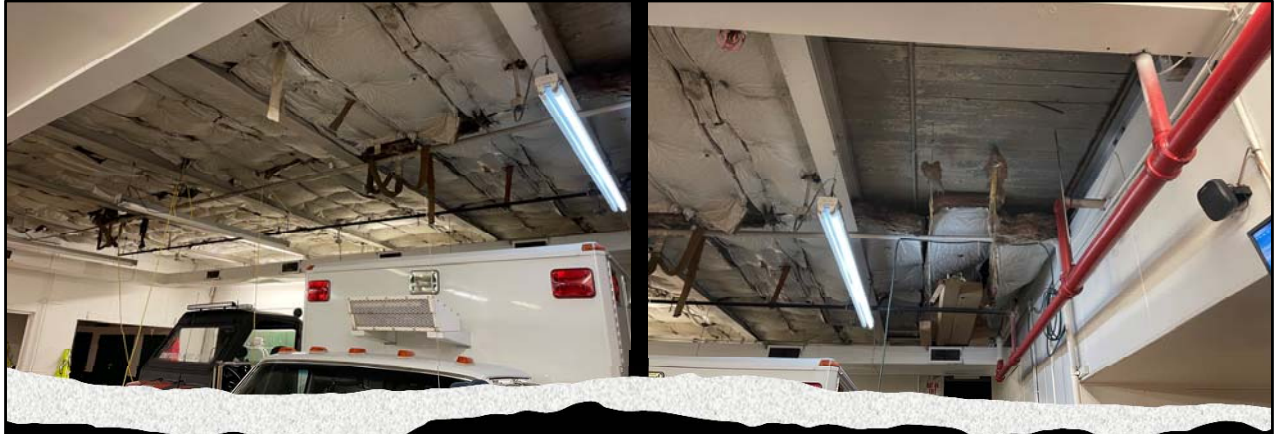
Poorly Insulated

The wood in the picture on the right is the roof decking.

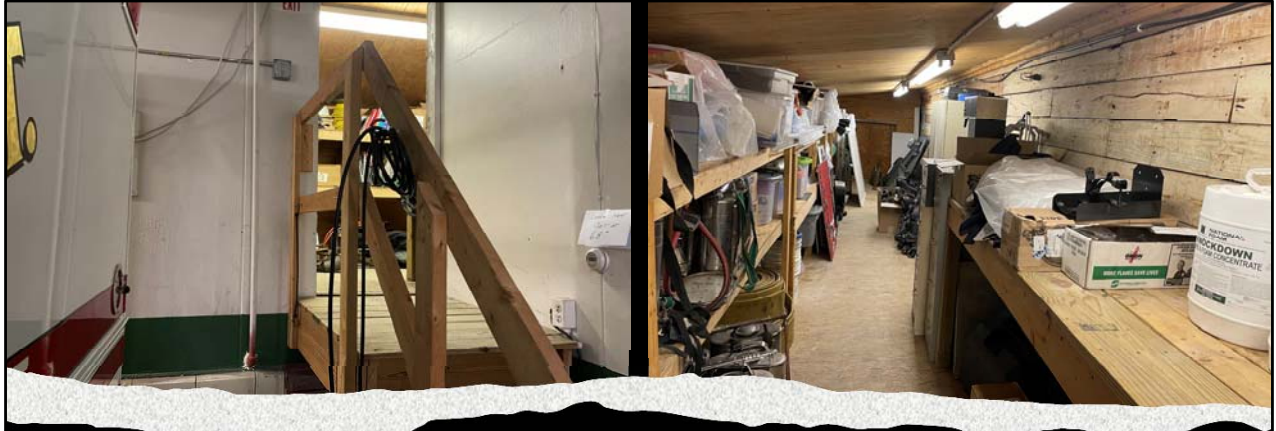
Cold Storage at Rear of Building Creating More Inefficiency

Door stays open to keep the storage area usable.

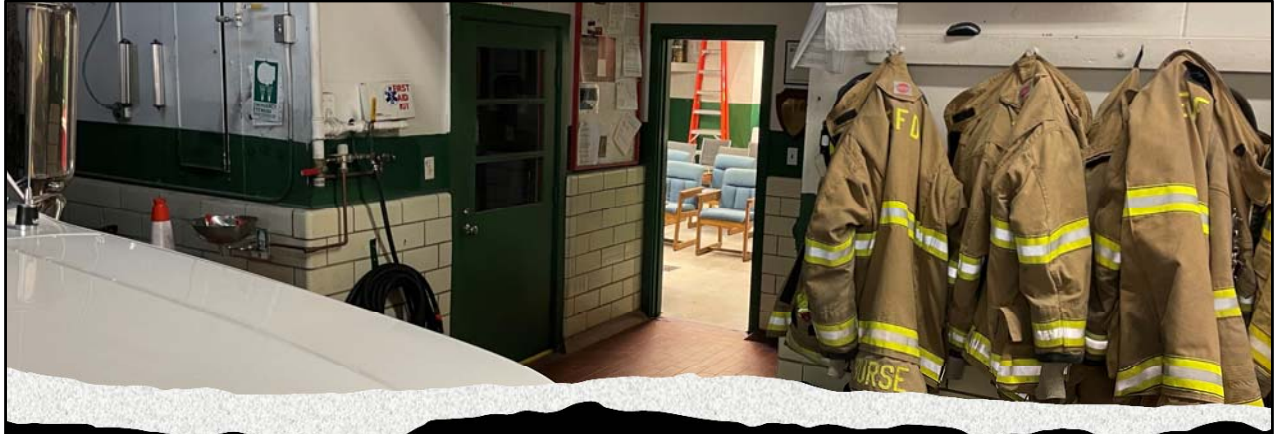
No Separation from Contaminated Area to Training Room and Living Spaces

Before I get to the contamination issues, the apparatus bay being open to the living areas means the bays need to be kept at a warmer temperature than they would be if separated.

Not having the bay properly separated from the living areas increases the likelihood of these carcinogens traveling through the station, contaminating other areas (<https://firefightercancersupport.org/resources/faq/>).

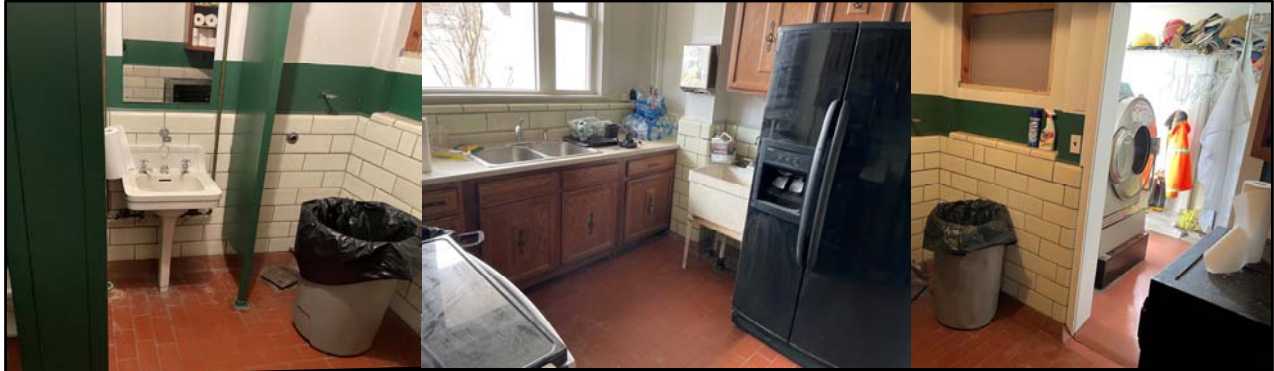
No Personal Decontamination Area (Shower) and Gear Decontamination is in Living Spaces

No shower facilities

To access the gear extractor unit, you must travel through the restroom.

Breathing mask and gear decontamination takes place in the deep sink that is located in the kitchen.

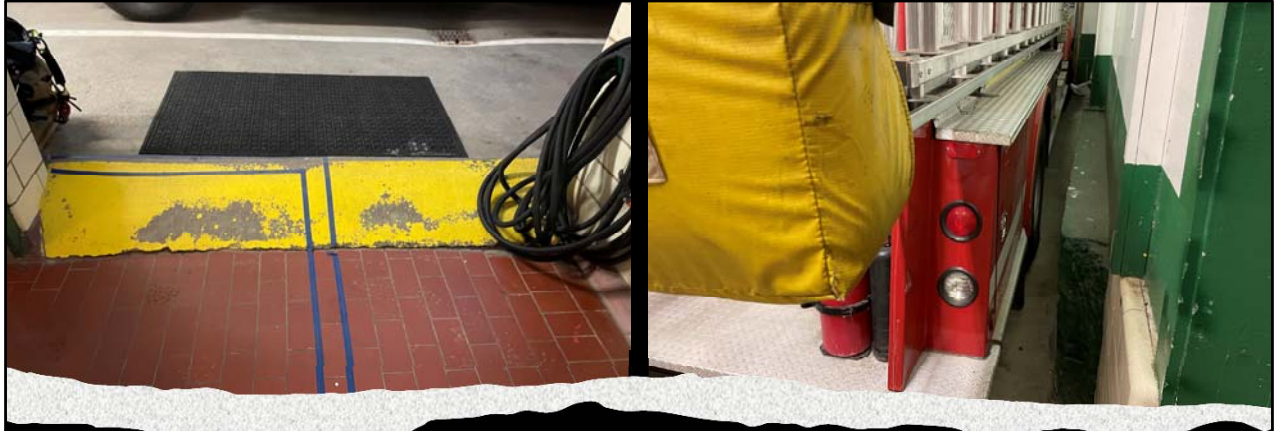
Trip Hazards and Tight Spaces

The Bay was raised to support the added weight of the fire apparatus, causing a trip hazard.

Reserve engine is very tight to the wall and needs to be pulled out of the station to access the compartments.

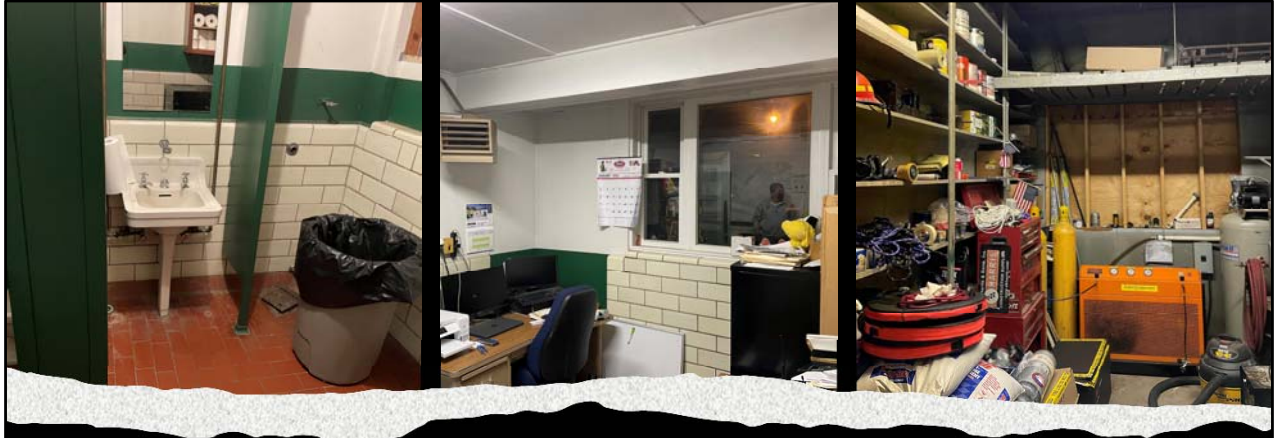
Limited Storage, Workspace

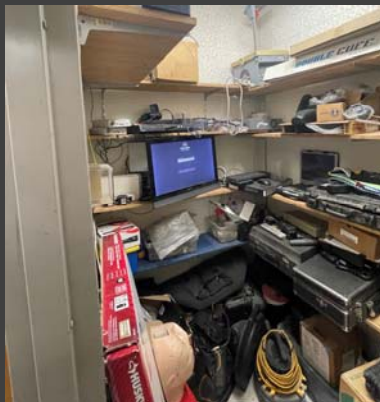
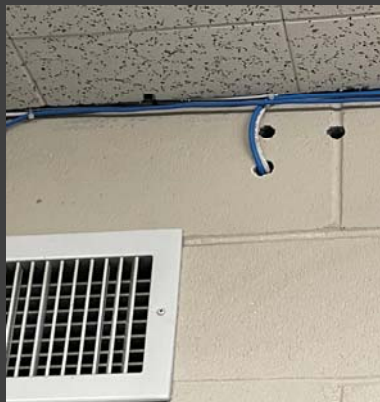
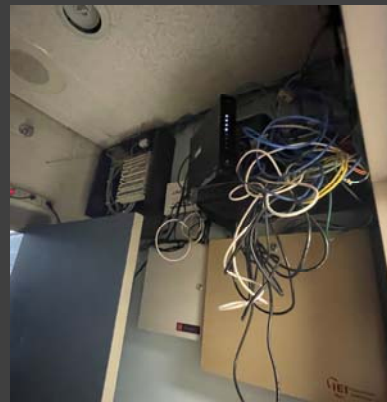
Mold and Poor Conditions

Building is seeing issues from the age of the building and lack of proper maintenance by the Town.

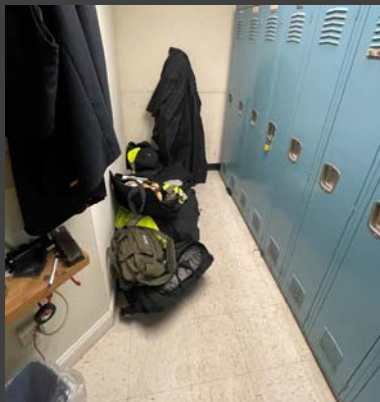
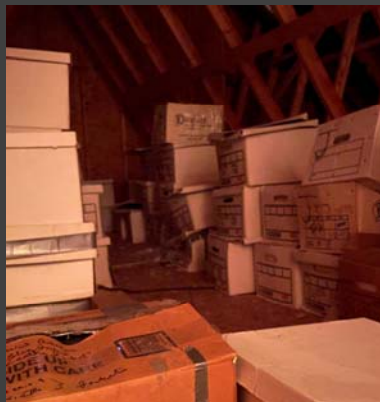
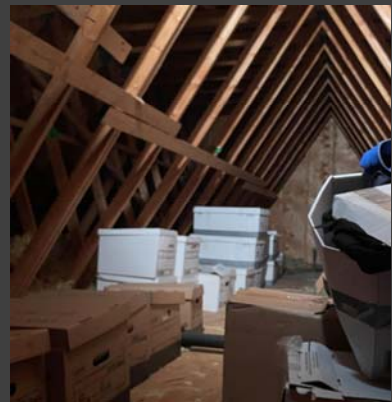
Building Not Designed for Today's Technology (Not CJIS Compliant)

Part of the CJIS compliance checklist is “Organizations that store CJIS must have policies and procedures in place to ensure that all forms of media are protected and disposed of securely when they are no longer in use. Server rooms should be secured using locks, alarms, cameras, etc.”

The Police department also has technology challenges because of the lack of conduit and IT space needs.

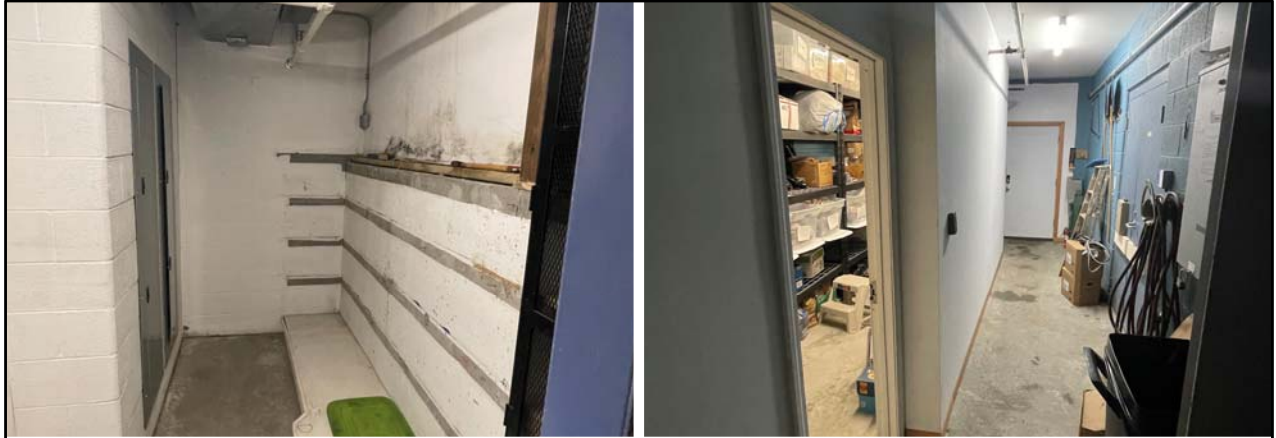
Lack of Space

To continue with the lack of space, file storage has been an issue with files stored in the attic space, evidence and other key pieces of equipment being stored in lockers and in the interview room and other spaces throughout the building.

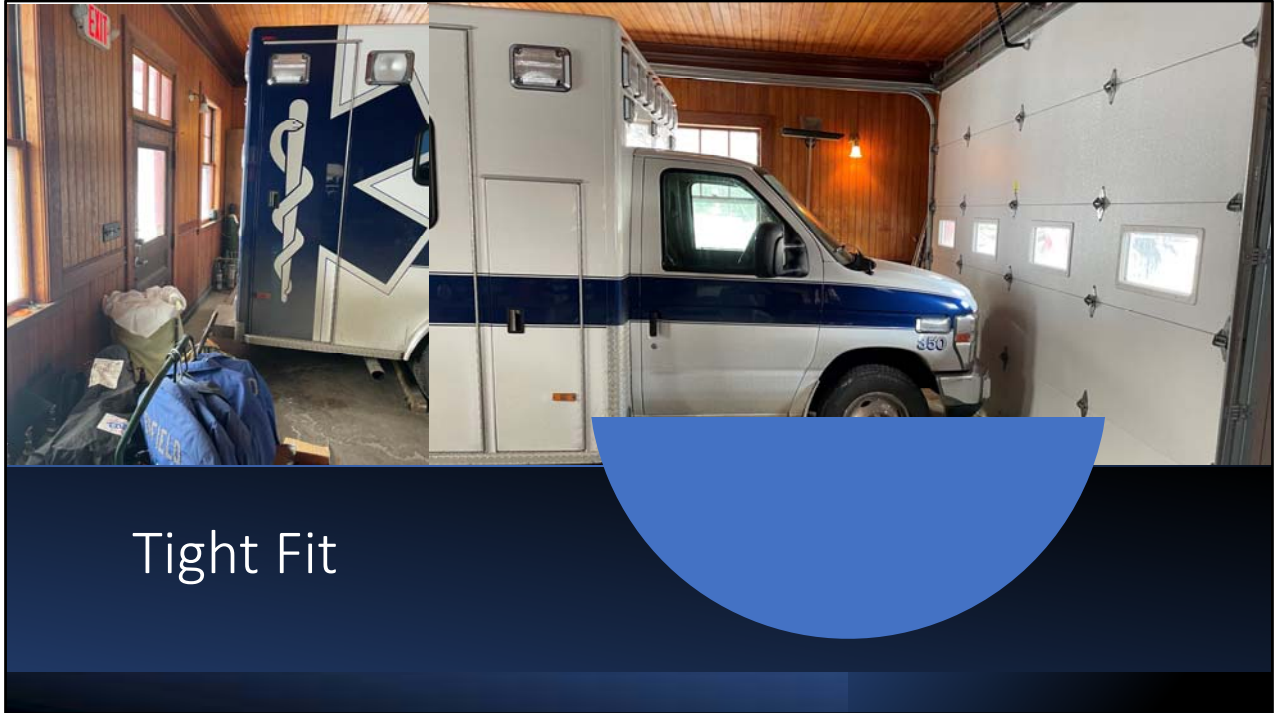
The ambulance fits very tightly into the building, making it difficult to restock or clean after calls. The ambulance, no matter the weather, needs to be pulled out of the station to decontaminate, wash, or to restock.

The ambulance also barely fits through the door and has lost a few antennas because of this.

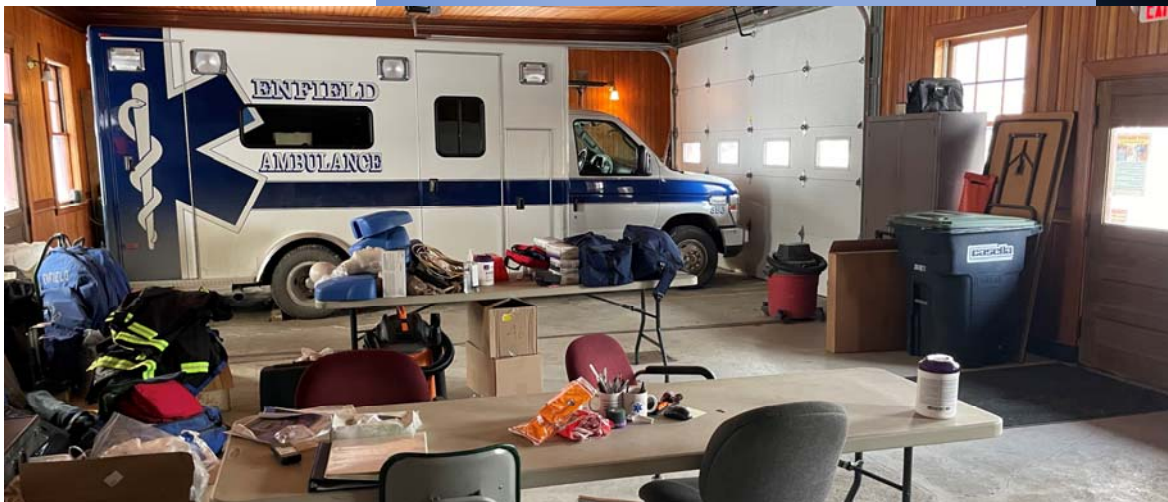
An Ambulance in the Training Room?
Not Safe and Does Not Meet State Requirements

There again is no diesel exhaust collection system, which causes diesel soot to be distributed throughout the building, which is a carcinogen.

In this small building, there is a strong smell of diesel fuel because of this.

Because of the lack of separation, no State EMS classes can be taught in this building, not even to our own responders.

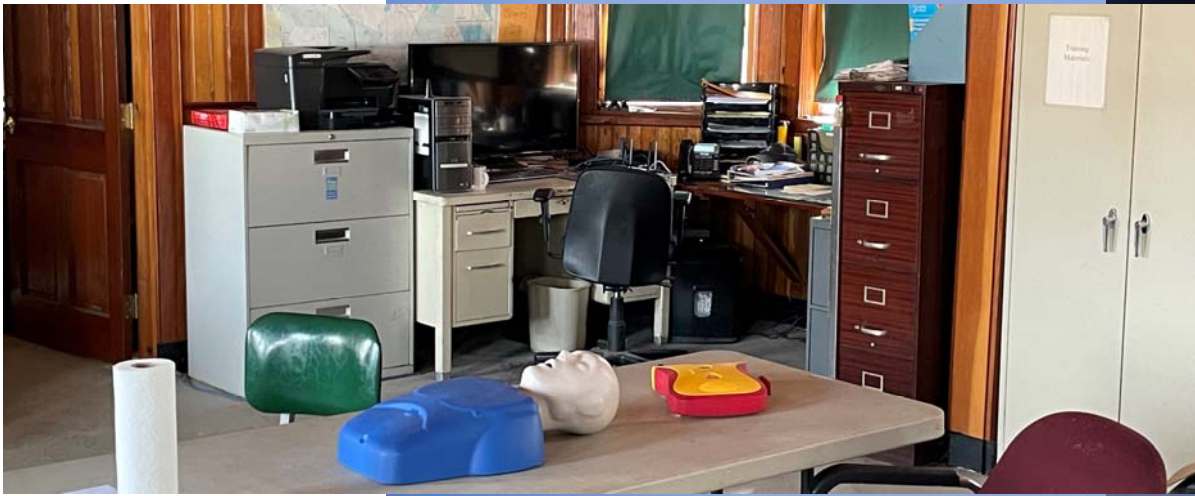
The Office in the Training Area Could Pose a HIPAA Violation

Having the office space in the training room, provides concerns about Health Insurance Portability and Accountability Act of 1996 (HIPAA) violations if someone was to complete their reports while someone else is in the room.

The office area is also open to the diesel fumes from the ambulance being in the same room.

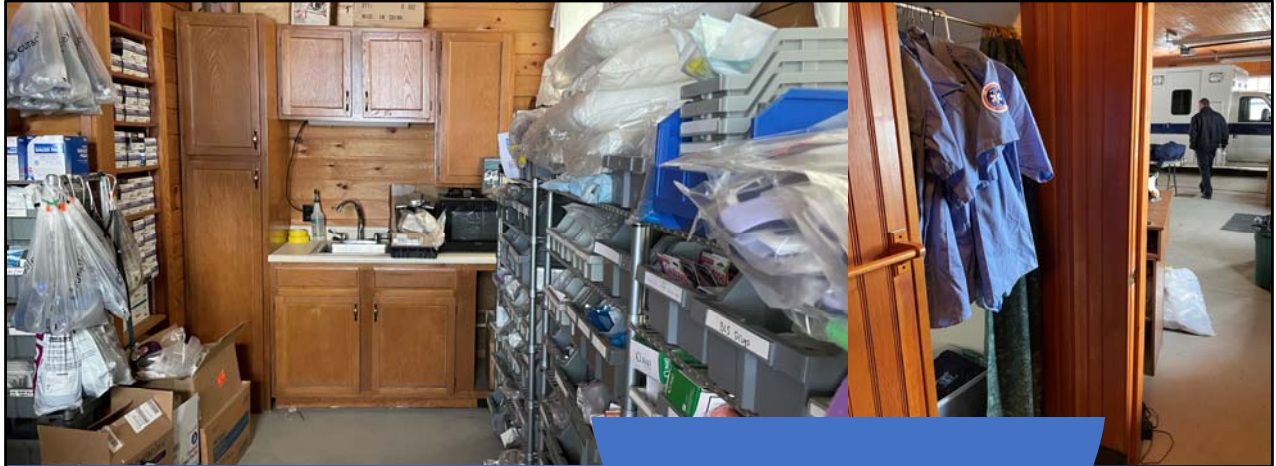
Storage Issues

As with our other facilities, the storage space is not adequate in the ambulance facility.

There is also evidence of diesel soot on the medical supplies.

With a lack of laundry facilities and storage, the shower is used to store uniforms, that would need to be moved before someone could wash up if they got bodily fluids on themselves.

Because of the lack of cleaning and laundry facilities many times the biohazard ends up going home with the responders to be cleaned.

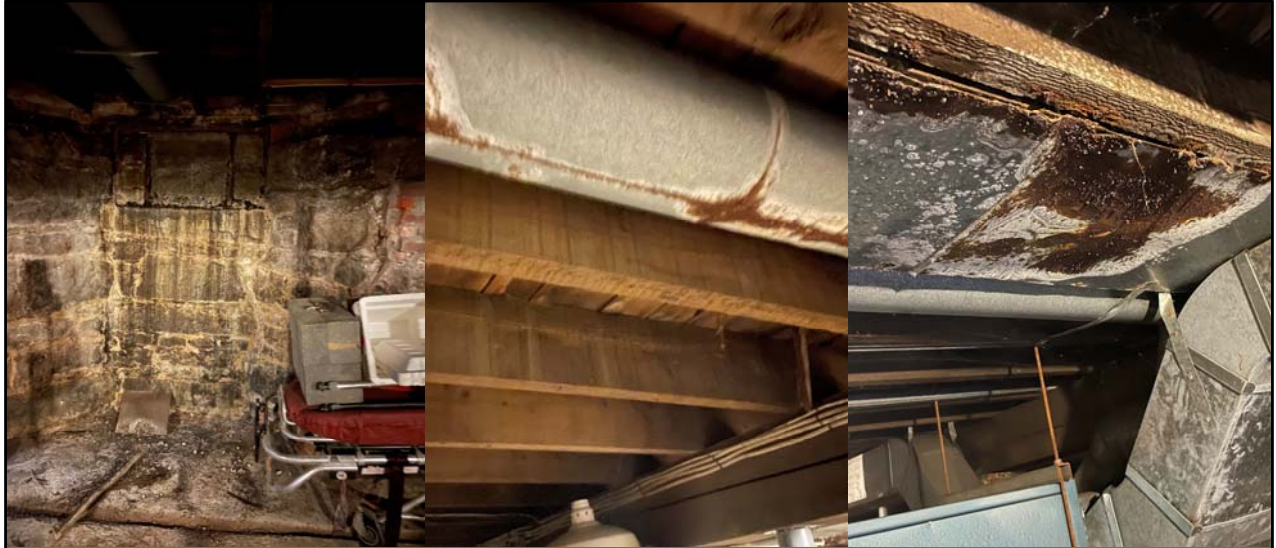
Water and Rust and Mold, Oh My!

The constant water in the basement is causing many issues with the building.

The Town goes through many sump pumps and has had many feet of water in the basement multiple times.

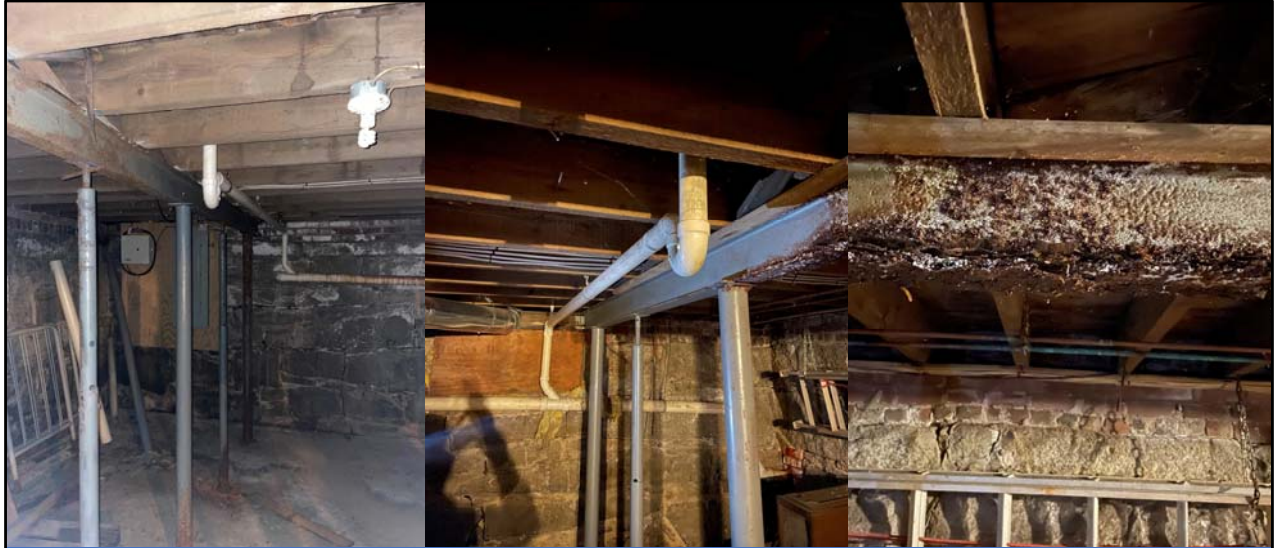
More Moisture Issues, Below Ambulance

The lally columns on the left are deteriorating. They have been replaced once, but some of them are within a year or so, of needing to be replaced again.

The I-beams that are rusting and separating are under the ambulance. The floor above them is a wooden floor covered with 4" of concrete.

The last two times I have been in the building, water was coming through the wall behind the electric panel, that can be seen in the left picture.
