Municipal Facilities Evaluation & Conceptual Design Project

Final Report & Recommendations of the
Municipal Facilities Advisory Committee

September 2020

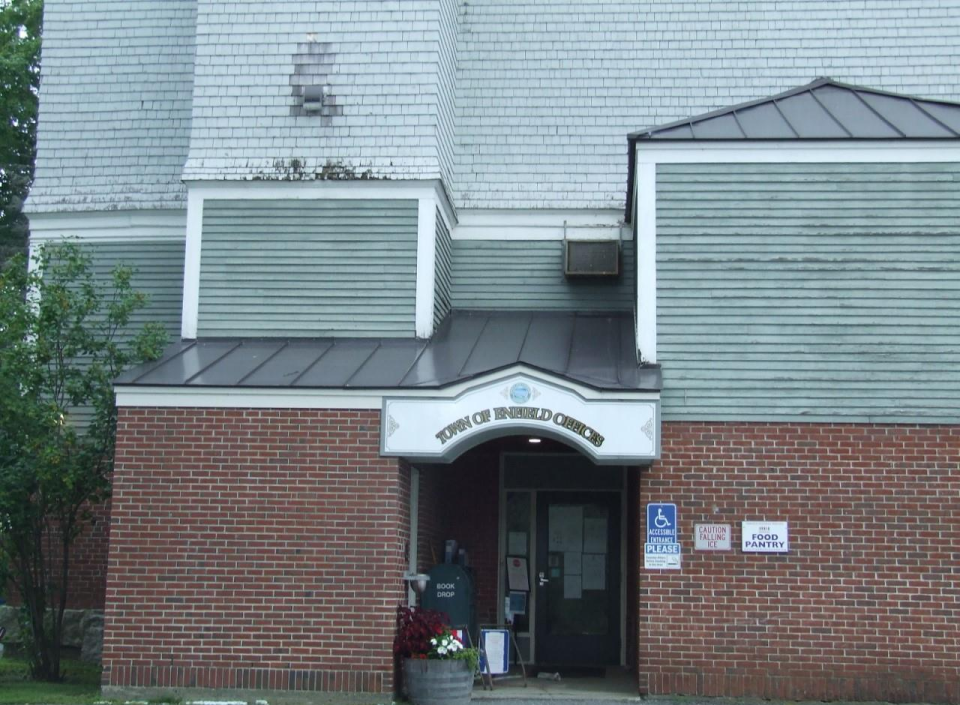
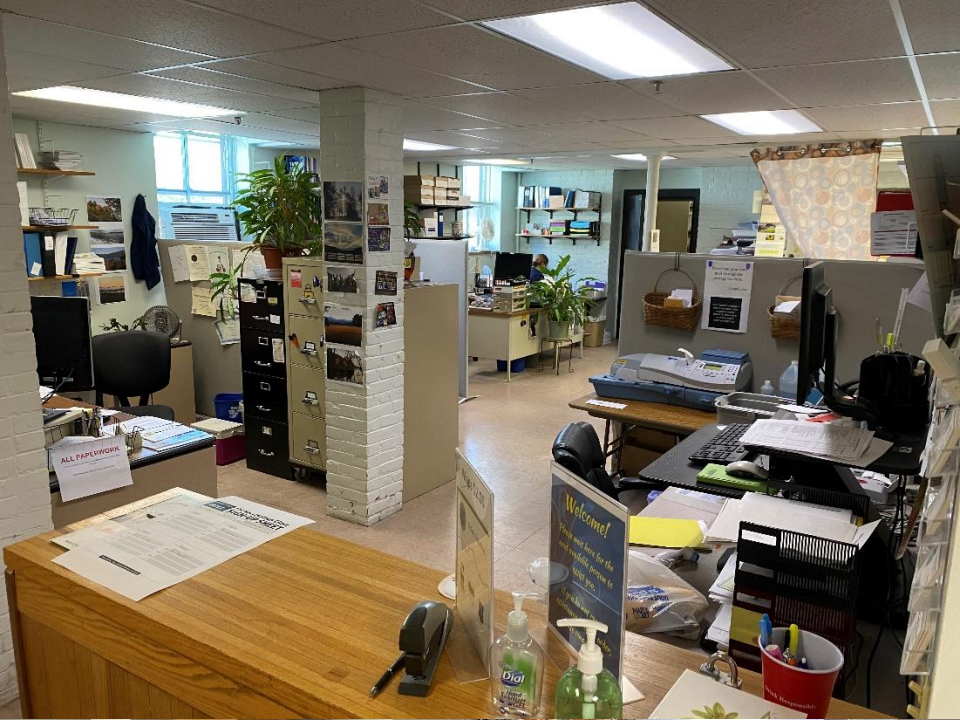
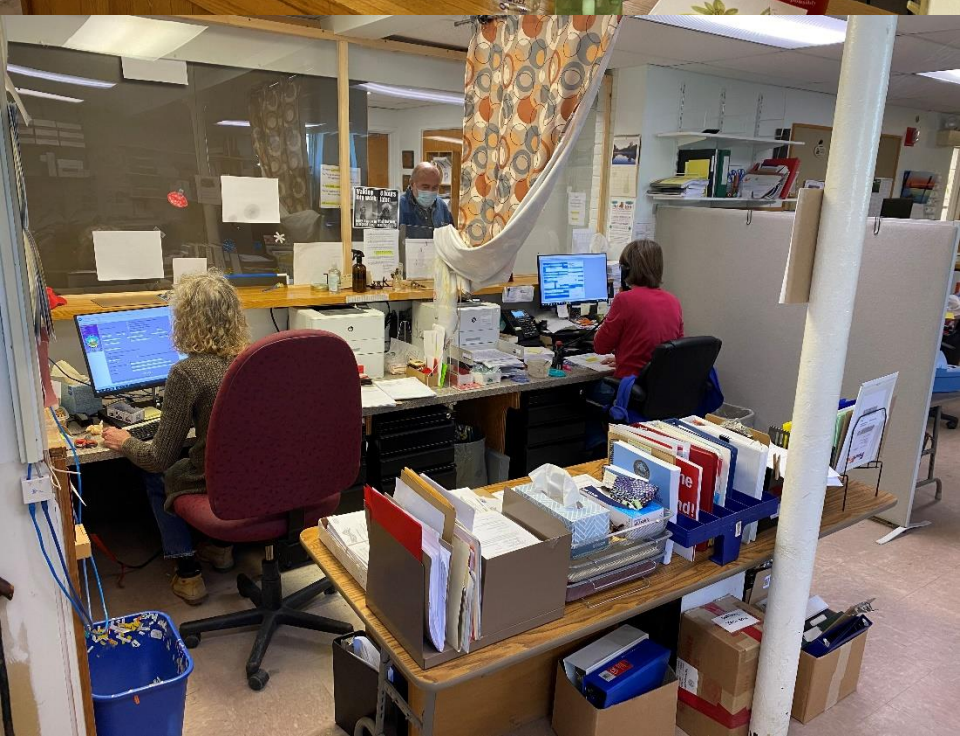
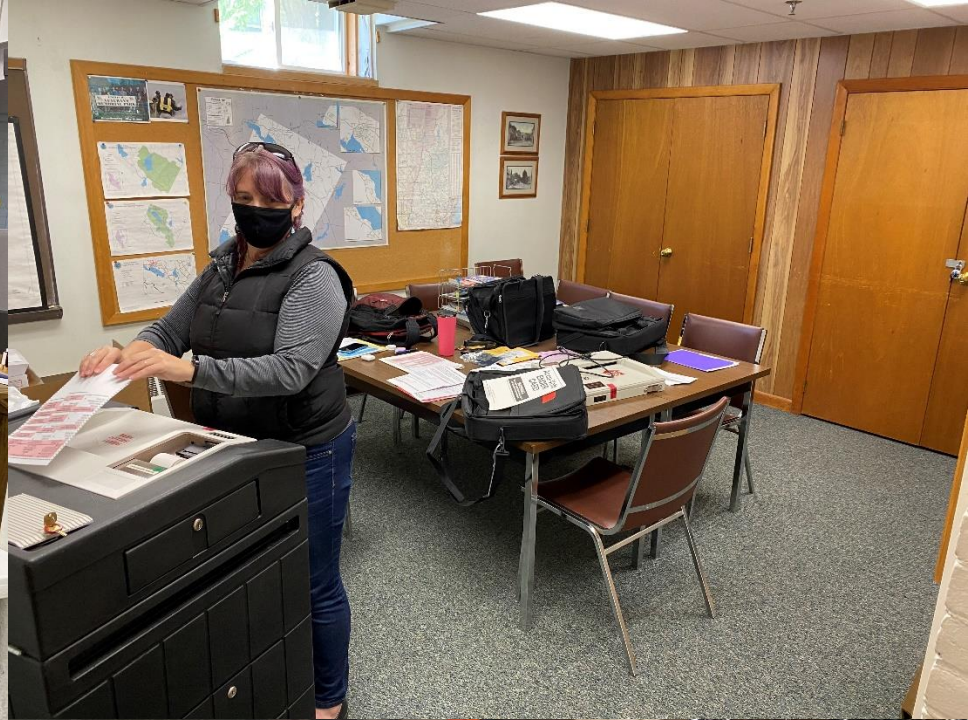
Unsatisfactory Facilities – Whitney Hall

- Building is historic and very much showing its age; worn and dingy interior. Roof, siding, fascia, foundation, tower are all in serious disrepair. Shortage of bathrooms (upper level). Outdated electrical. Totally inadequate energy wise. Antiquated and slow-moving elevator. Extensive costs for heating due to poor condition and aging mechanical systems. Lack of central cooling system (compromises productivity). Poorly insulated. Drafty windows. Pest infestation. Inadequate sound proofing.

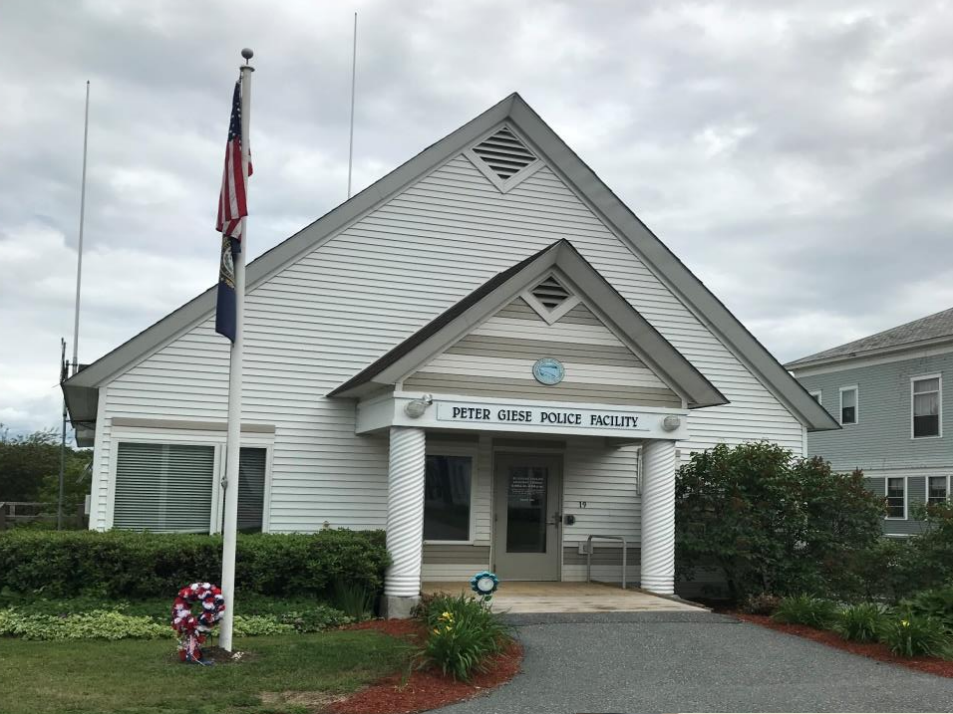
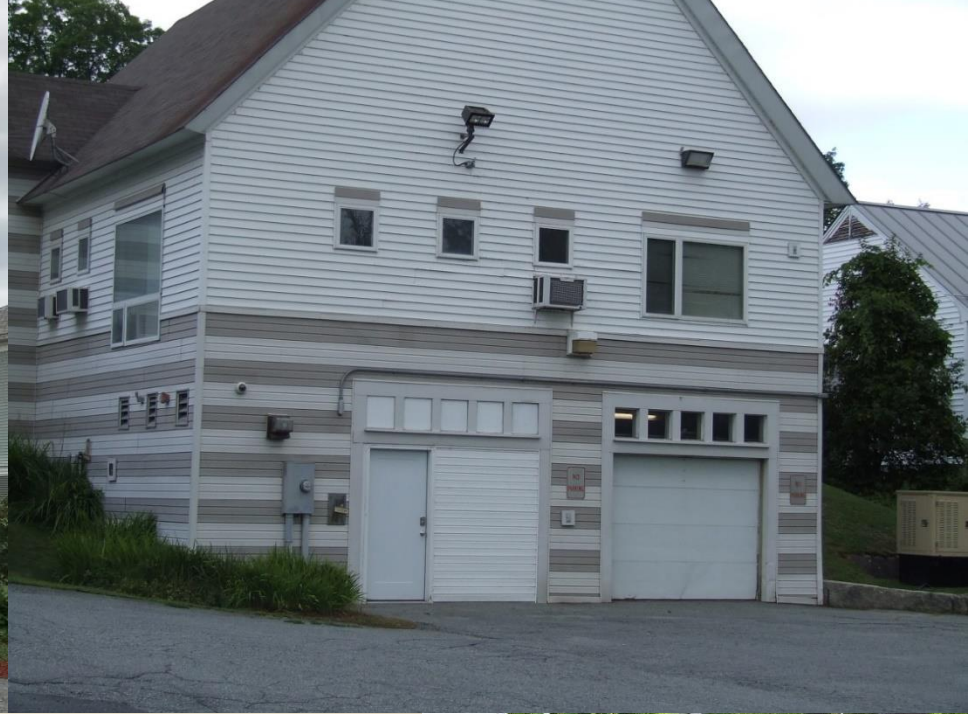
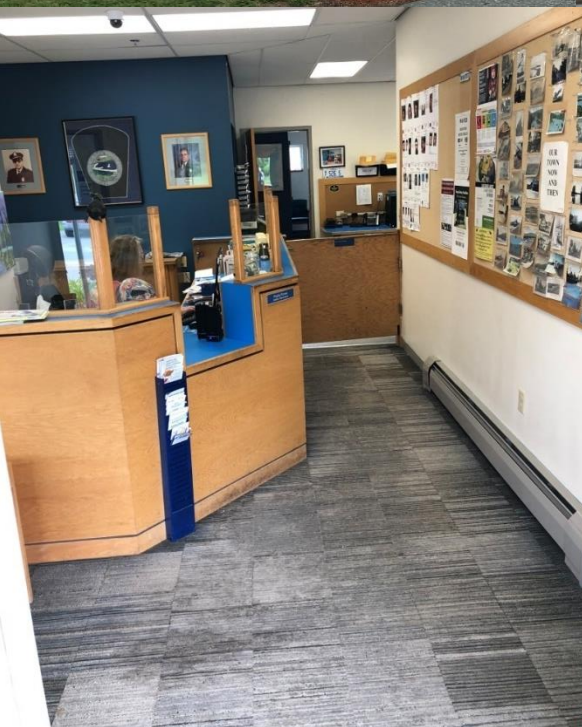
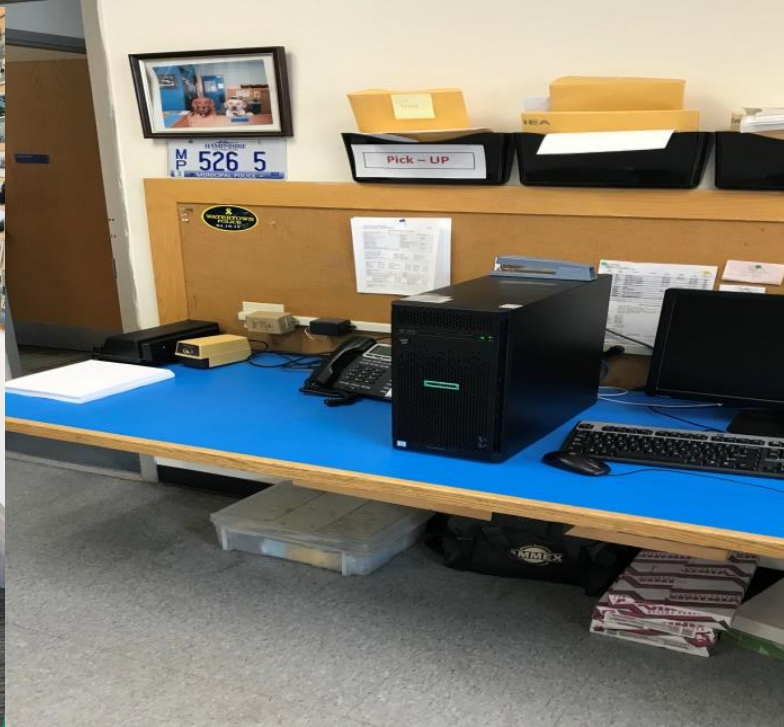
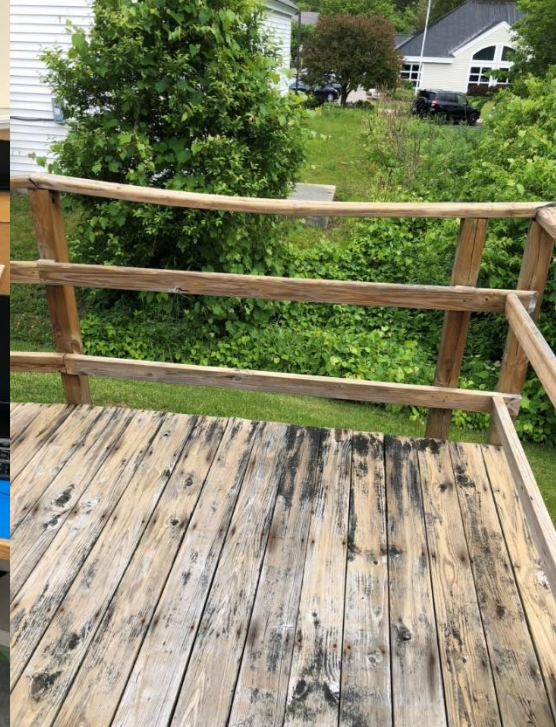
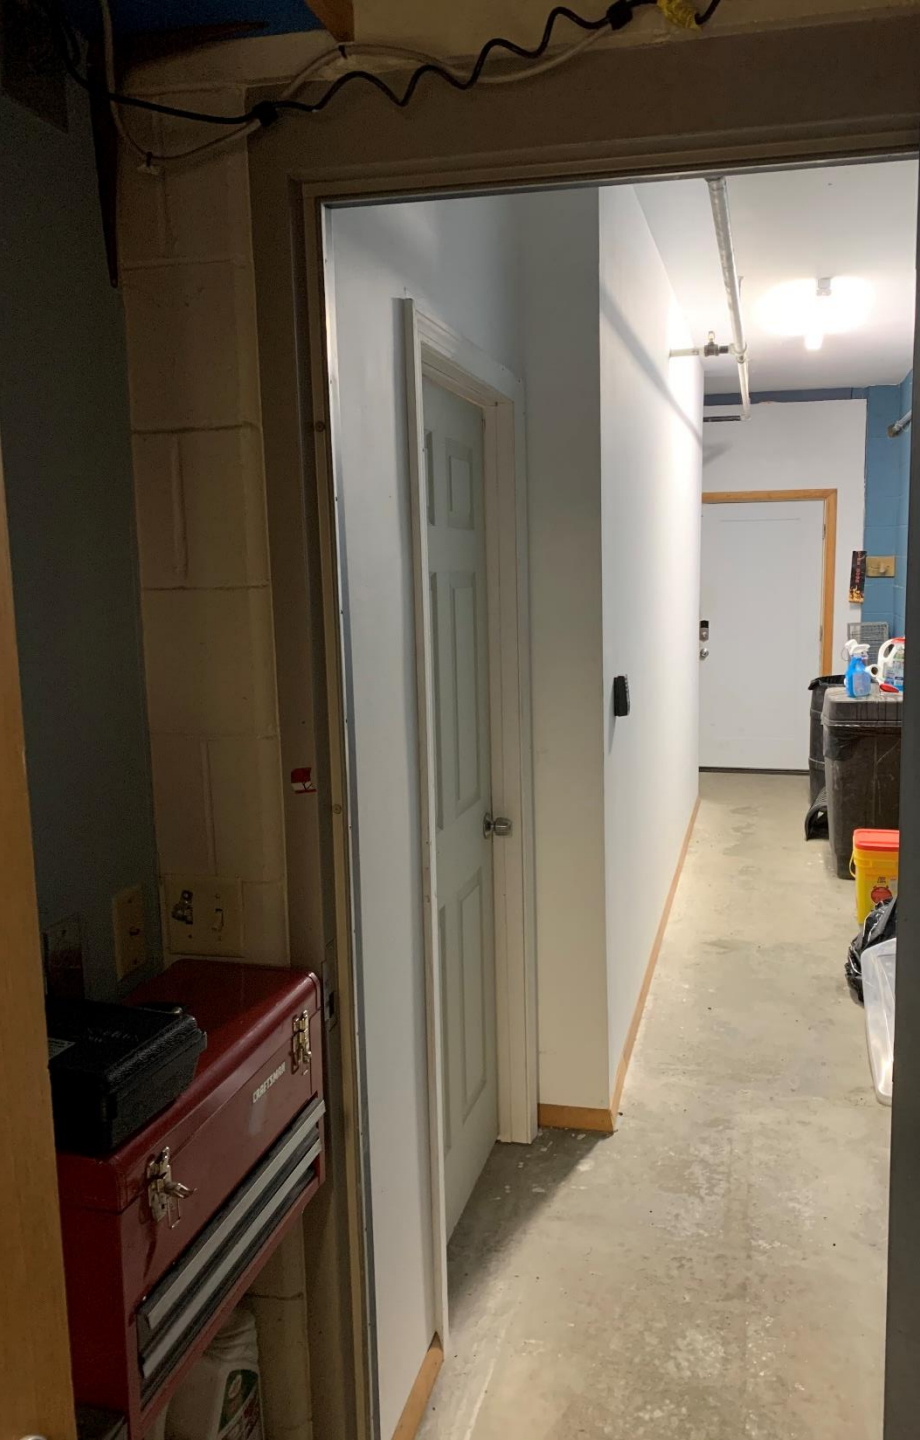
Unsatisfactory Facilities – Public Safety Police Station

- Inadequate square footage. Heating cooling system does not work properly despite many attempts to repair (unhealthy and compromises productivity). External appearance inconsistent with historical character of Enfield village. Roof uncompliant with snow load requirements.

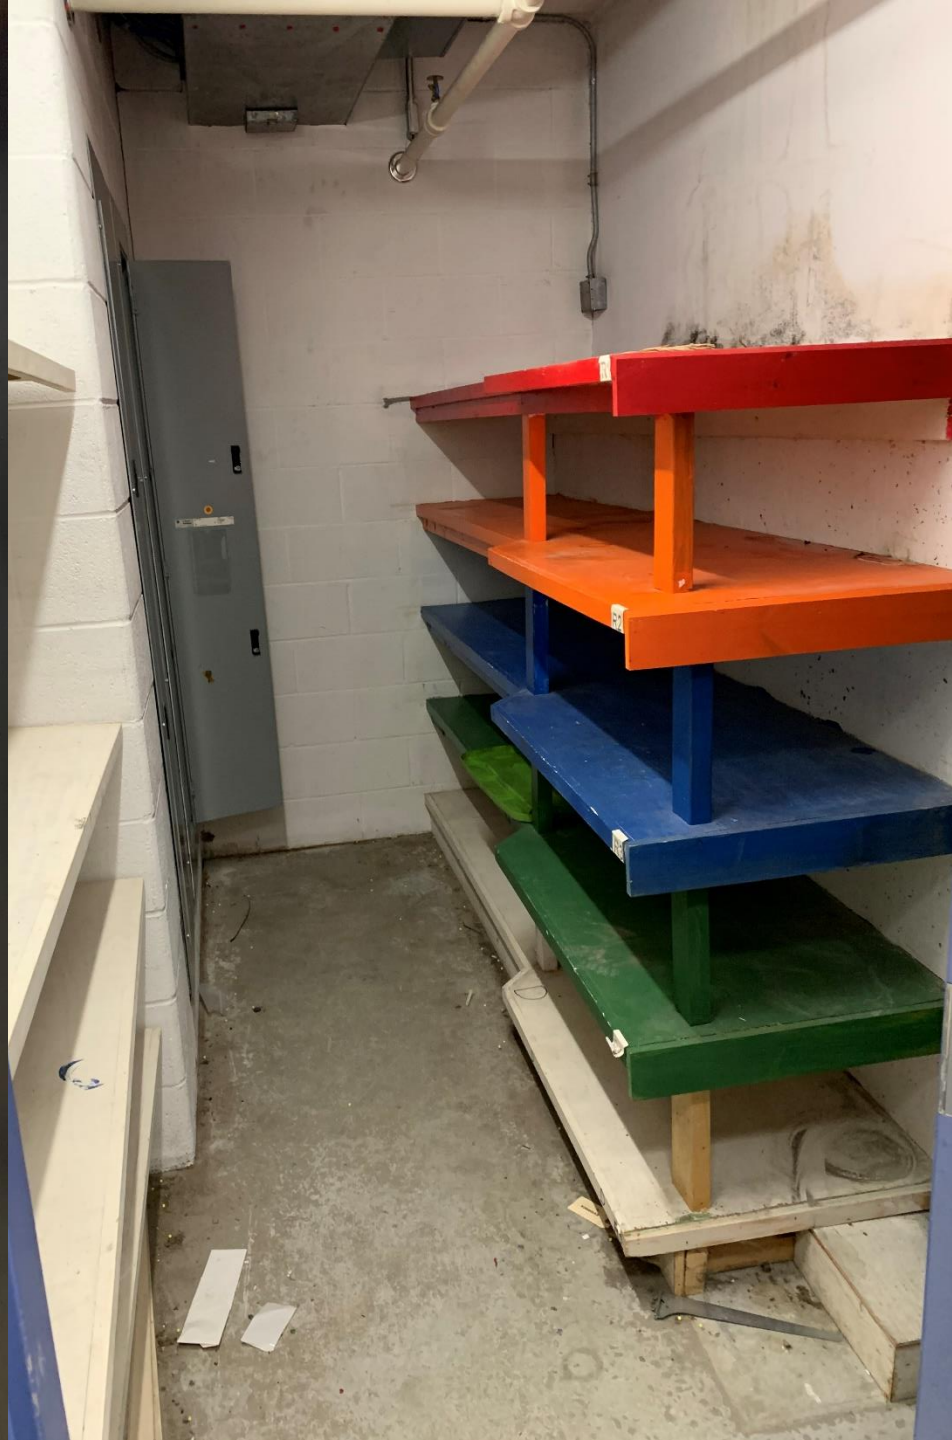
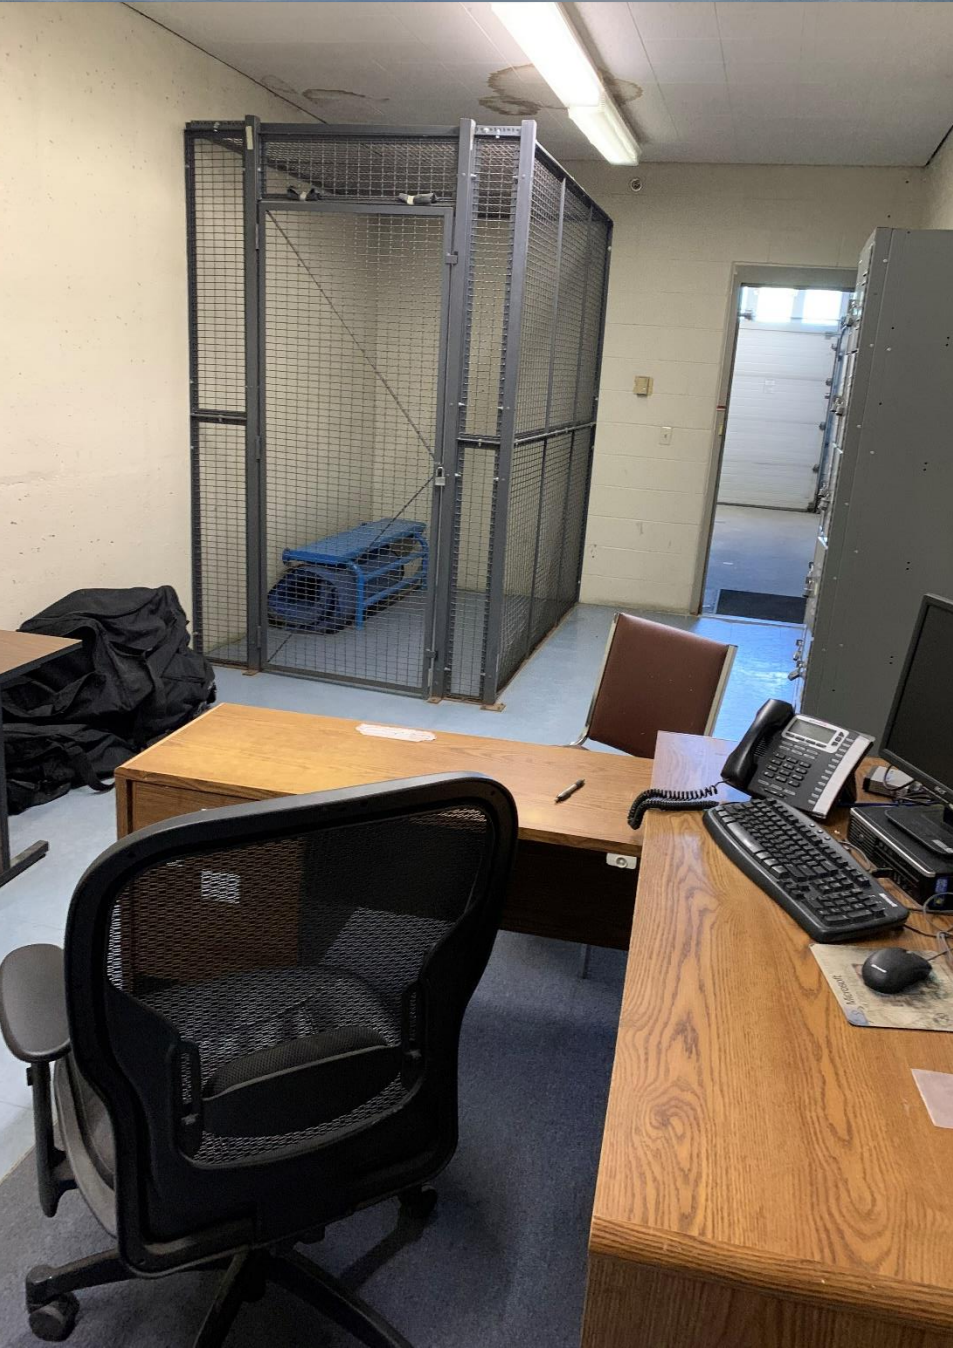
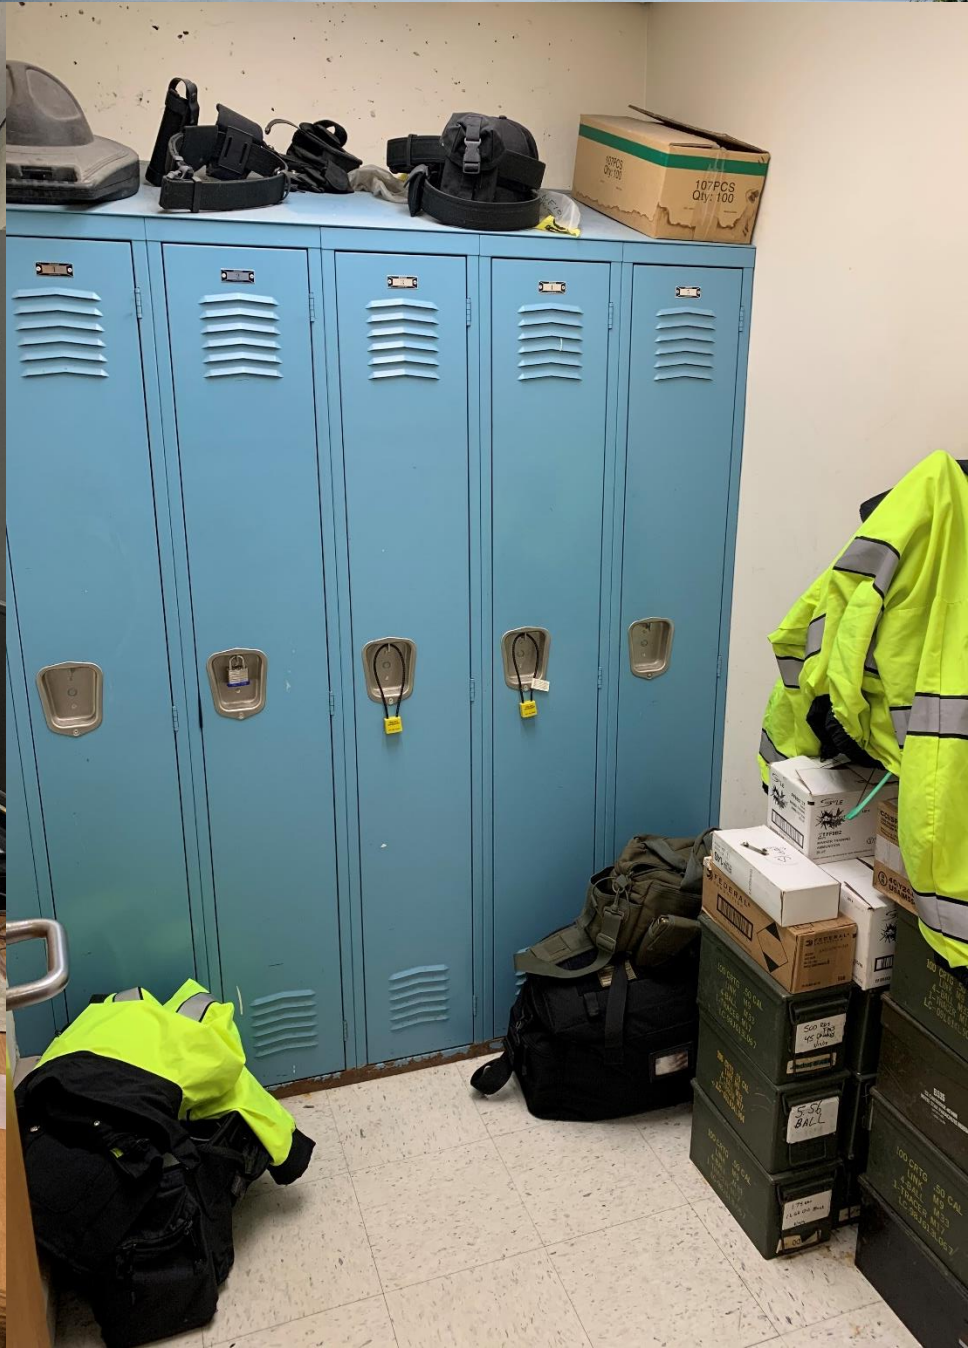
- Poor layout for operations and customer service. Cramped office spaces. No potential for expansion. Noncompliant with many industry standards/requirements related to safety and security. Garage stall repurposed for evidence storage, but space size still inadequate. Poorly designed and undersized booking area presents significant safety concerns to personnel and the public. Lack of file storage space. Lack of vehicle impound facility. Insufficient vehicle garaging capability (causing increased response time during inclement weather). Victim/witness interview environment (space, privacy) hinders ability to treat victims with compassion. Undersized and ill-equipped EOC. Physical separation from fire and EMS presents barriers to collaboration.

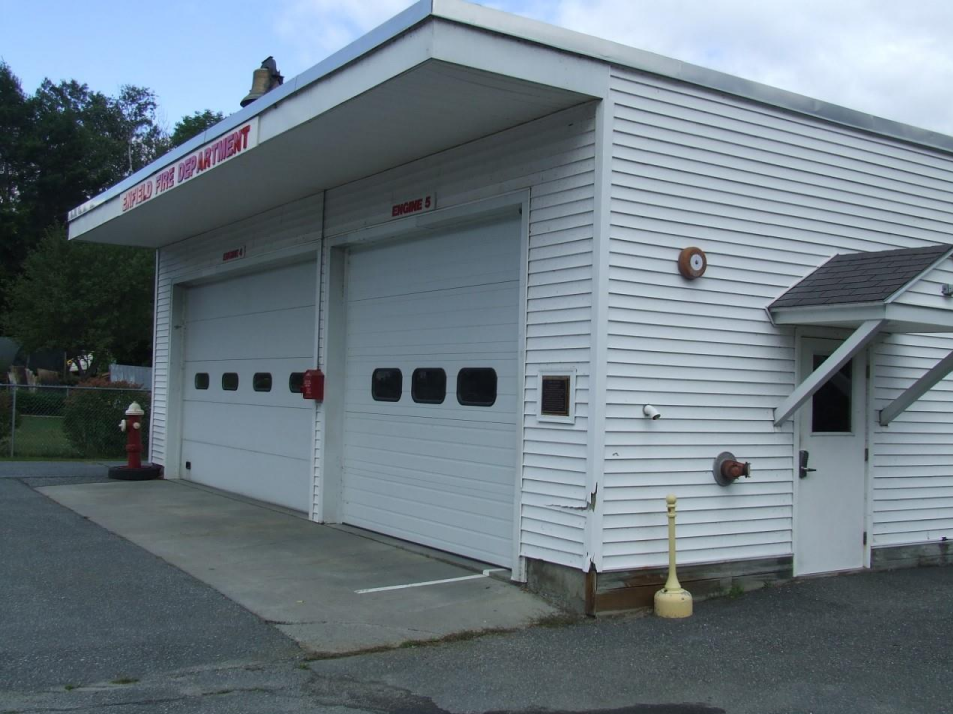
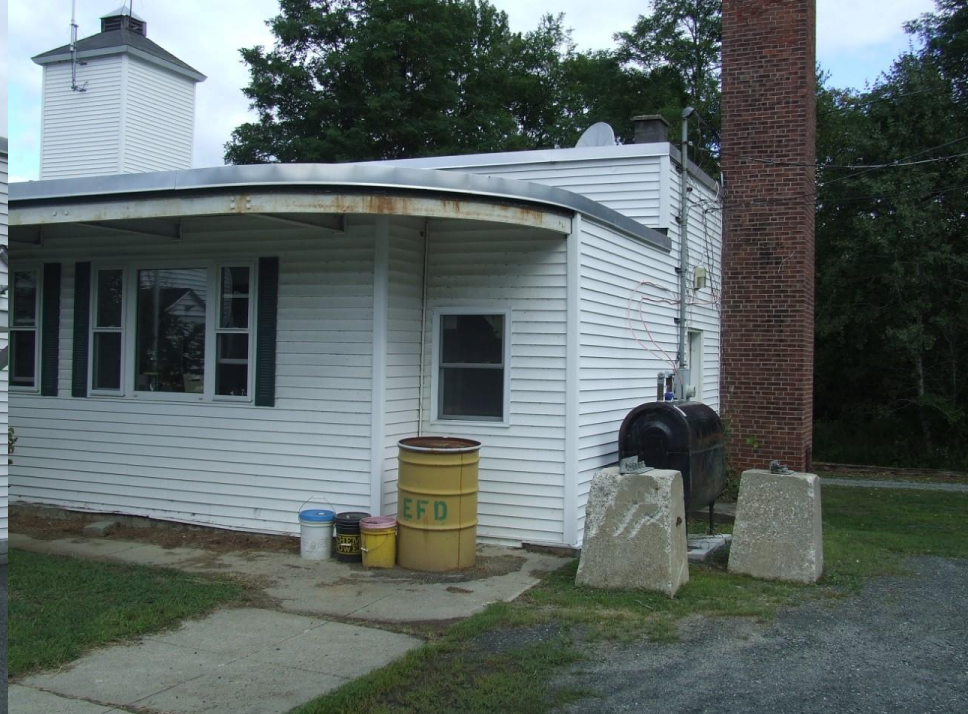
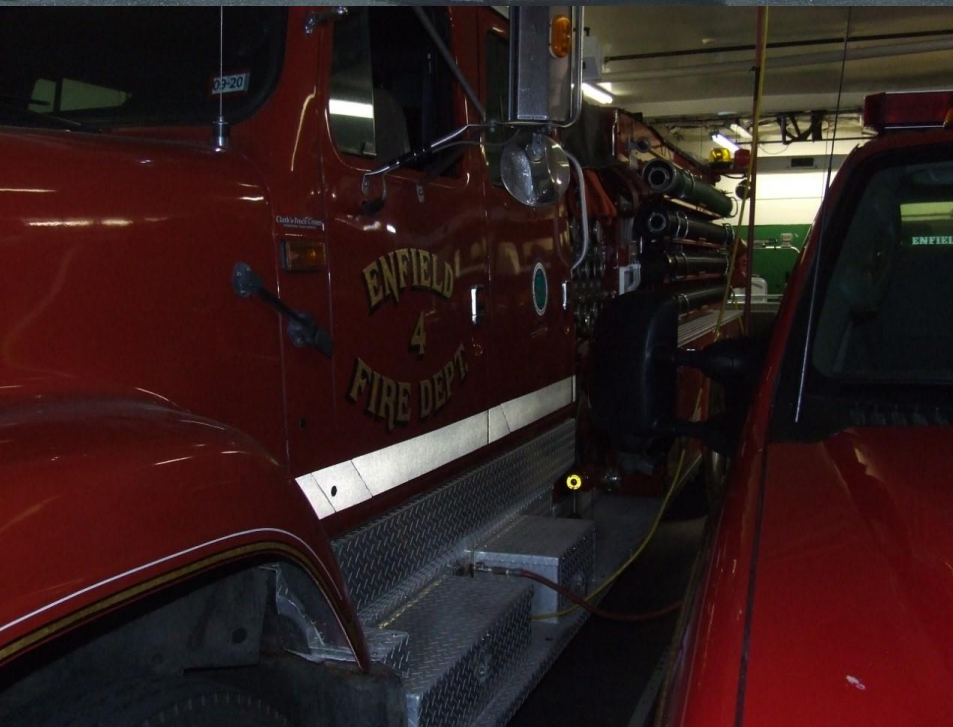
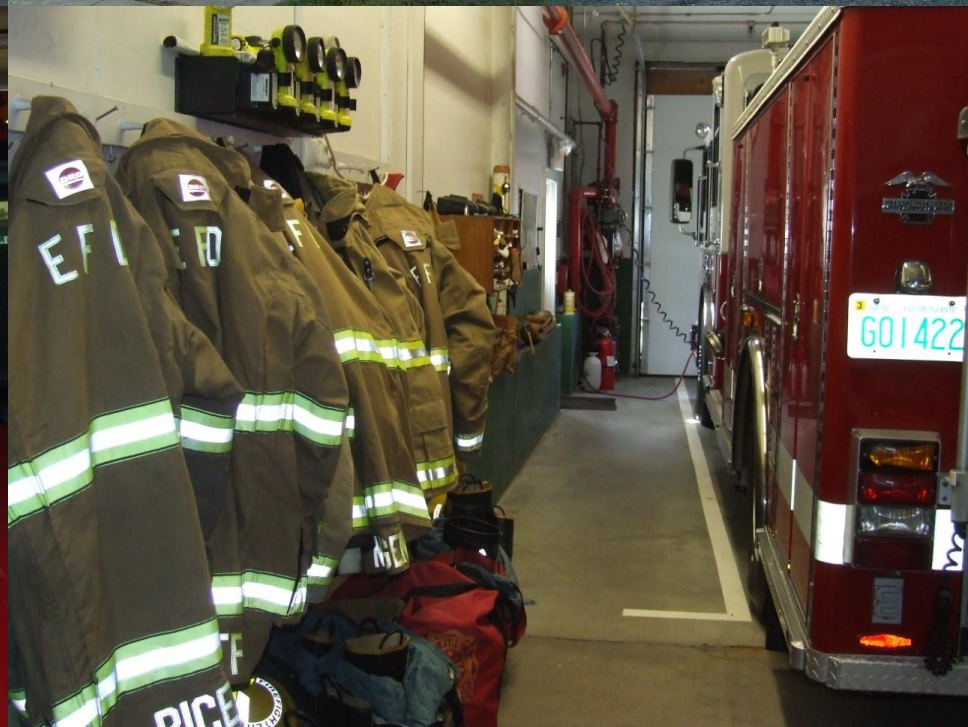
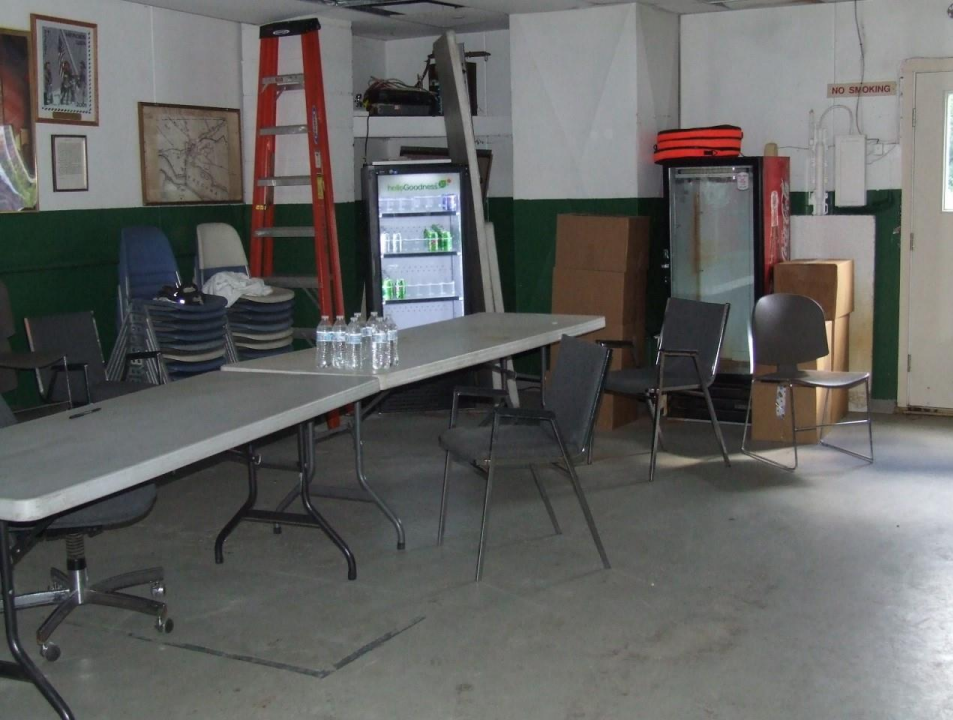
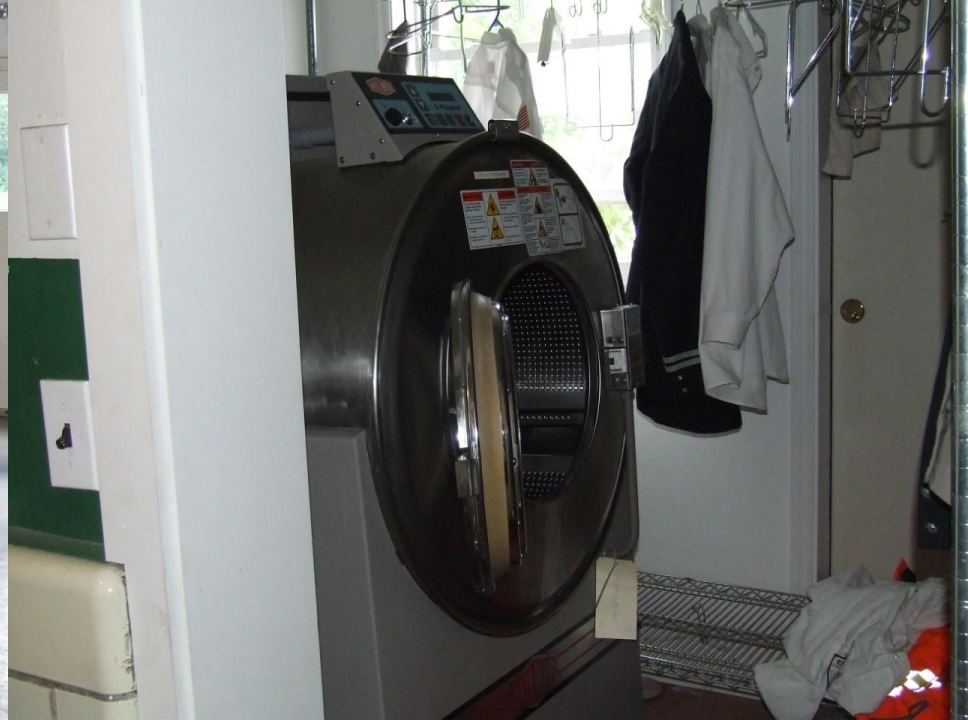
Unsatisfactory Facilities – Public Safety Union Street Fire Station

- Old facility that was not designed for its present use. Dingy and highly worn. Significantly undersized for present/future needs. Parcel not suitable for expansion. Replacement roof needed. Chronic problems with heating system. No cooling system. Poorly insulated.

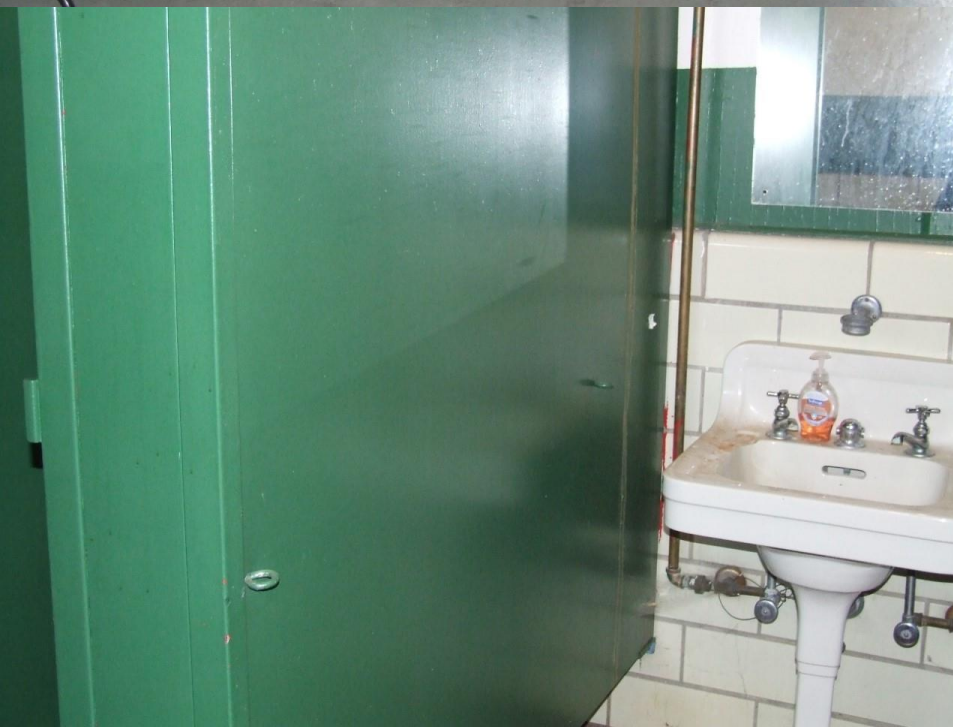
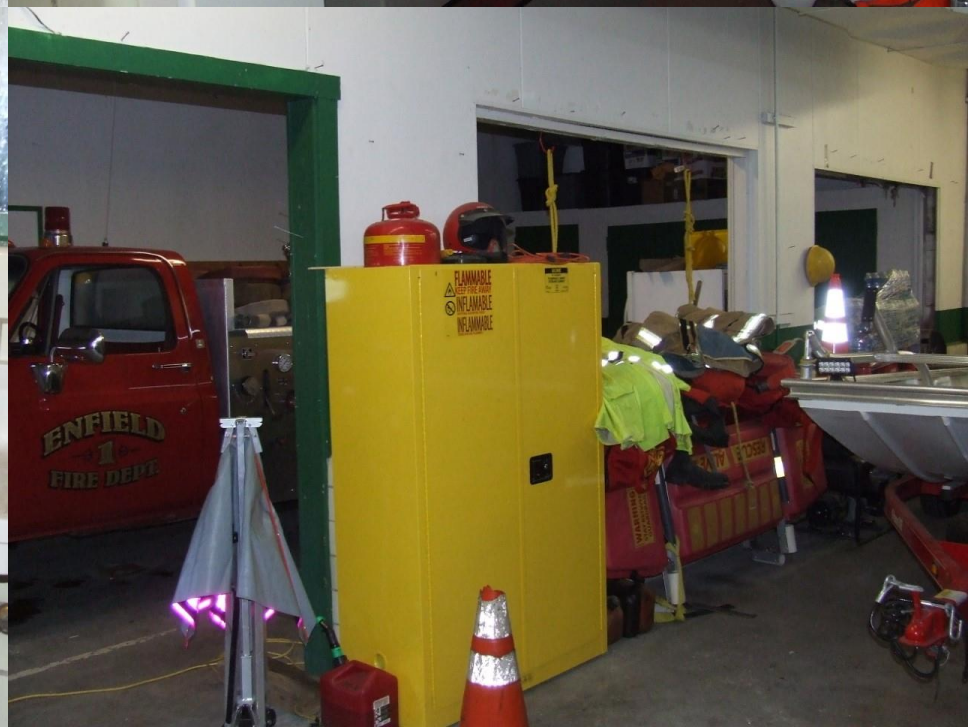
- Inadequate square footage for personnel and vehicle/equipment storage. Undersized meeting/training space. Poor layout for operations, noncompliant with many industry standards & requirements. Lacks personal/equipment lockers and shower rooms. Health and safety of personnel is compromised due to: insufficient hygiene area to clean up following calls, hazardous materials, body fluids, etc. Physical separation from ambulance facility impedes efforts to integrate Fire and EMS functions.

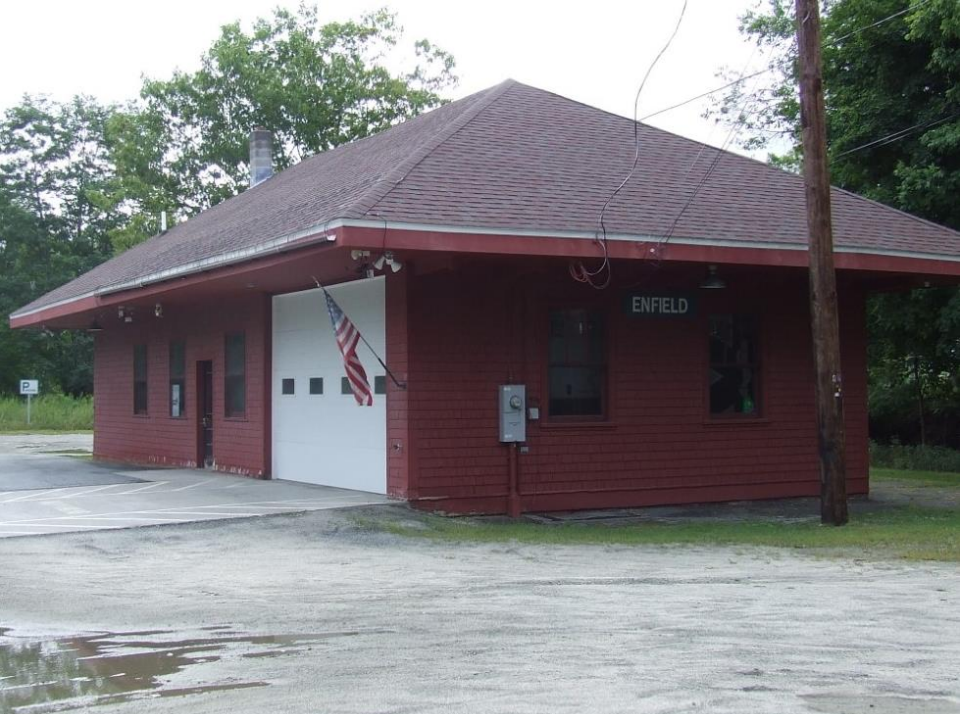
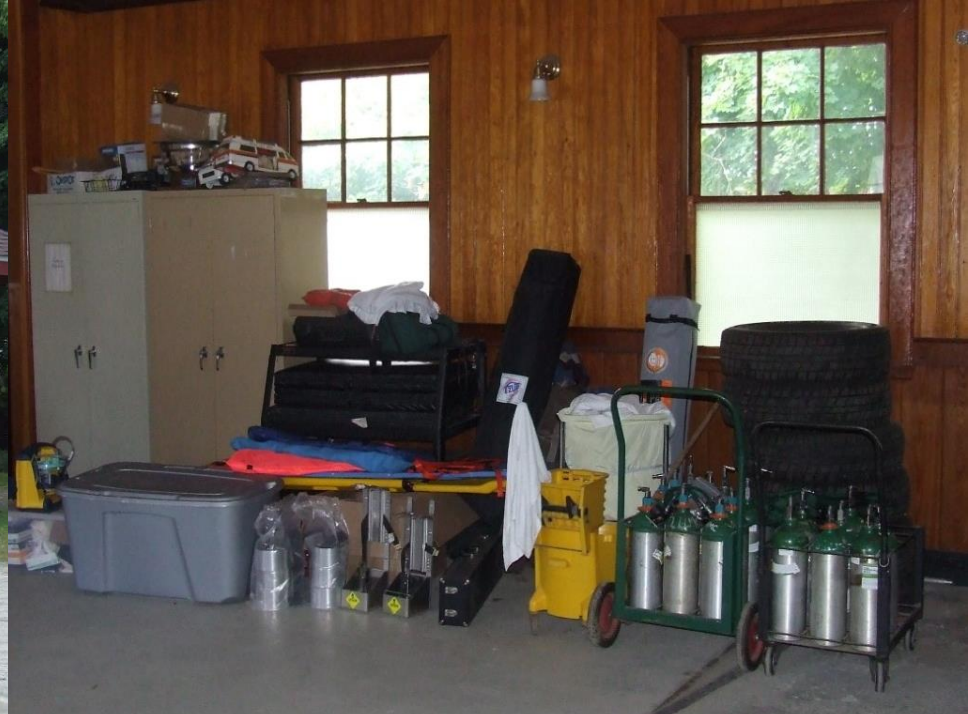
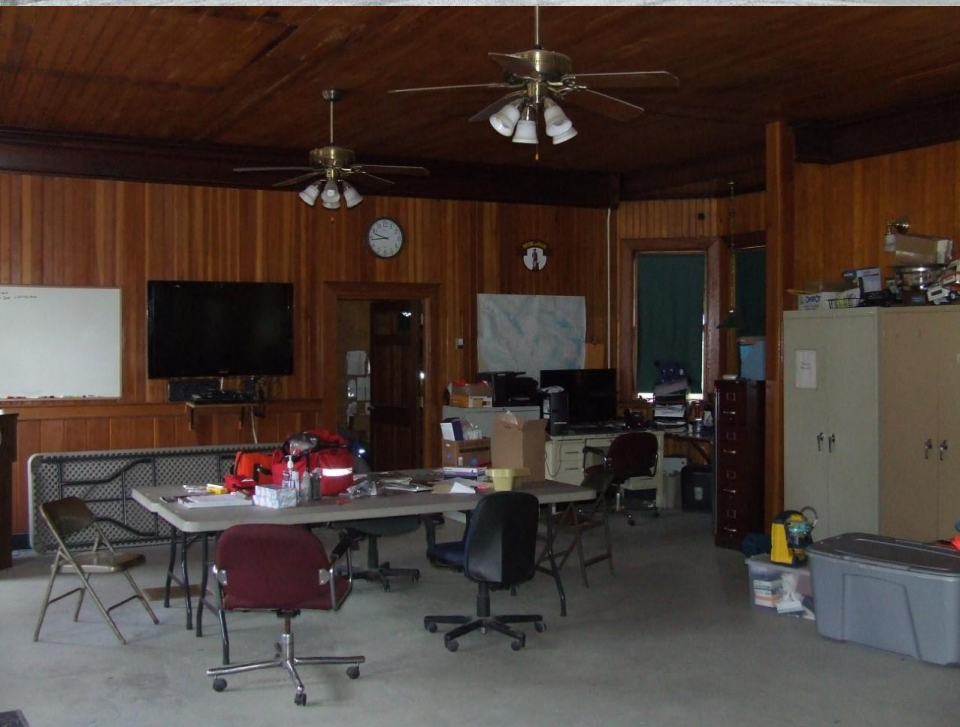
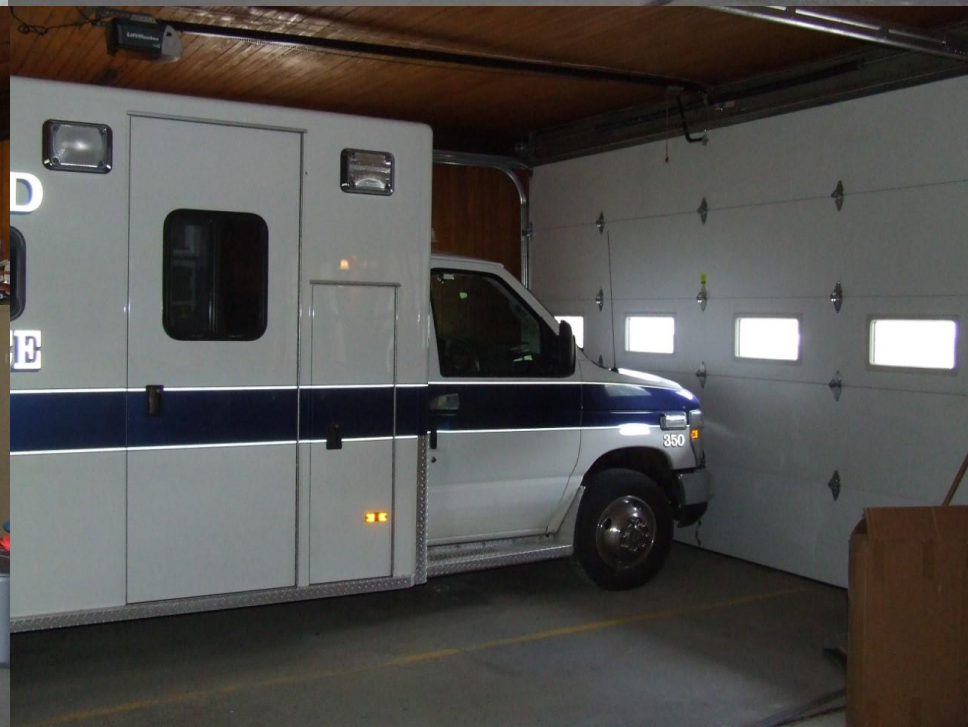
Unsatisfactory Facilities – Public Safety Depot Street Ambulance Building

- Old facility that was not designed for its present use. Significantly undersized for present/future needs. Dingy and heavily worn. Structural columns are deteriorating. Parcel not owned by the Town. Not a good candidate for renovations and expansion. Basement is dirt floor. Regularly experiences significant flooding. Musty and unsanitary. Poor indoor air quality (furnace ventilation). Aged mechanical, plumbing and electrical systems. No cooling system.

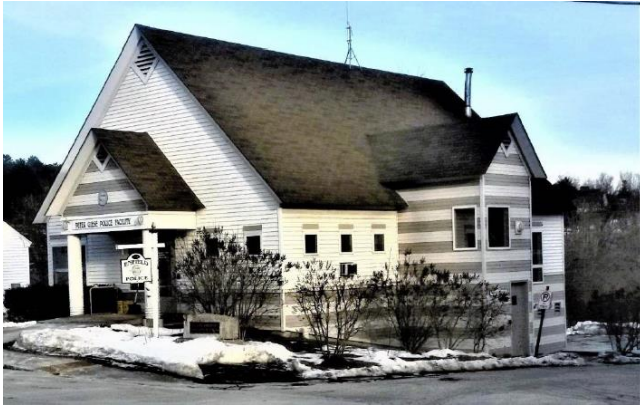
Built in 1992
Served as the
Enfield Police
Station from
1992 to present.

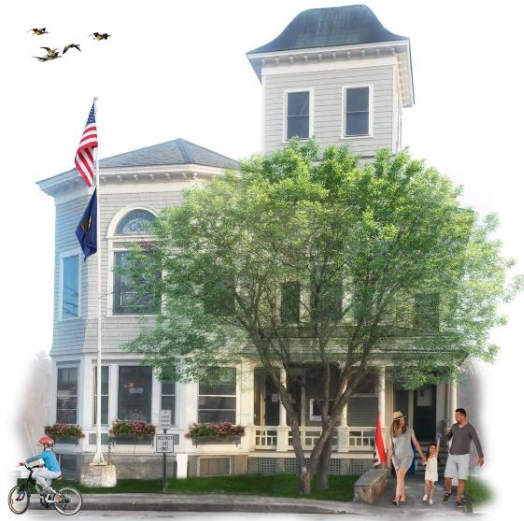
Whitney Hall

Built in 1900
Serves as the
home of the
Enfield Town
Offices, Enfield
Public Library, and
Voting is held at
Whitney Hall.
