Whitney Hall

Enfield's Union Street Fire Station

Enfield's Police Station

Enfield's Ambulance Building

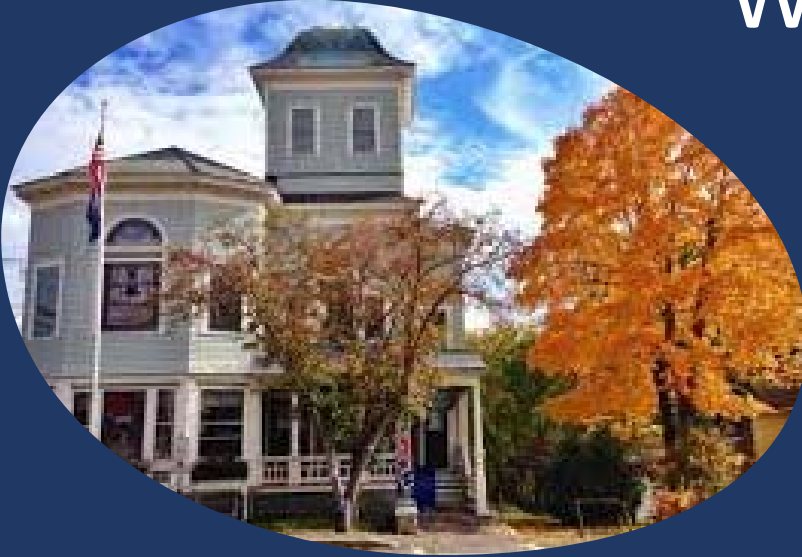
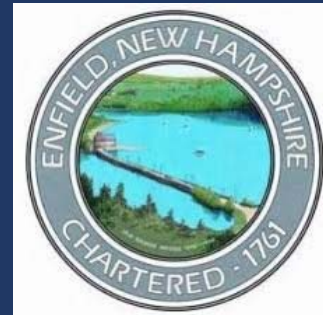
Queen Anne/Shingle Style building built in 1900-1901

In 1976 the building underwent major renovation and now also contains the Enfield Town Offices.

In 1993 the building underwent another major renovation that included the installation of the elevator and renovations to the library and town offices.
