Appendix B

Manhole Inspection Summary

MANHOLE INSPECTION FORM

Client: Enfield, NH
 Date: 5/9/2019
 Time: 8:13
 Staff Initials: TH

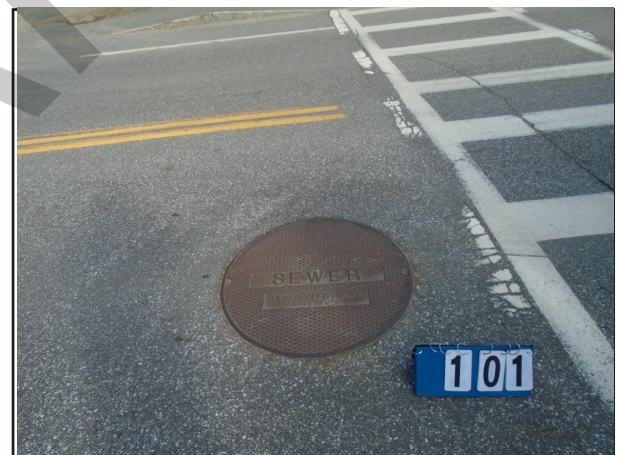
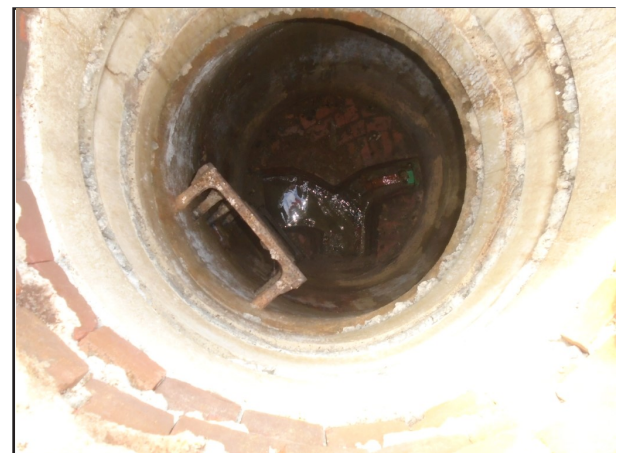
Manhole ID#: 101
 Accessible? Yes
 Street: Main St
 Near House #: _____
 Exterior Photo #: 101A
 Interior Photo #: 101B

Type? Concrete Ring
 Condition? Fair
 I/I? Past Inactive
 Comments: _____

Type? Precast Concrete
 Condition? Good
 I/I? Past Inactive
 Comments: _____

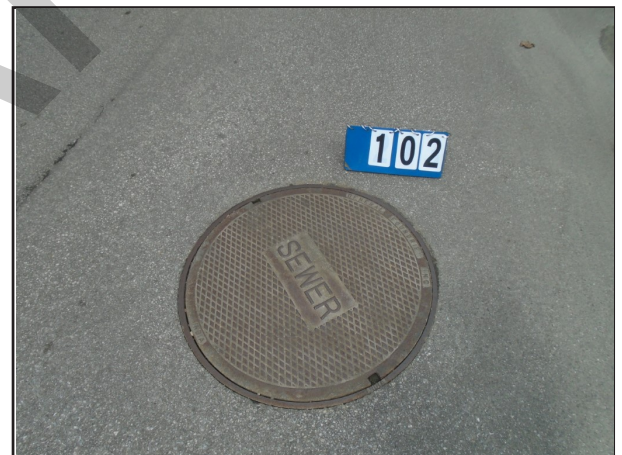
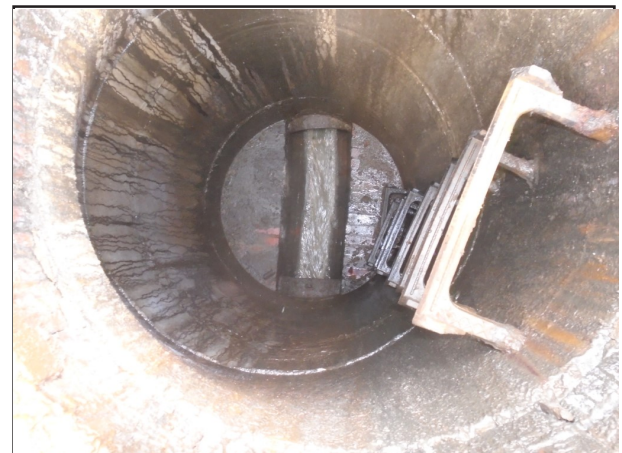
Type? Brick
 Condition? Fair
 I/I? Past Inactive
 Comments? _____

Type? Precast Concrete
 Condition? Fair
 I/I? Active Light
 Comments? Active Light I/I

Type? Brick
 Condition? Good
 I/I? Active Light
 Comments: Active Light I/I

Active Light I/I

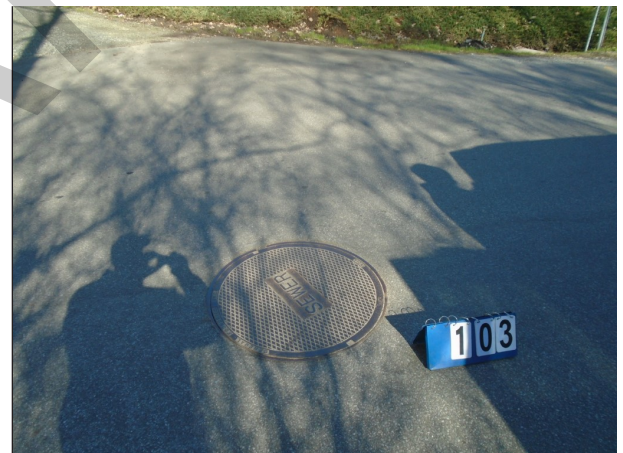
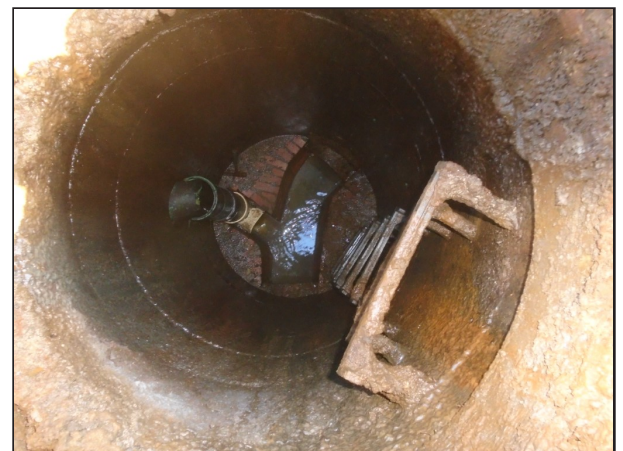
Type? Brick
 Condition? Fair
 I/I? Past Inactive
 Comments? _____

Type? Precast Concrete
 Condition? Fair
 I/I? Active Light
 Comments? Active Light I/I

Type? Brick
 Condition? Good
 I/I? Active Light
 Comments: Active Light I/I

Active Light I/I

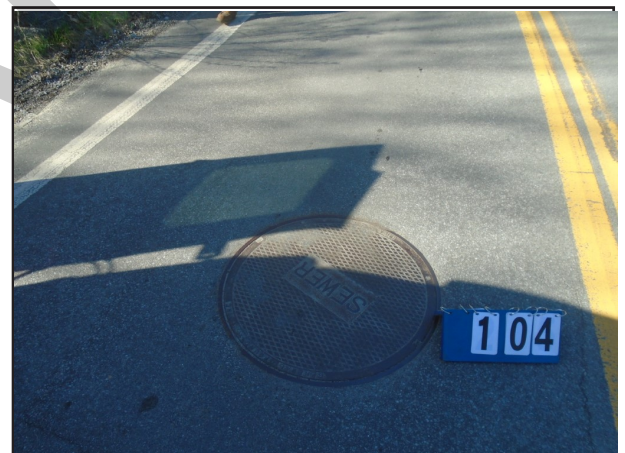
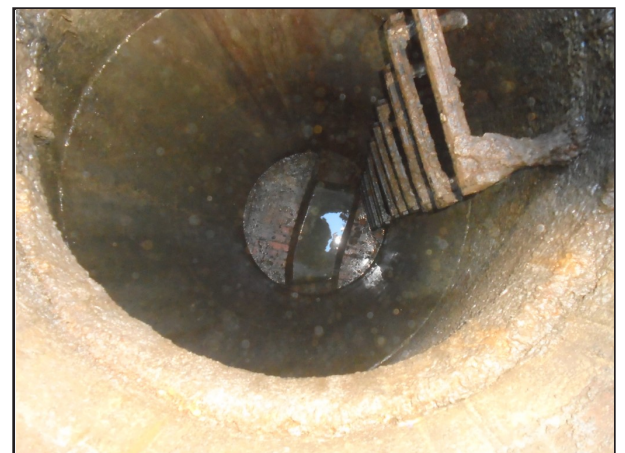
Type? Brick
 Condition? Fair
 I/I? Past Inactive
 Comments? _____

Type? Precast Concrete
 Condition? Good
 I/I? Active Light
 Comments? Active Light I/I

Type? Brick
 Condition? Good
 I/I? Active Light
 Comments: Active Light I/I

Active Light I/I

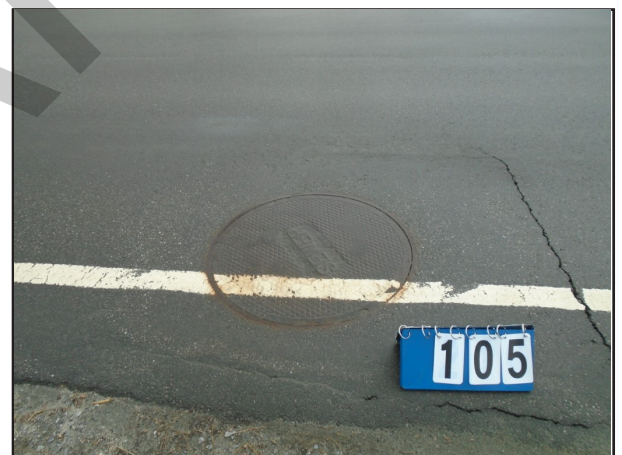
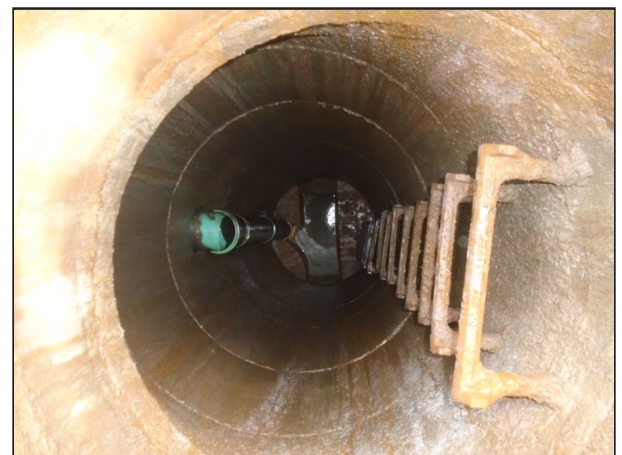
Type? Precast Concrete
 Condition? Good
 I/I? Active Light
 Comments? Active Light I/I

Active Light I/I

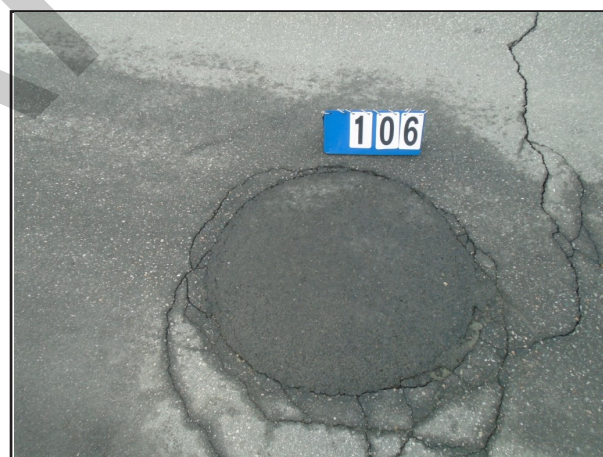
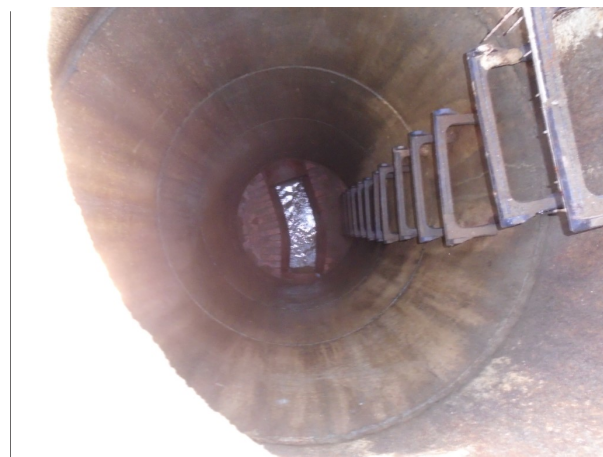
Type? Brick
 Condition? Fair
 I/I? Past Inactive
 Comments? _____

Type? Precast Concrete
 Condition? Good
 I/I? Past Inactive
 Comments? _____

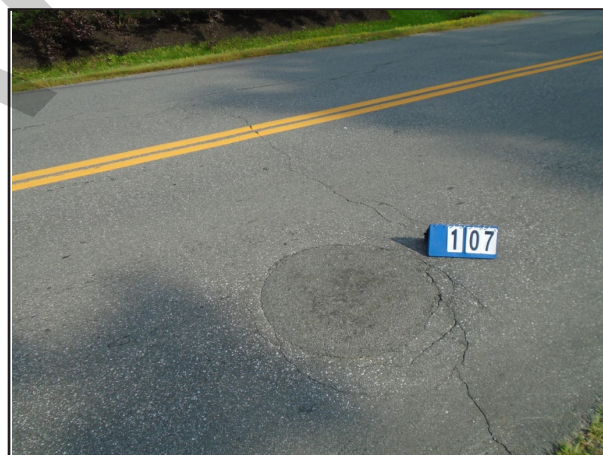
Paved Over, Exterior Photo
 Mislabelled 106

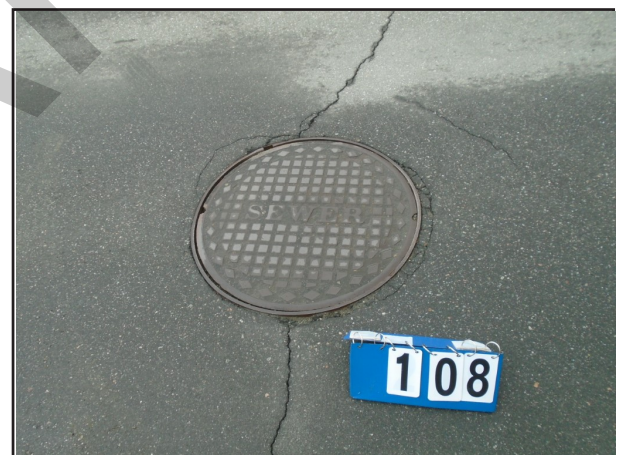
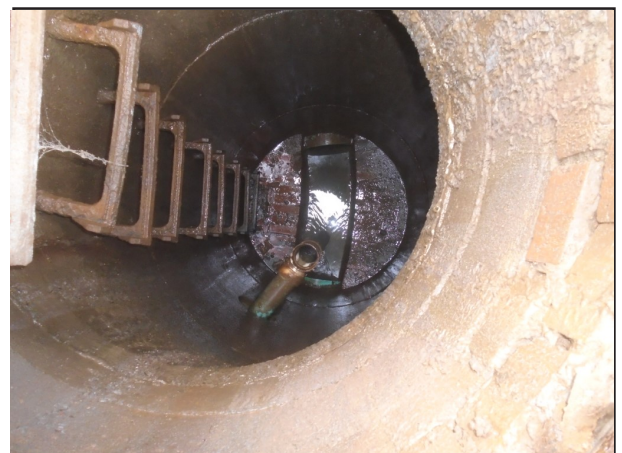
Type? Brick
 Condition? Fair
 I/I? Active Light
 Comments? Active Light I/I

Type? Precast Concrete
 Condition? Good
 I/I? Active Light
 Comments? Active Light I/I

Type? Brick
 Condition? Fair
 I/I? Active Light
 Comments: Active Light I/I

Active Light I/I

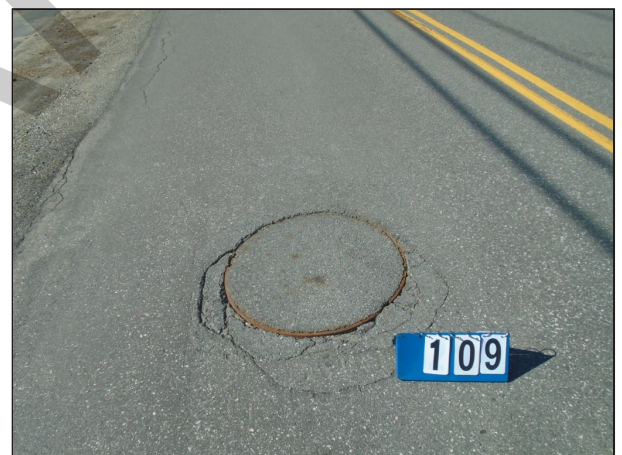
Paved Over

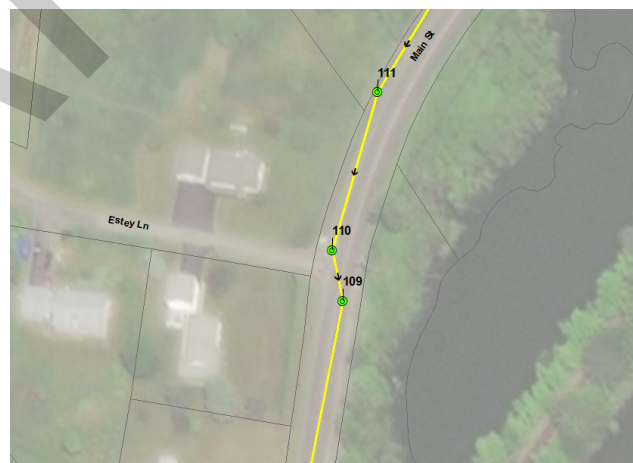
Could Not Locate

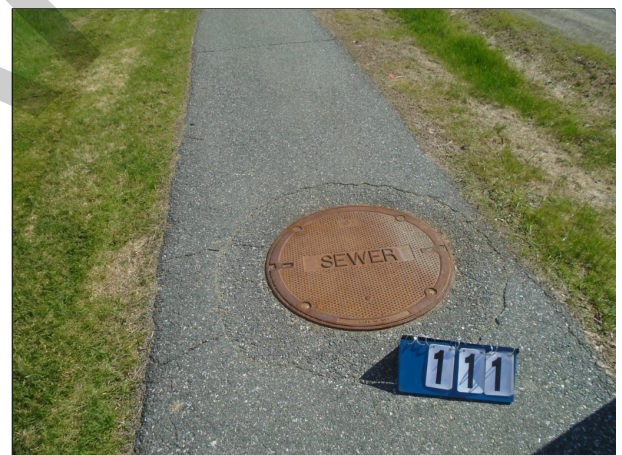
Bolted Cover

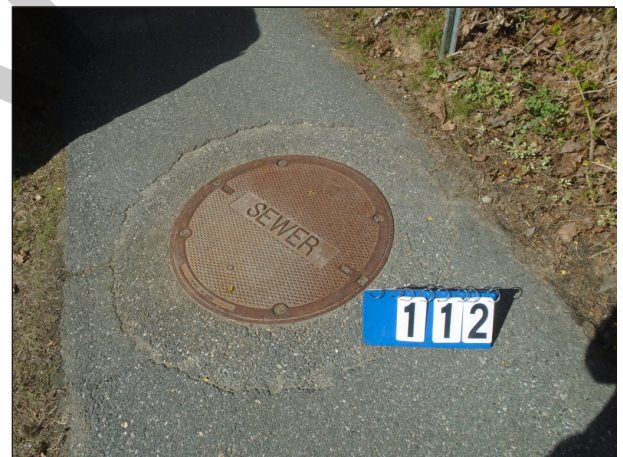
Bolted Cover

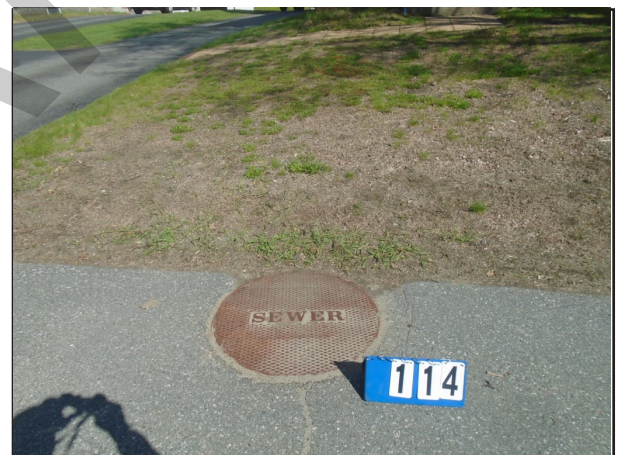
Could Not Open

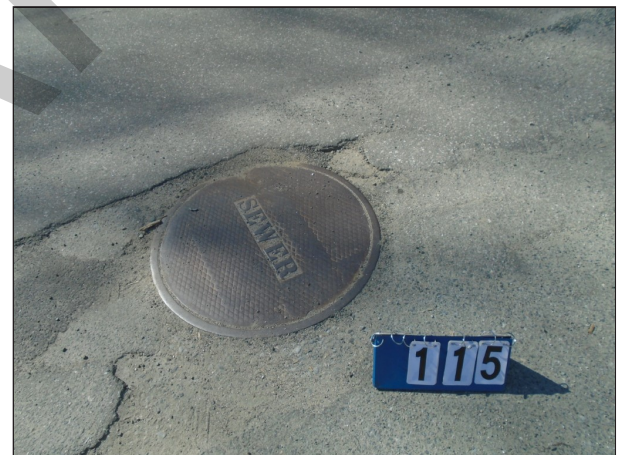
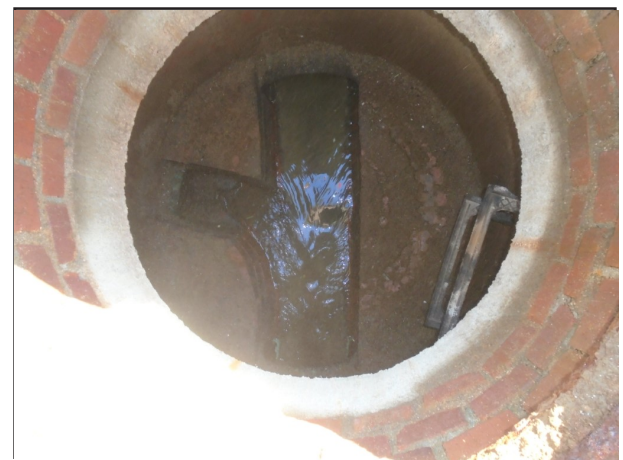
Type? Brick
 Condition? Fair
 I/I? Past Inactive
 Comments _____

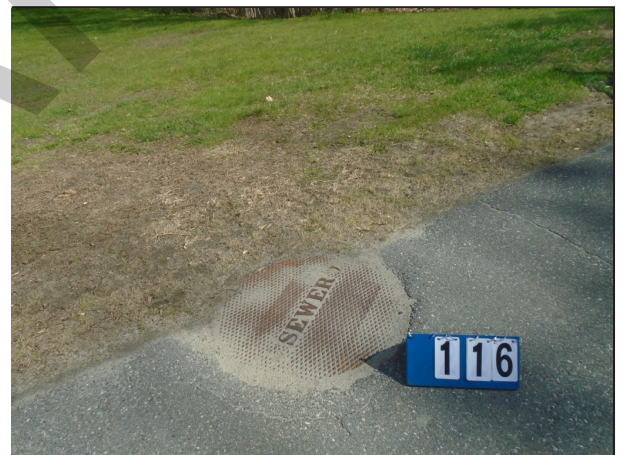
Could Not Open

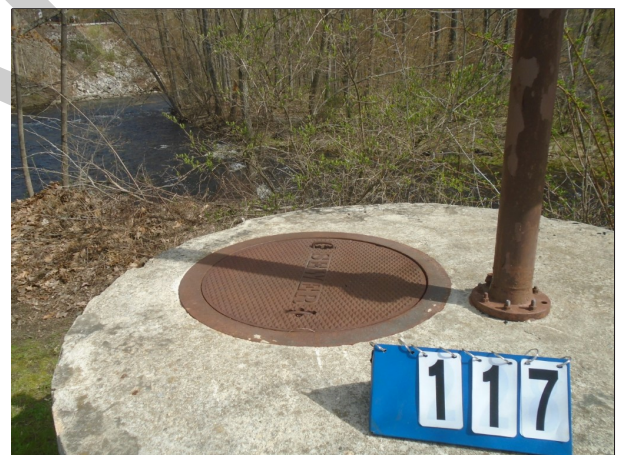
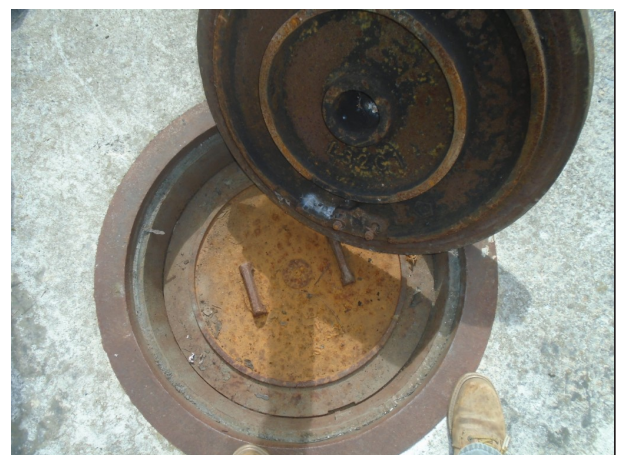
Could Not Open

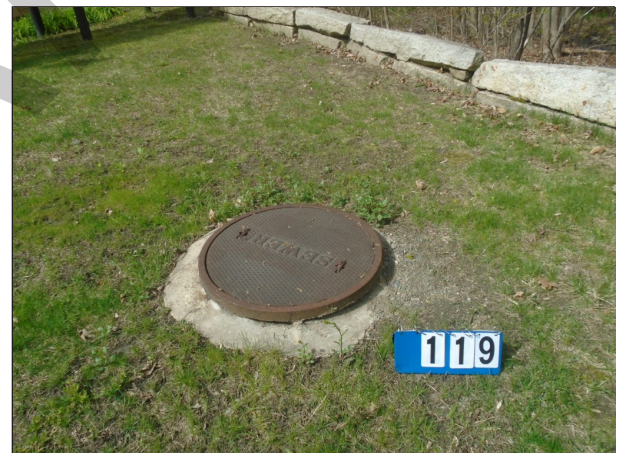
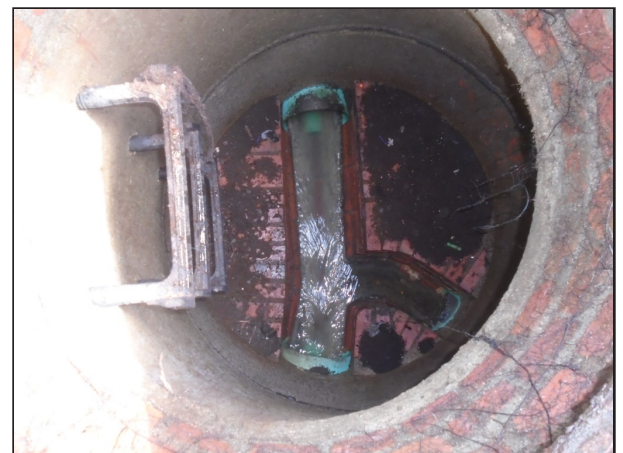
Roots

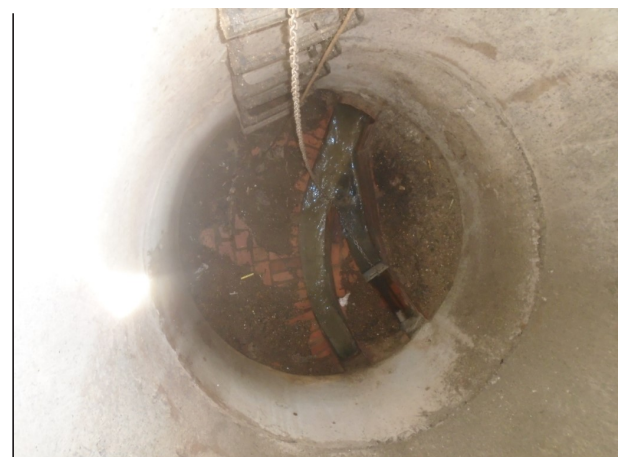
Interior Manhole Photo

Type? Brick
 Condition? Good
 I/I? None
 Comments: Siphon - Two 6-Inch Outlets

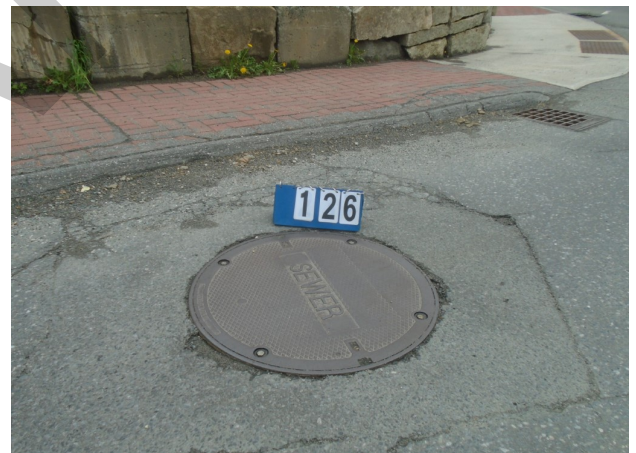
Exterior Manhole Photo

Bolted Cover

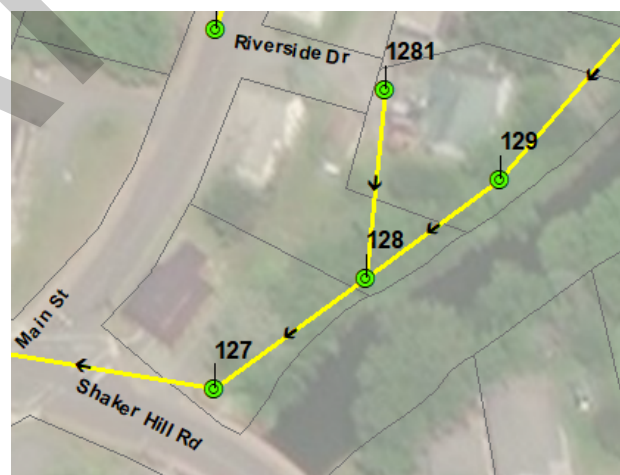
Exterior Manhole Photo

Could Not Locate

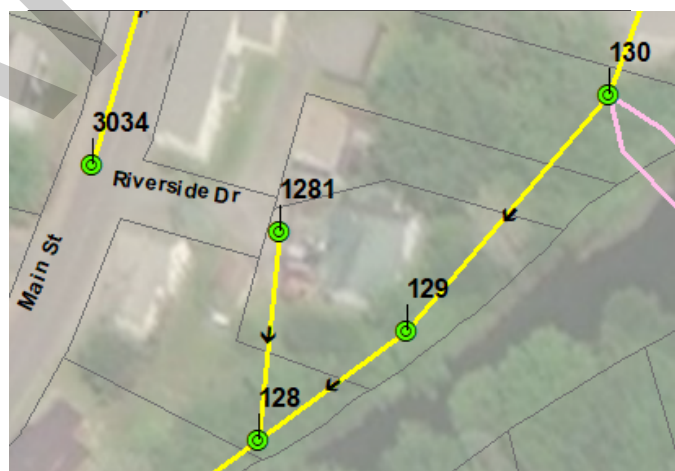
Exterior Manhole Photo

Could Not Locate

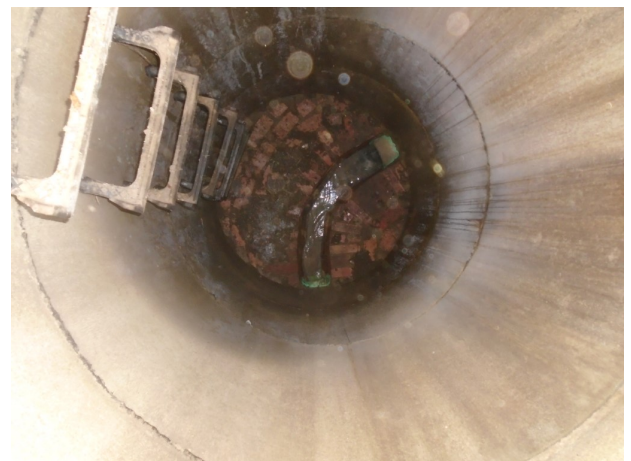
Interior Manhole Photo

Type? Brick
 Condition? Poor
 I/I? Past Inactive
 Comments? Loose/Missing Bricks from Riser

Loose/Missing Bricks from Riser

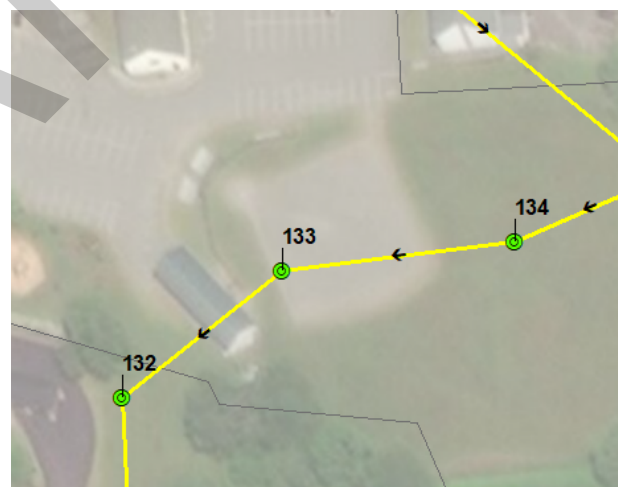
Exterior Manhole Photo

Could Not Locate

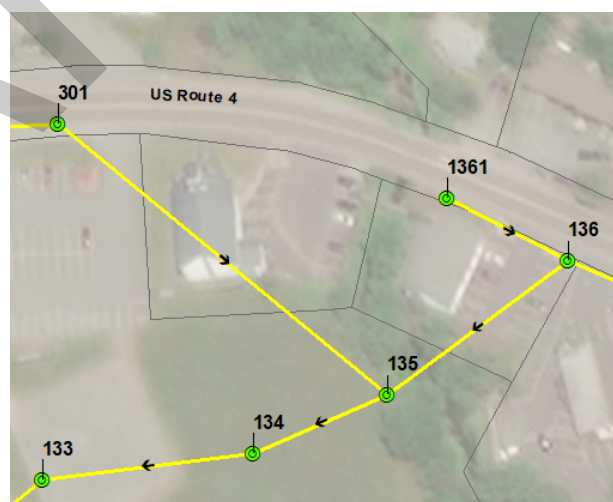
Exterior Manhole Photo

Could Not Locate

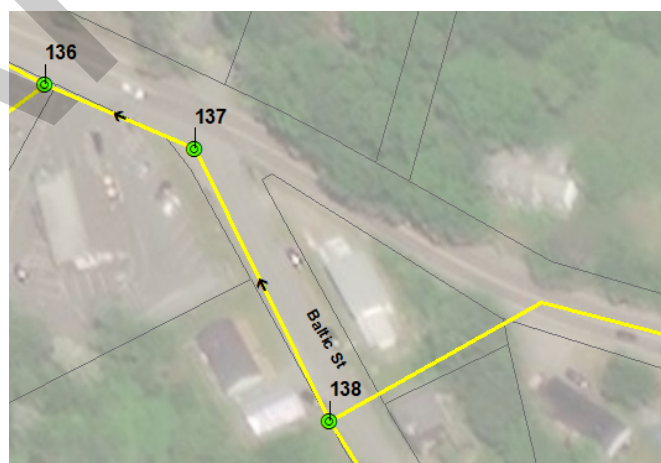
Exterior Manhole Photo

Could Not Open

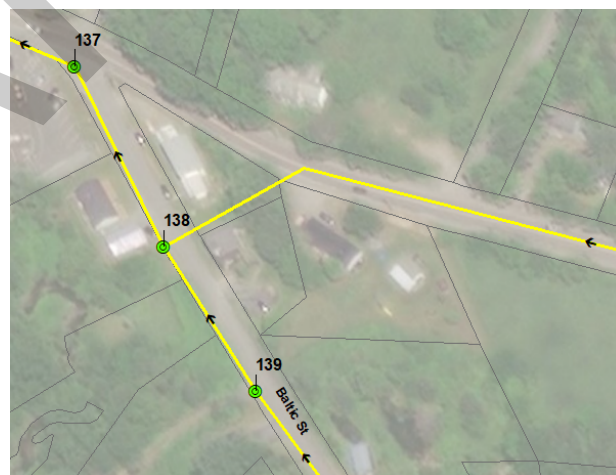
Exterior Manhole Photo

Could Not Open

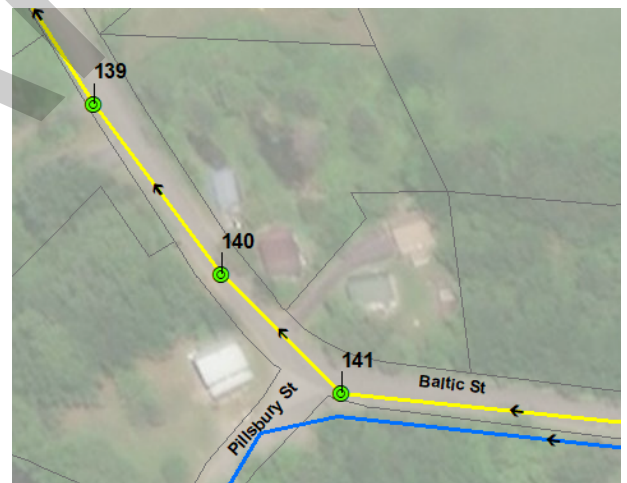
Exterior Manhole Photo

Could Not Locate

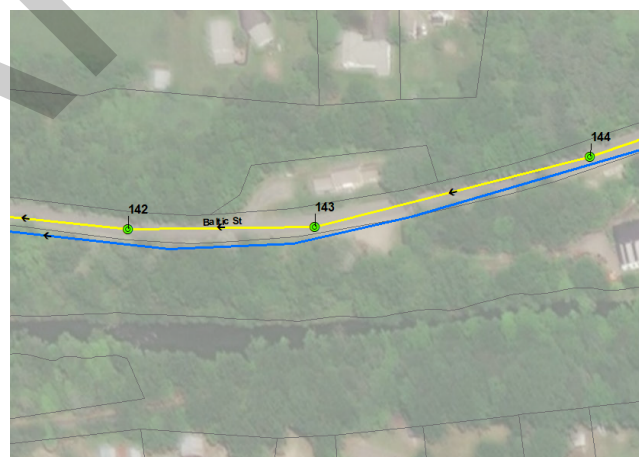
Exterior Manhole Photo

Could Not Locate

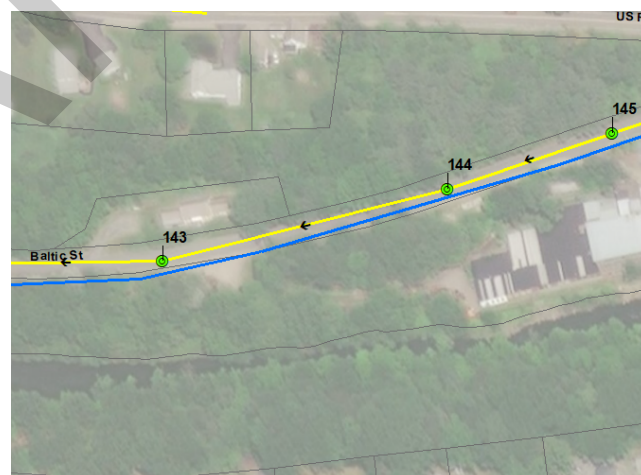
Exterior Manhole Photo

Could Not Locate

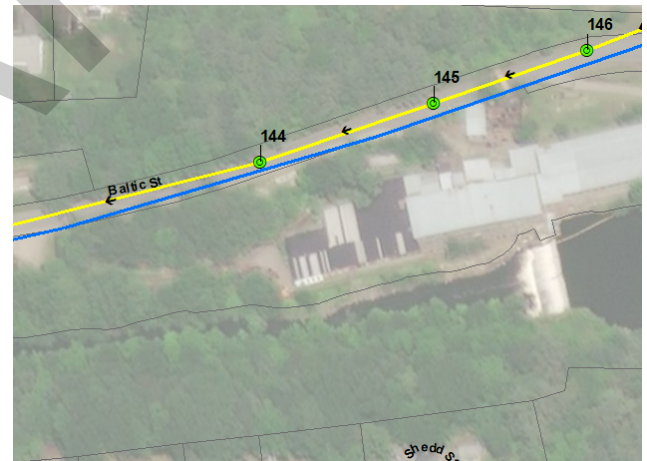
Exterior Manhole Photo

Could Not Open

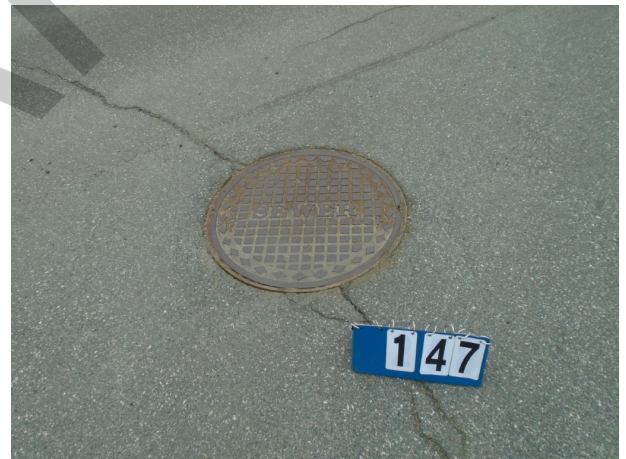
Exterior Manhole Photo

Could Not Open

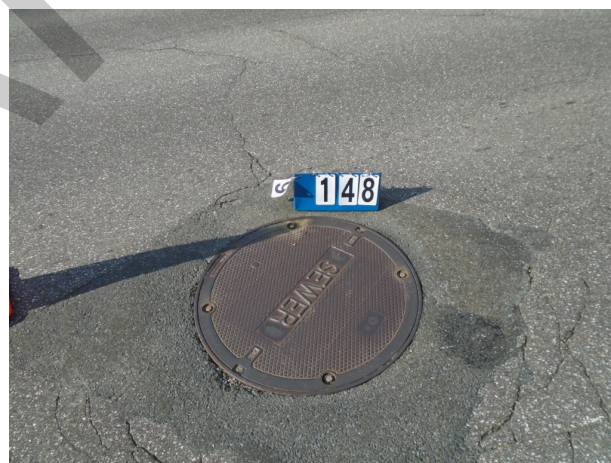
Exterior Manhole Photo

Bolted Cover

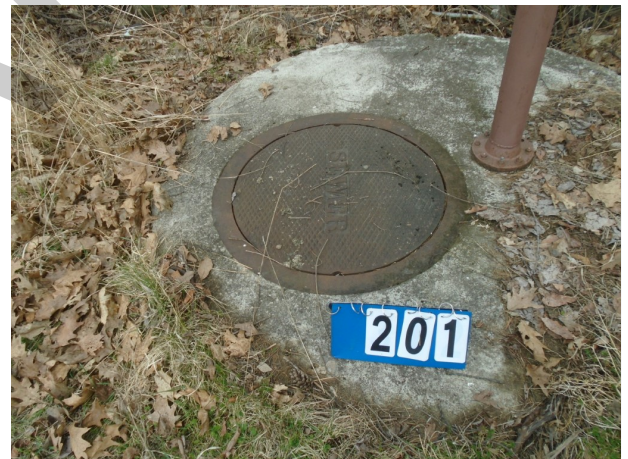
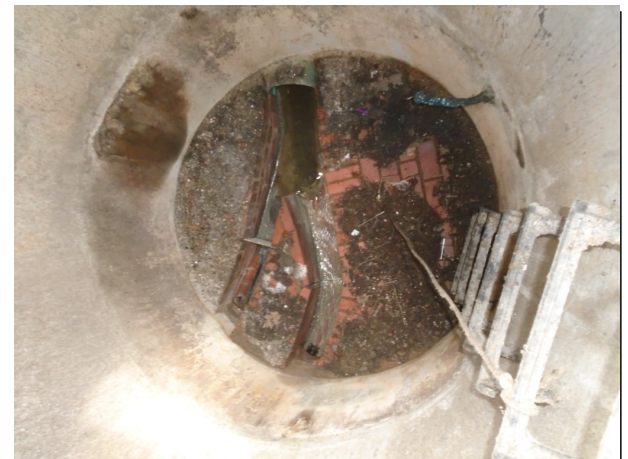
Type? Brick
 Condition? Fair
 I/I? None
 Comments: _____

Type? Brick
 Condition? Fair
 I/I? None
 Comments: Siphon - Two 6-Inch Outlets

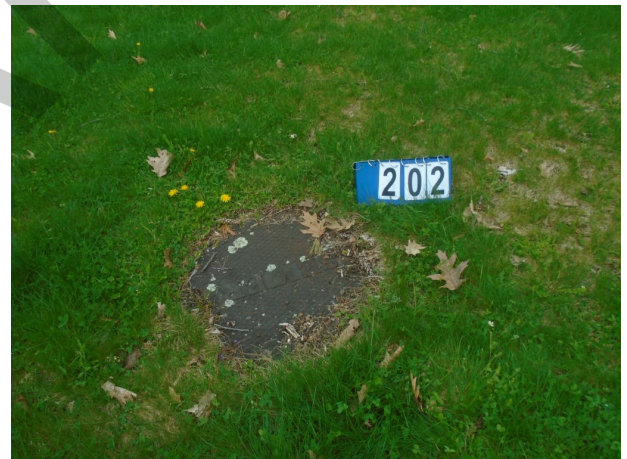
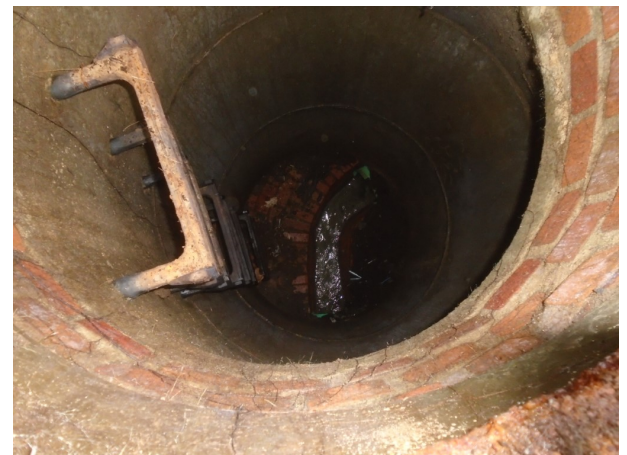
Type? Brick
 Condition? Fair
 I/I? Past Inactive
 Comments? Roots

Roots

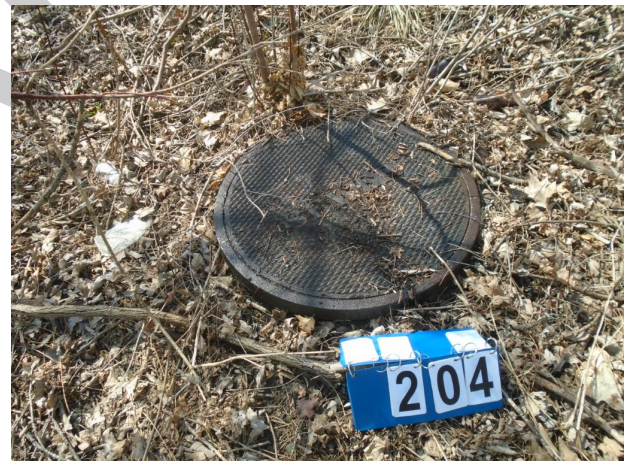
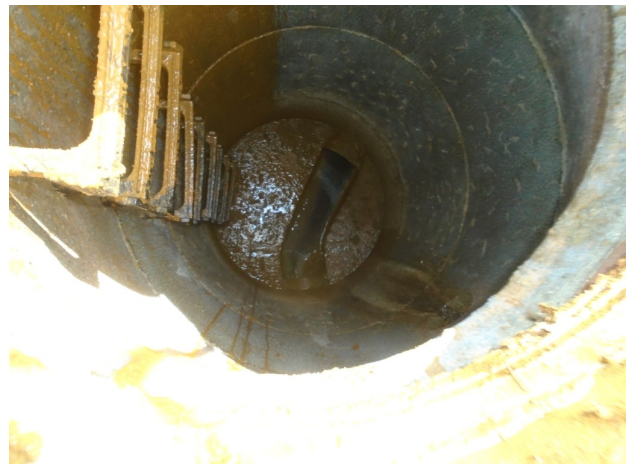
Type? Brick
 Condition? Poor
 I/I? Active Moderate
 Comments? Active Moderate I/I

Type? Precast Concrete
 Condition? Good
 I/I? Active Moderate
 Comments? Active Moderate I/I

Type? Plastic Coated
 Condition? Fair
 Comments? _____

Type? Brick
 Condition? Fair
 I/I? Active Moderate
 Comments: Active Moderate I/I

Active Moderate I/I

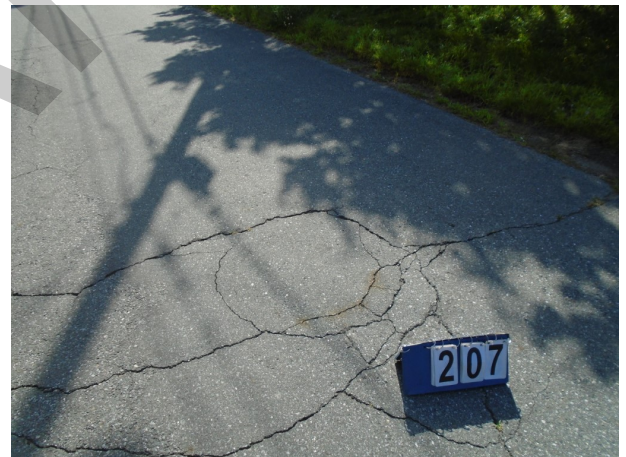
Paved Over

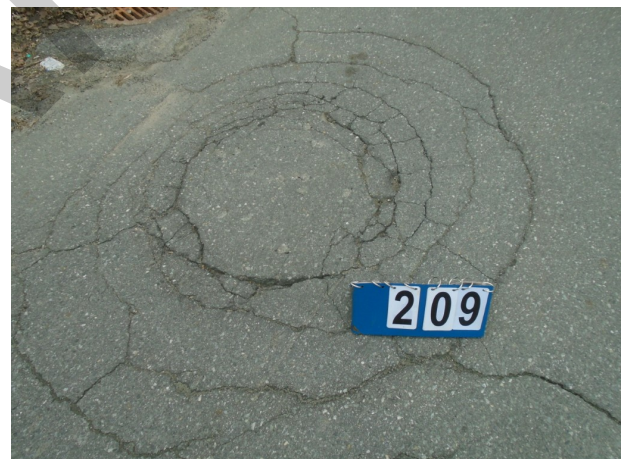
Paved Over

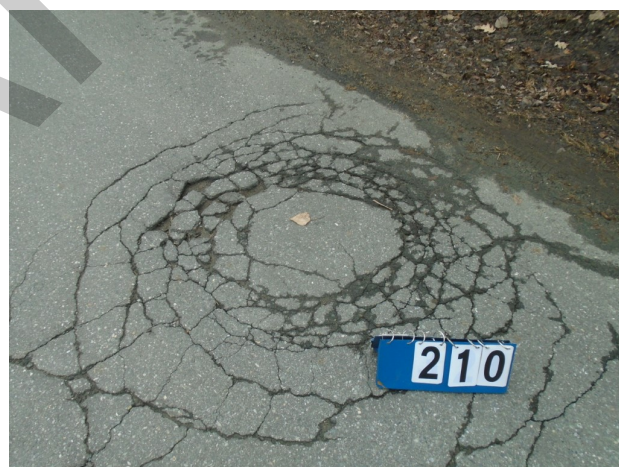
Exterior Manhole Photo

Paved Over

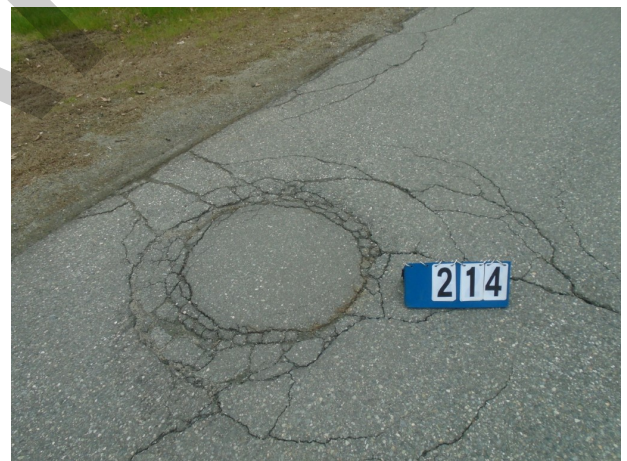
Exterior Manhole Photo

Paved Over

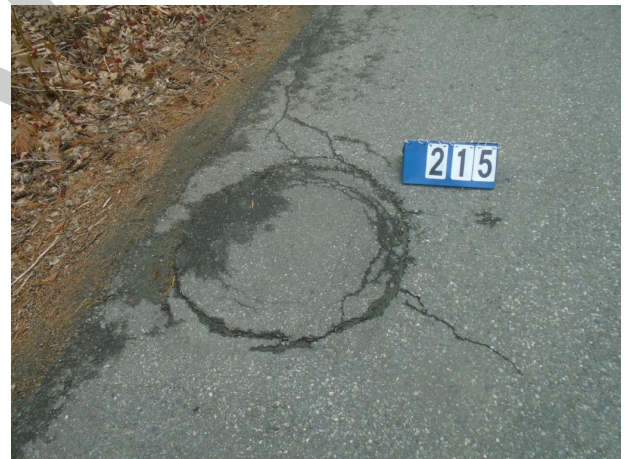
Exterior Manhole Photo

Paved Over

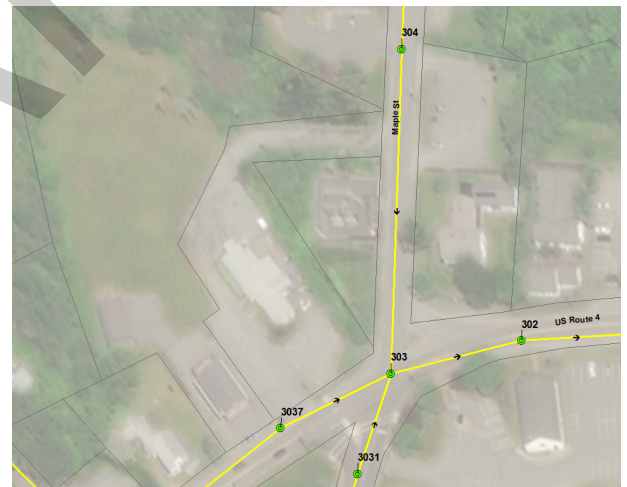
Exterior Manhole Photo

Could Not Locate

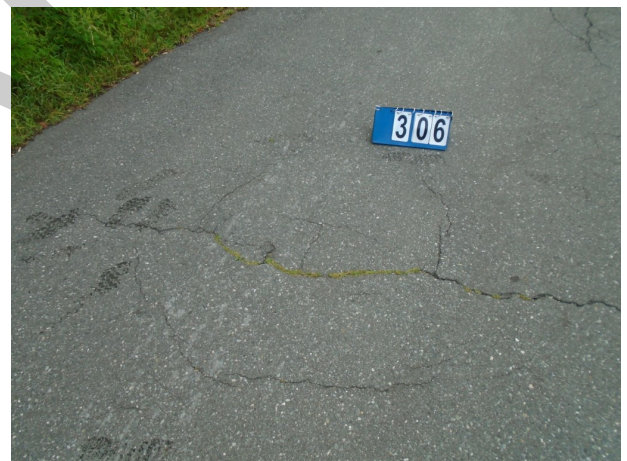
Exterior Manhole Photo

Paved Over

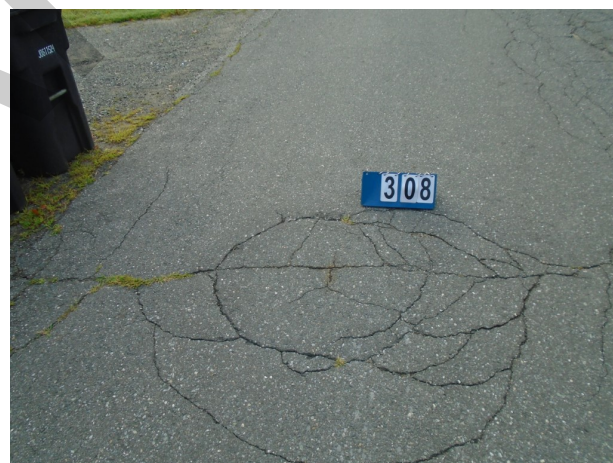
Exterior Manhole Photo

Paved Over

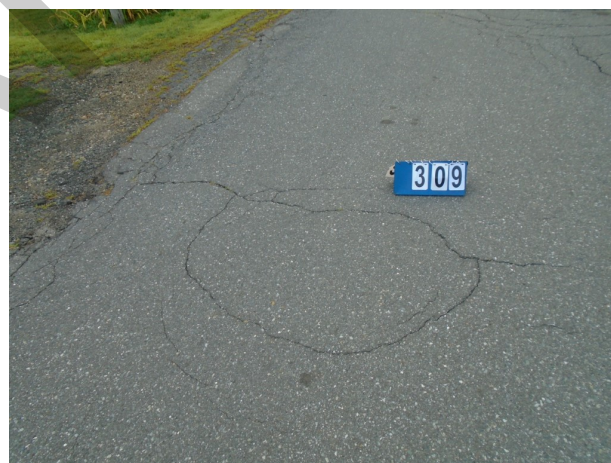
Exterior Manhole Photo

Paved Over

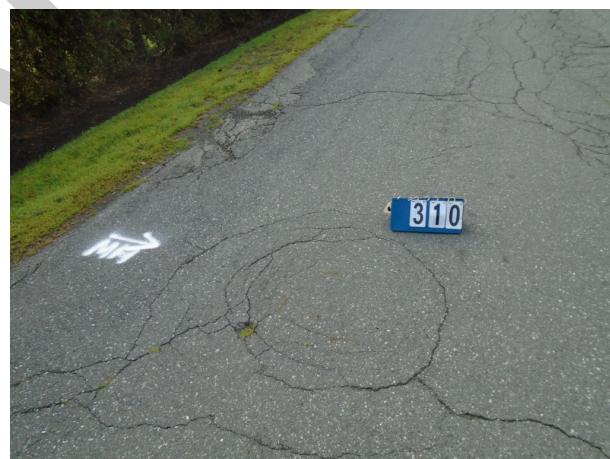
Exterior Manhole Photo

Paved Over

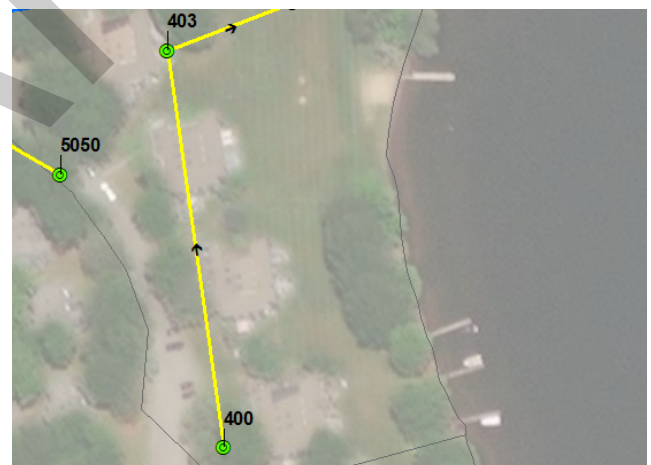
Exterior Manhole Photo

Could Not Locate

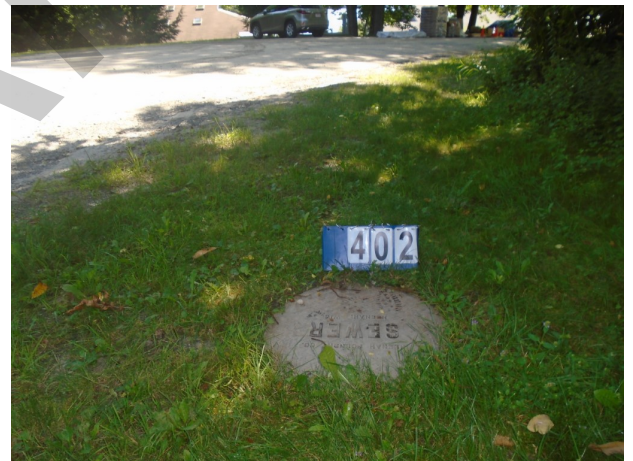
Exterior Manhole Photo

Could Not Open

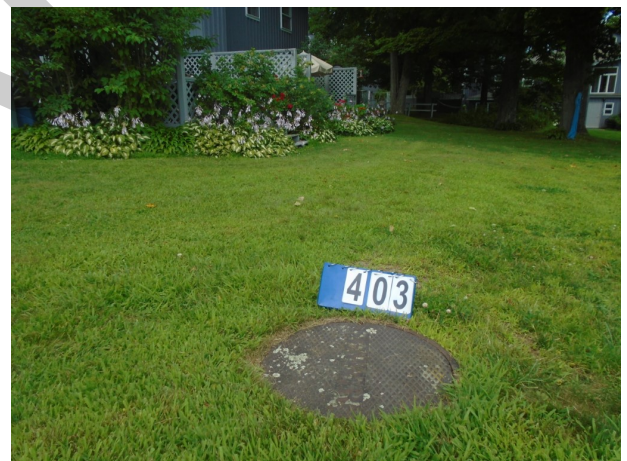
Exterior Manhole Photo

Type? Brick
 Condition? Fair
 I/I? Past Inactive
 Comments? _____

Type? Concrete
 Condition? Fair
 I/I? None
 Comments: _____

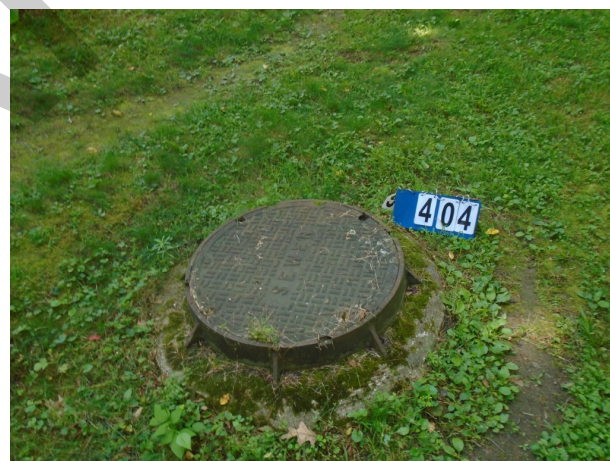
Exterior Manhole Photo

Type? Brick
 Condition? Fair
 I/I? Past Inactive
 Comments: _____

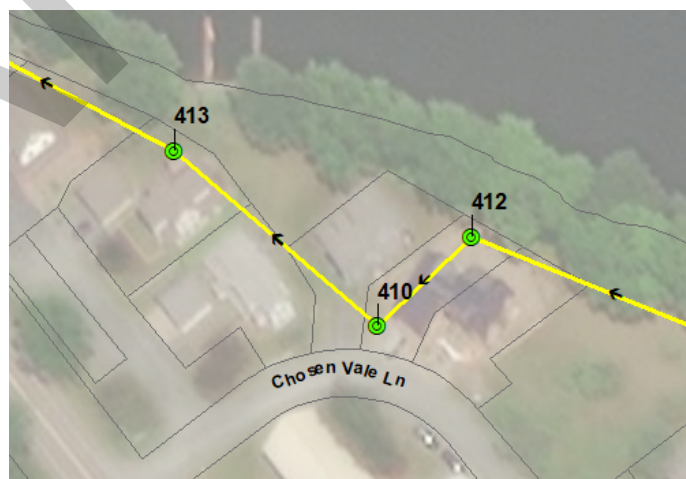
Exterior Manhole Photo

Could Not Locate

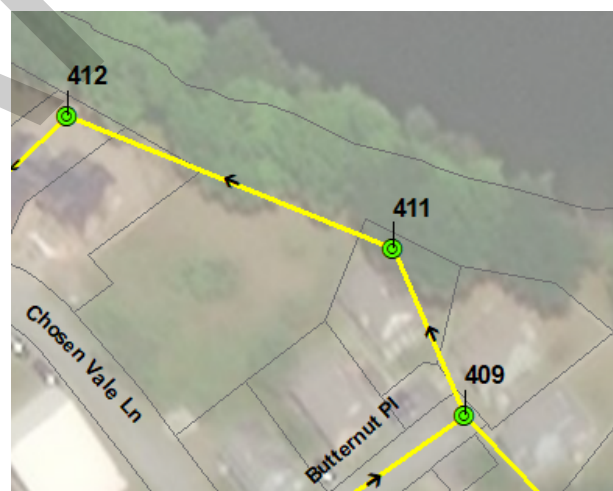
Exterior Manhole Photo

Could Not Locate

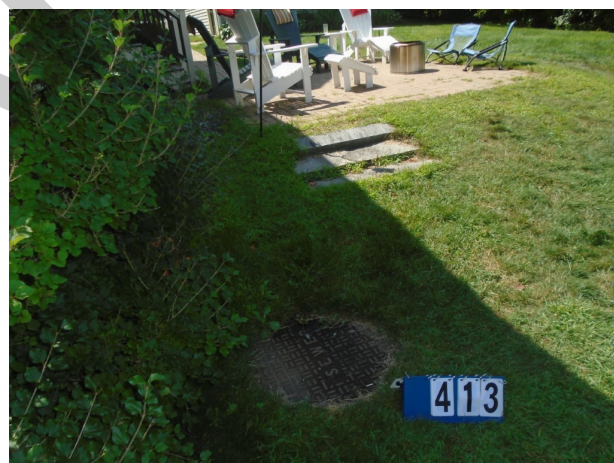
Exterior Manhole Photo

Type? Concrete Ring
 Condition? Fair
 I/I? Past Inactive
 Comments: _____

Type? Precast Concrete
 Condition? Fair
 I/I? Past Inactive
 Comments: _____

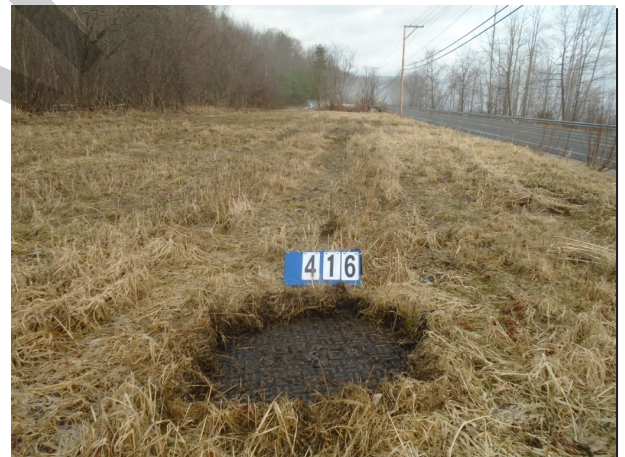
Exterior Manhole Photo

Active Light I/I

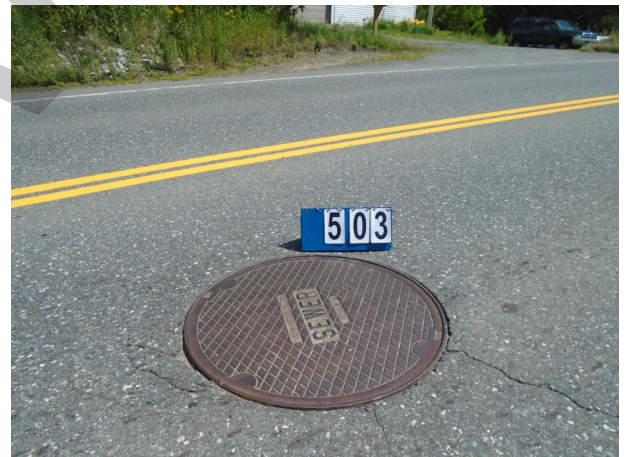
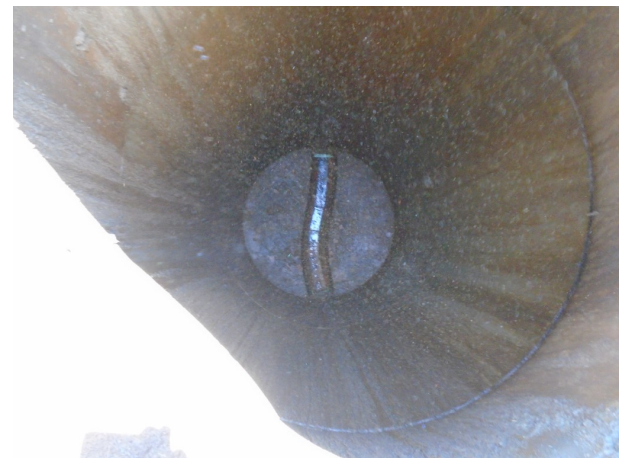
Exterior Manhole Photo

Type? Brick
 Condition? Good
 I/I? Past Inactive
 Comments: _____

Type? Precast Concrete
 Condition? Good
 I/I? Past Inactive
 Comments: _____

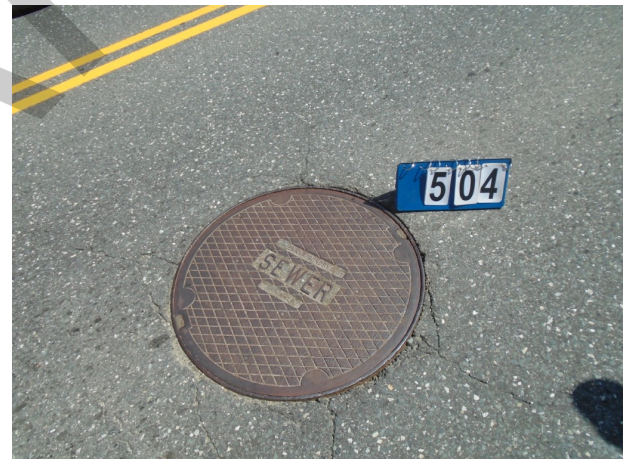
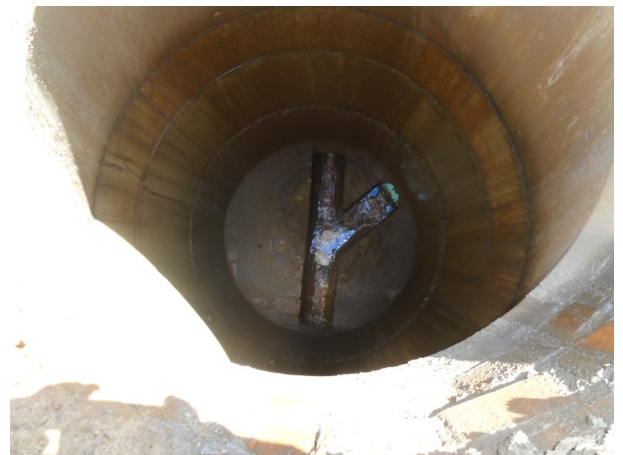
Exterior Manhole Photo

Type? Brick
 Condition? Fair
 I/I? Past Inactive
 Comments? _____

Type? Brick
 Condition? Fair
 I/I? Past Inactive
 Comments: _____

Type? Brick
 Condition? Fair
 I/I? None
 Comments: _____

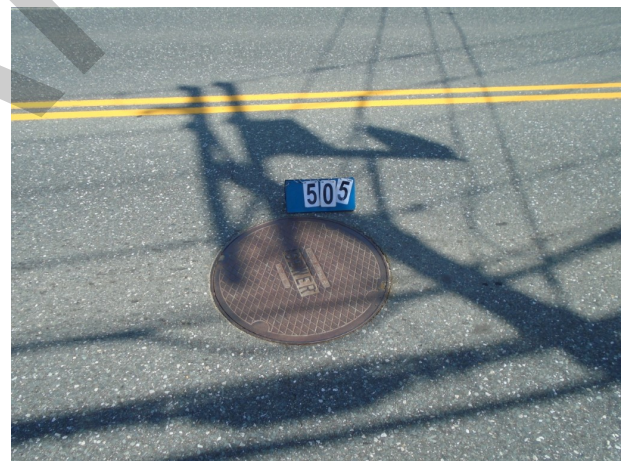
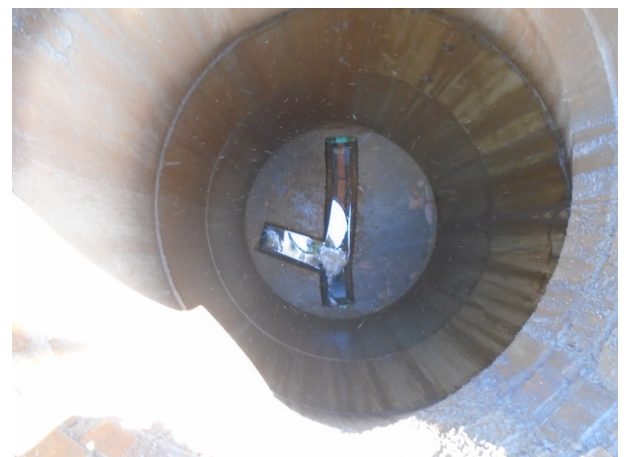
Exterior Manhole Photo

Type? Brick
 Condition? Good
 I/I? Past Inactive
 Comments? _____

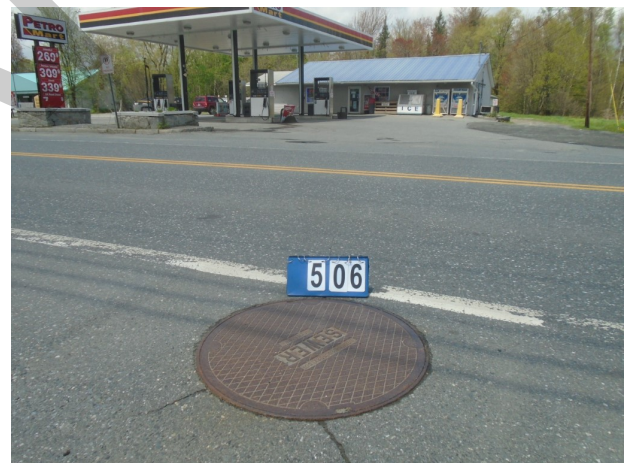
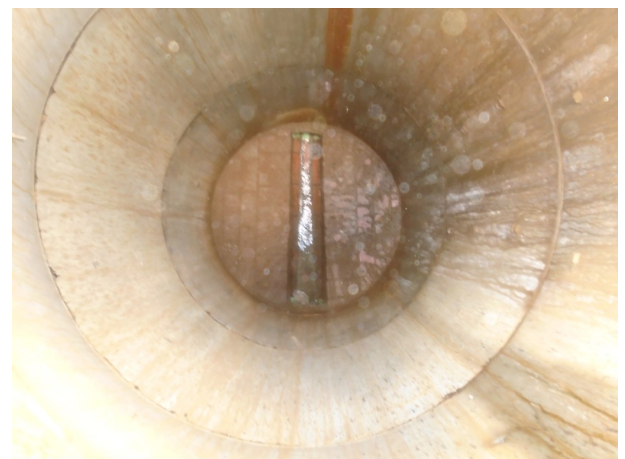
Exterior Manhole Photo

Type? Brick
 Condition? Fair
 I/I? Past Inactive
 Comments? _____

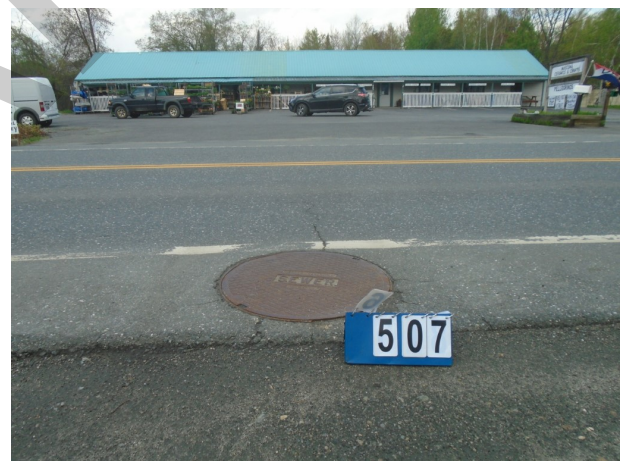
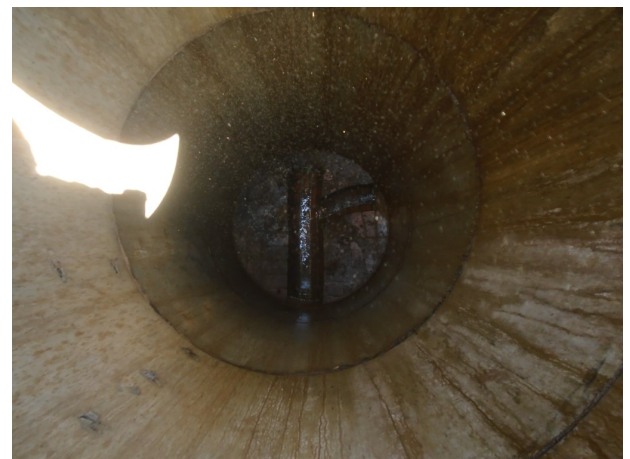
Exterior Manhole Photo

Type? Brick
 Condition? Fair
 I/I? Past Inactive
 Comments? _____
