Appendix B

Manhole Inspection Summary

MANHOLE INSPECTION FORM

Client: Enfield, NH
 Date: 5/9/2019
 Time: 8:13
 Staff Initials: TH

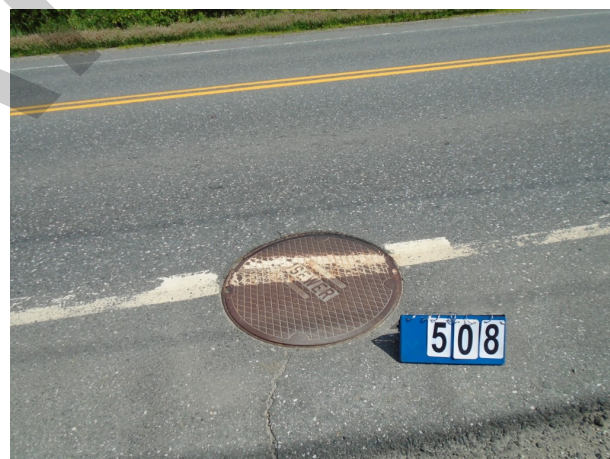
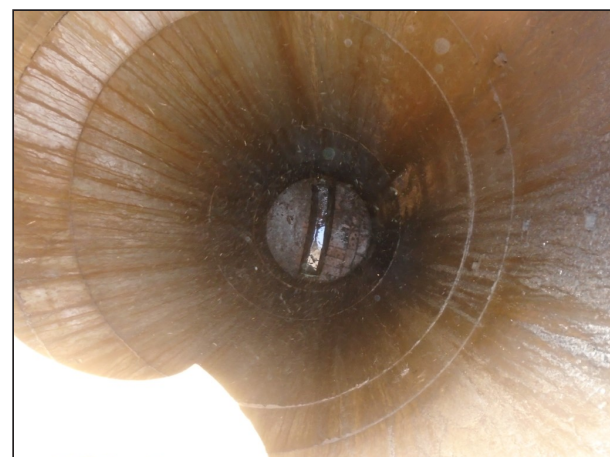
Exterior Manhole Photo

Type? Brick
 Condition? Fair
 I/I? Past Inactive
 Comments? _____

Type? Precast Concrete
 Condition? Fair
 I/I? Past Inactive
 Comments? _____

Type? Brick
 Condition? Fair
 I/I? Past Inactive
 Comments: _____

Type? Brick
 Condition? Fair
 I/I? None
 Comments: _____

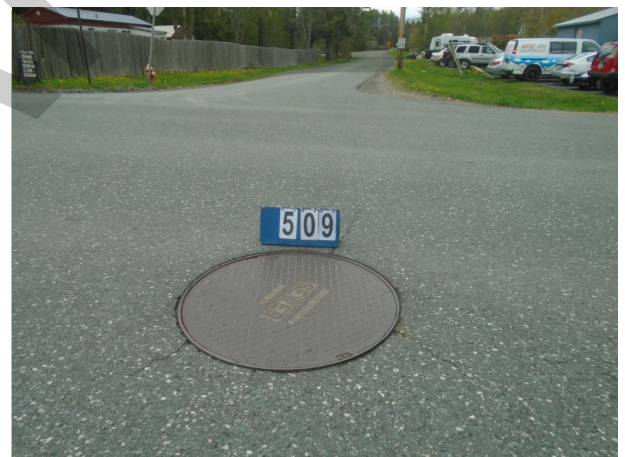
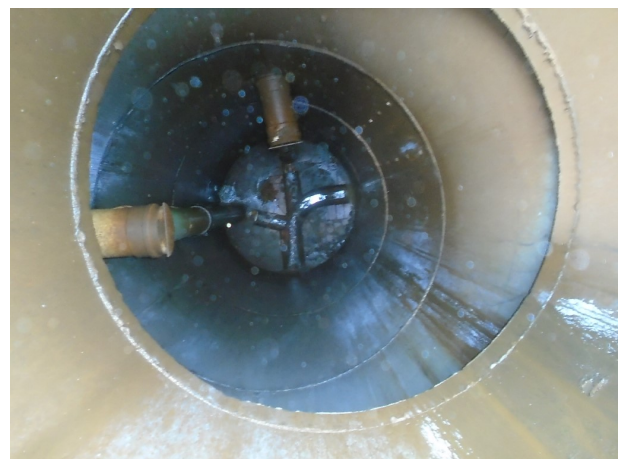
Exterior Manhole Photo

Type? Brick
 Condition? Fair
 I/I? Past Inactive
 Comments? _____

Type? Precast Concrete
 Condition? Fair
 I/I? Active Light
 Comments? Active Light I/I

Type? Brick
 Condition? Good
 I/I? Active Light
 Comments: Active Light I/I

Active Light I/I

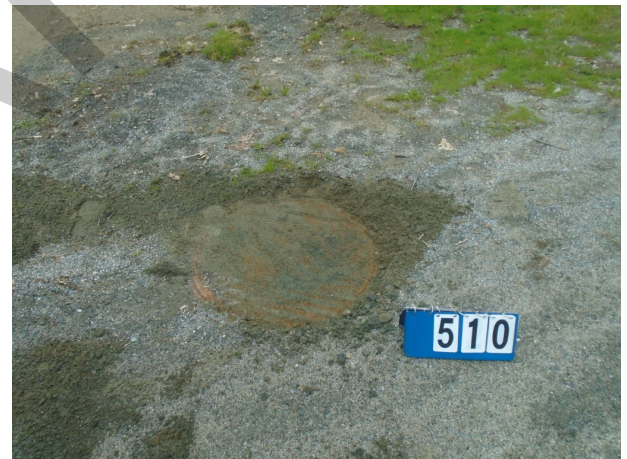
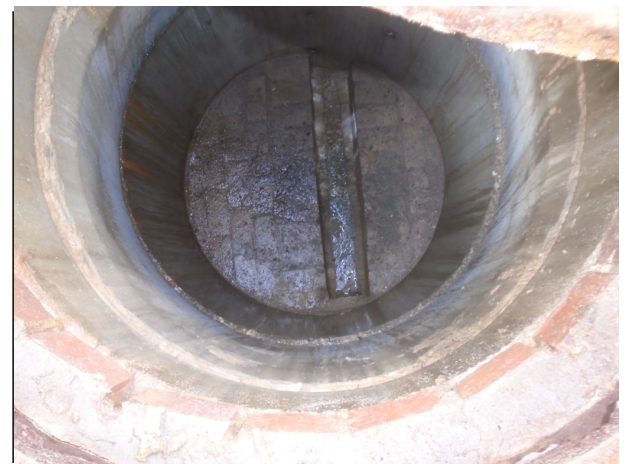
Exterior Manhole Photo

Type? Brick
 Condition? Fair
 I/I? Past Inactive
 Comments? _____

Type? Precast Concrete
 Condition? Fair
 I/I? Active Light
 Comments? Active Light I/I

Type? Brick
 Condition? Fair
 I/I? Active Light
 Comments: Active Light I/I

Active Light I/I

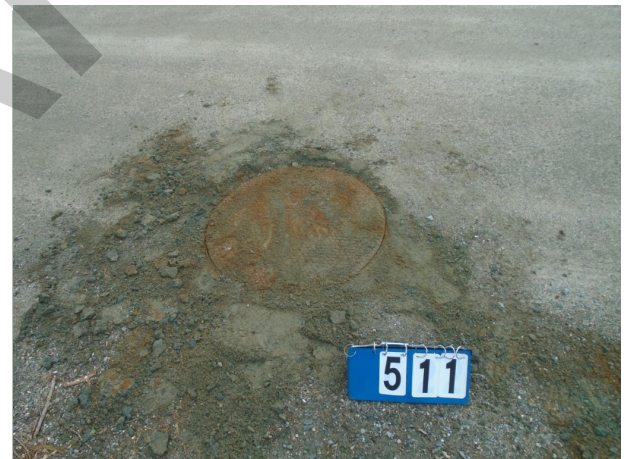
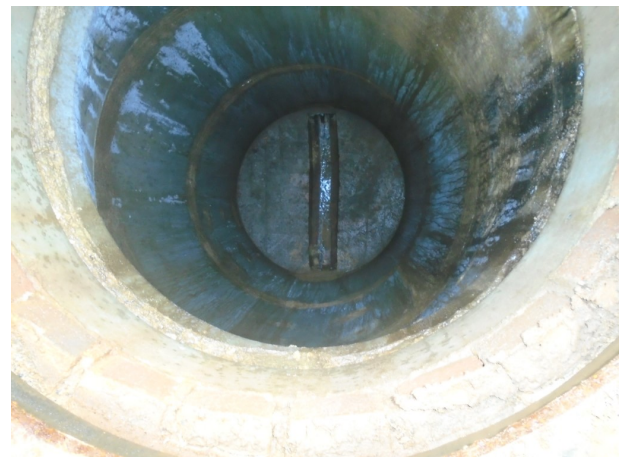
Exterior Manhole Photo

Type? Precast Concrete
 Condition? Fair
 I/I? Active Light
 Comments? Active Light I/I

Type? Brick
 Condition? Good
 I/I? Active Light
 Comments: Active Light I/I

Active Light I/I

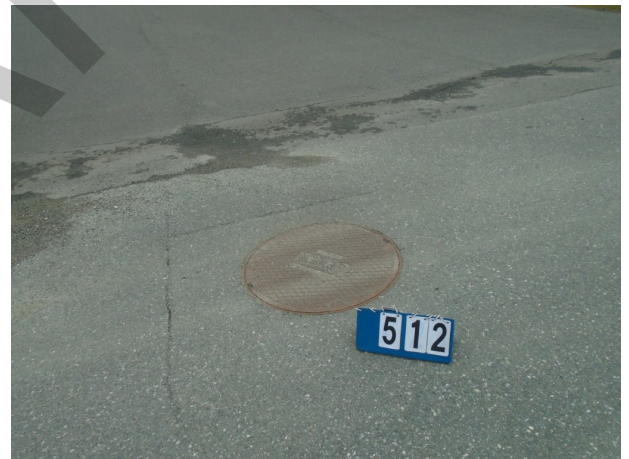
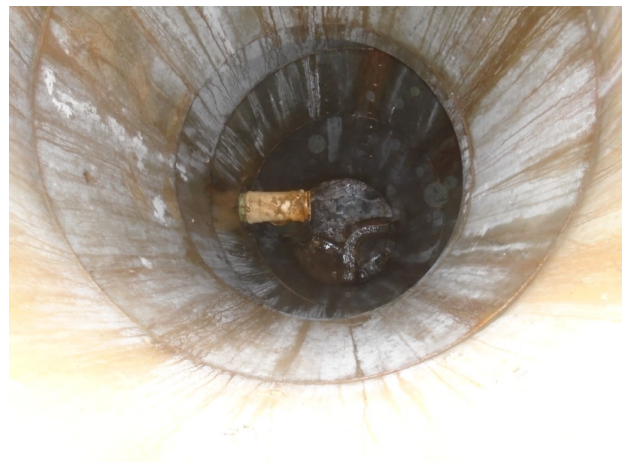
Exterior Manhole Photo

Type? Brick
 Condition? Fair
 I/I? Active Light
 Comments? Active Light I/I

Type? Precast Concrete
 Condition? Fair
 I/I? Past Inactive
 Comments? _____

Type? Brick
 Condition? Good
 I/I? Active Light
 Comments: Active Light I/I

Active Light I/I

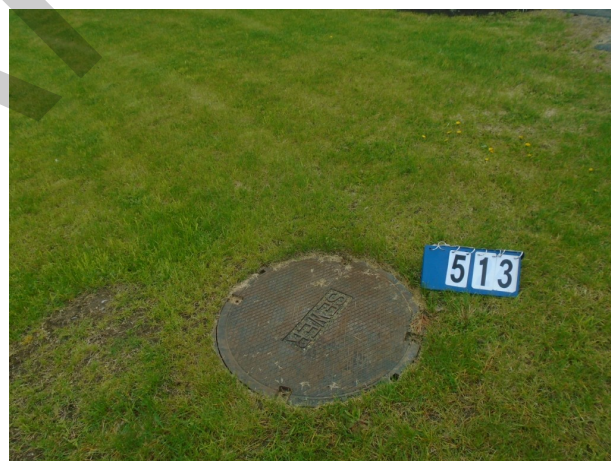
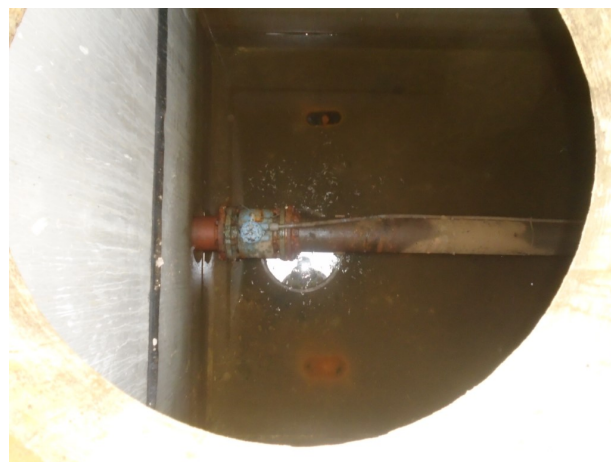
Exterior Manhole Photo

Enclosed Pipe - Pump Station

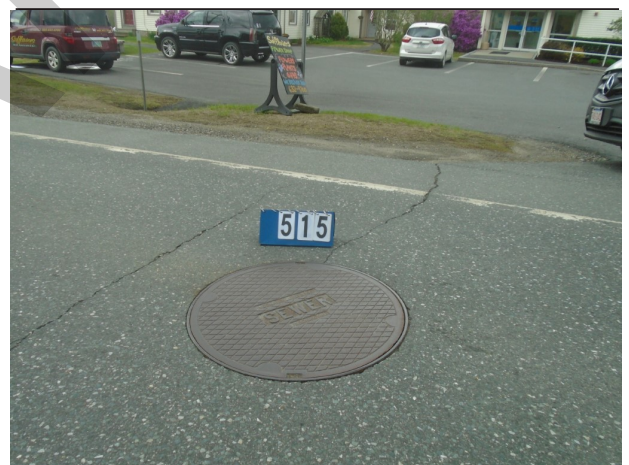
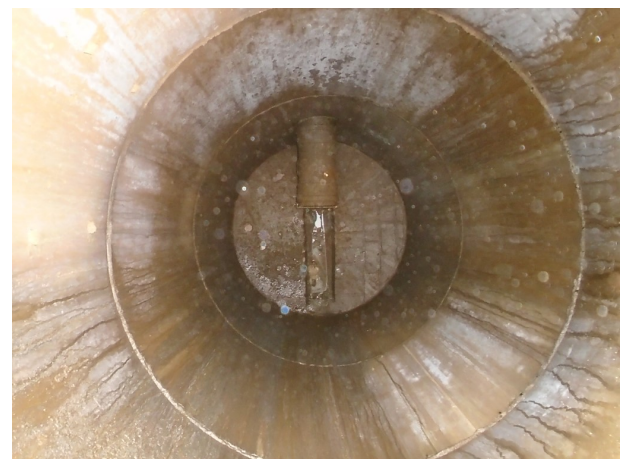
Exterior Manhole Photo

Type? Brick
 Condition? Fair
 I/I? Past Inactive
 Comments? _____

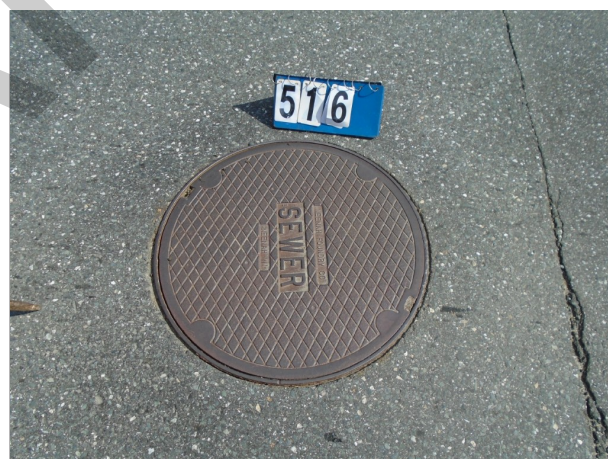
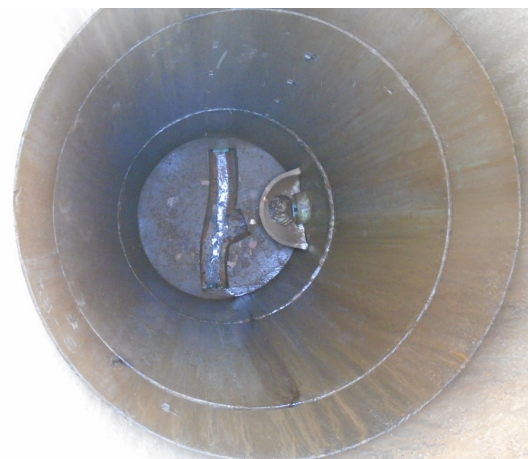
Exterior Manhole Photo

Type? Brick
 Condition? Fair
 I/I? Past Inactive
 Comments? _____

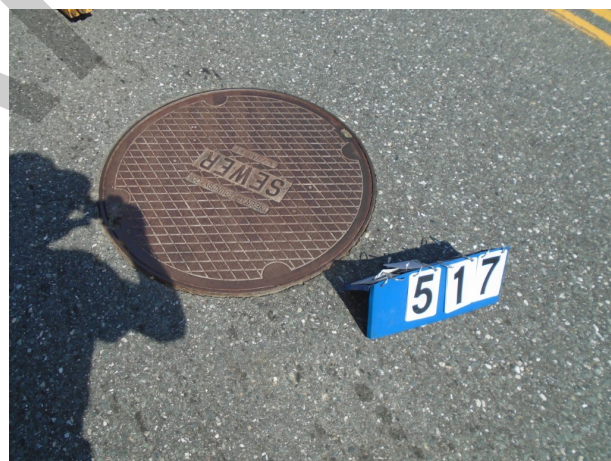
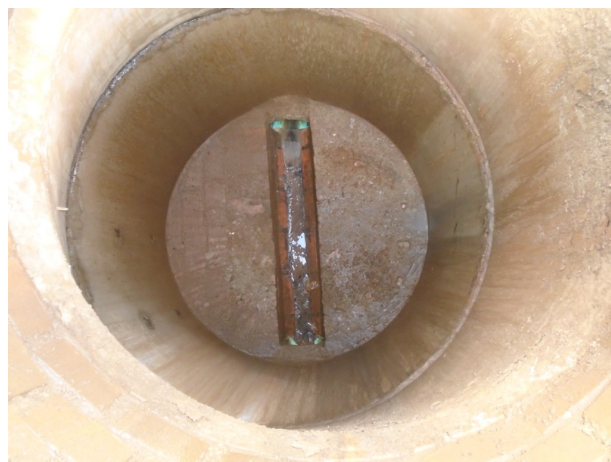
Exterior Manhole Photo

Type? Brick
 Condition? Fair
 I/I? Past Inactive
 Comments? _____

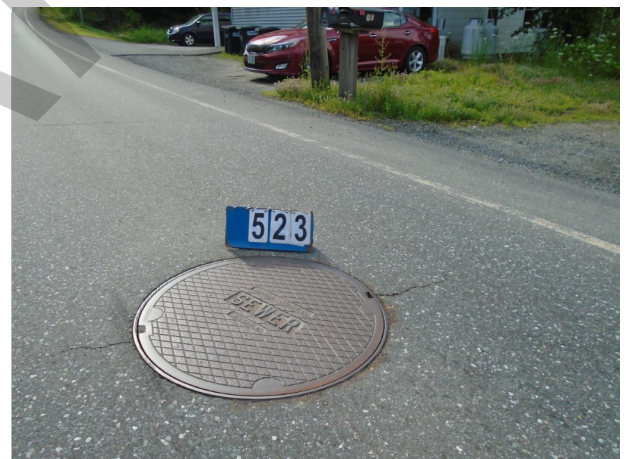
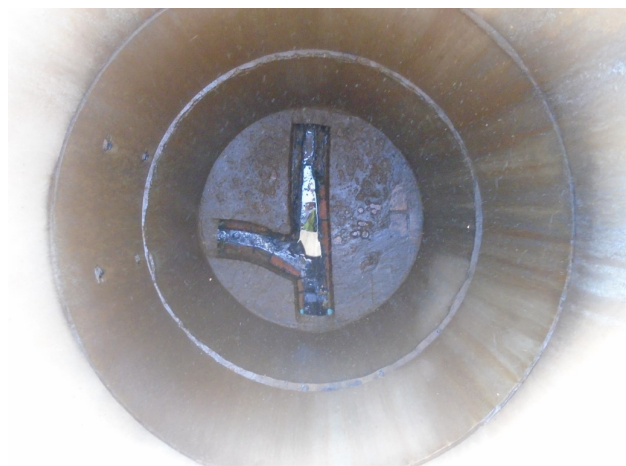
Exterior Manhole Photo

Active Light I/I

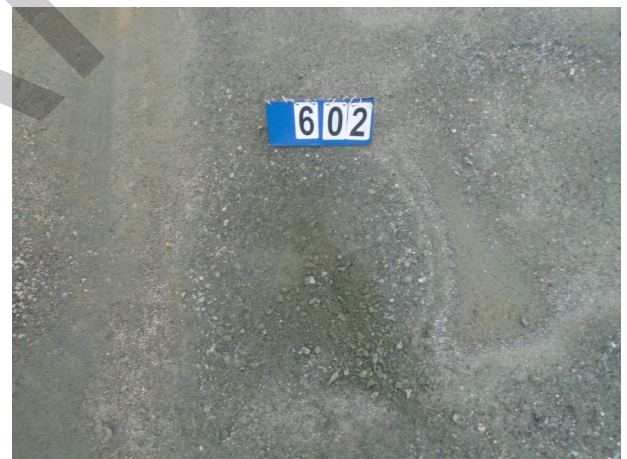
Exterior Manhole Photo

Paved Over

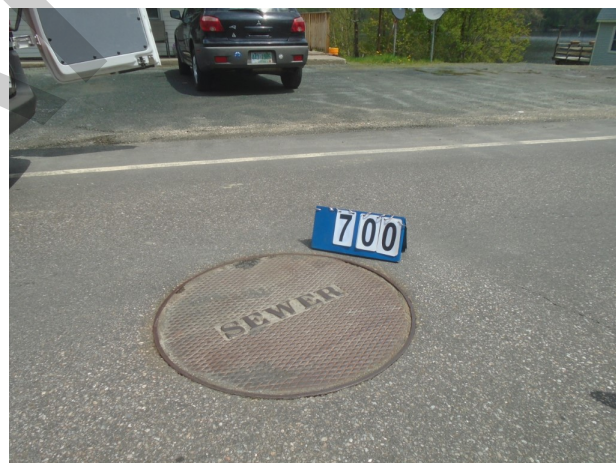
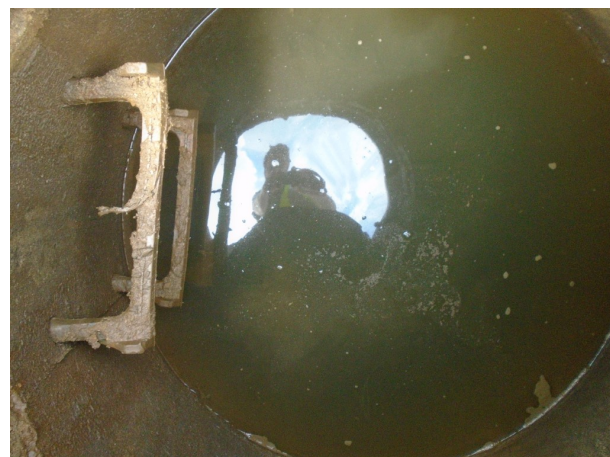
Type? Brick
 Condition? Fair
 I/I? Past Inactive
 Comments? _____

Type? Precast Concrete
 Condition? Fair
 I/I? Past Inactive
 Comments? _____

Type? Plastic Coated
 Condition? Fair
 Comments? _____

Type? _____
 Condition? _____
 I/I? _____
 Comments: Not Visible - Surcharged

Surcharged

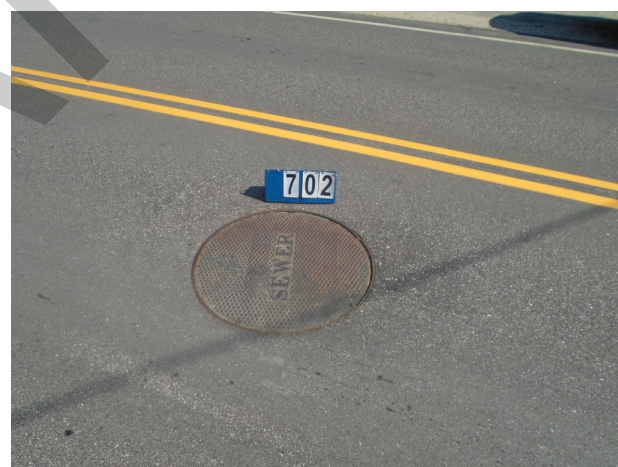
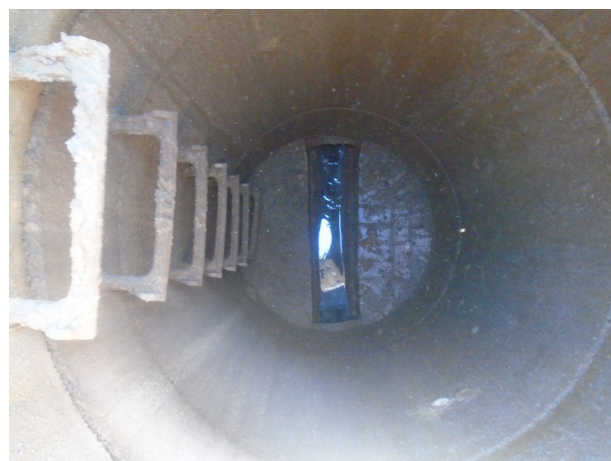
Type? Brick
 Condition? Fair
 I/I? Past Inactive
 Comments: _____

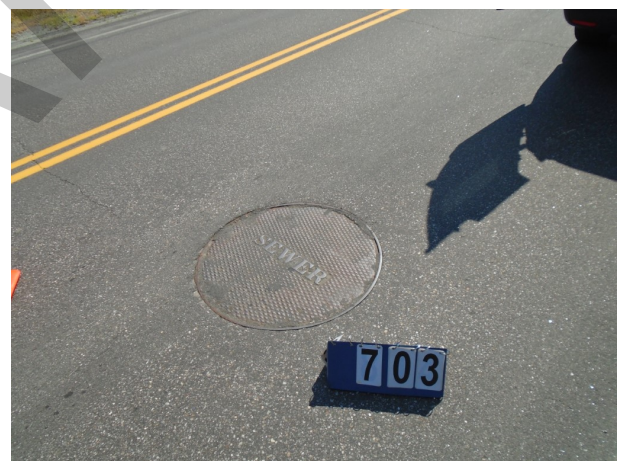
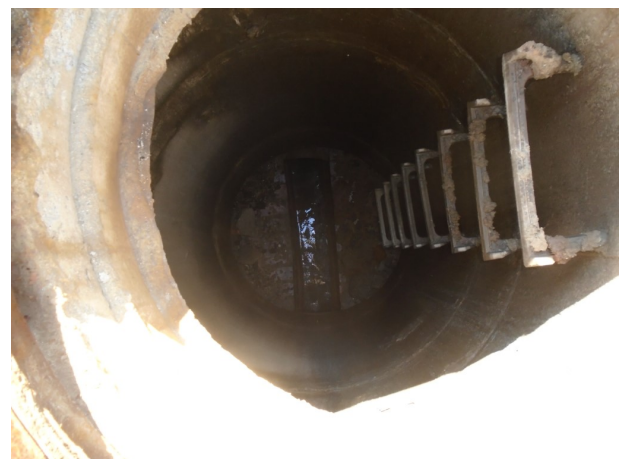
Type? Brick
 Condition? Fair
 I/I? Past Inactive
 Comments: _____

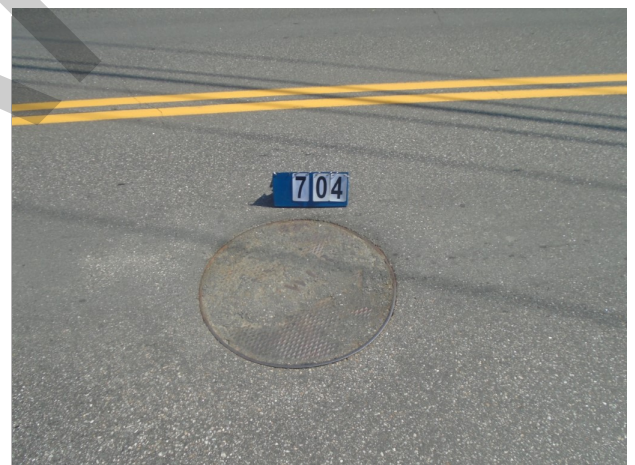
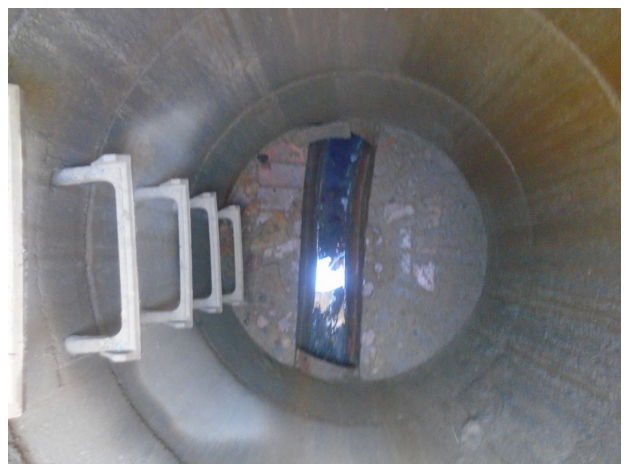
Type? Brick
 Condition? Fair
 I/I? Past Inactive
 Comments _____

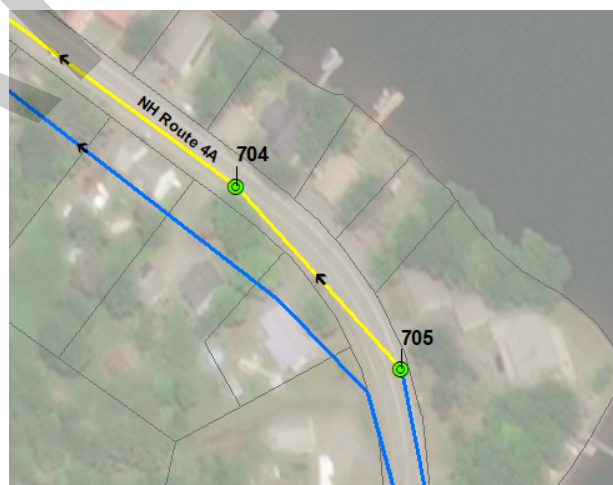
Could Not Locate

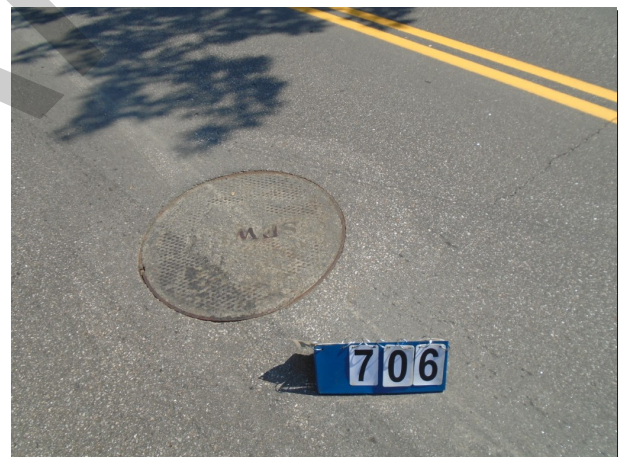
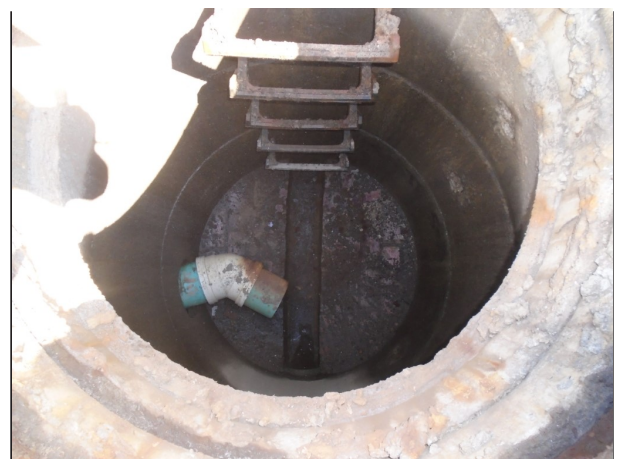
Type? Concrete Ring
 Condition? Fair
 I/I? Past Inactive
 Comments? _____

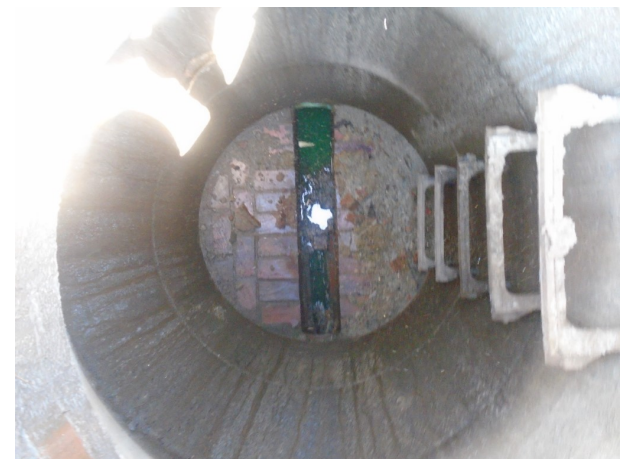
Type? Brick
 Condition? Poor
 I/I? Past Inactive
 Comments? Loose/Missing Bricks from Riser

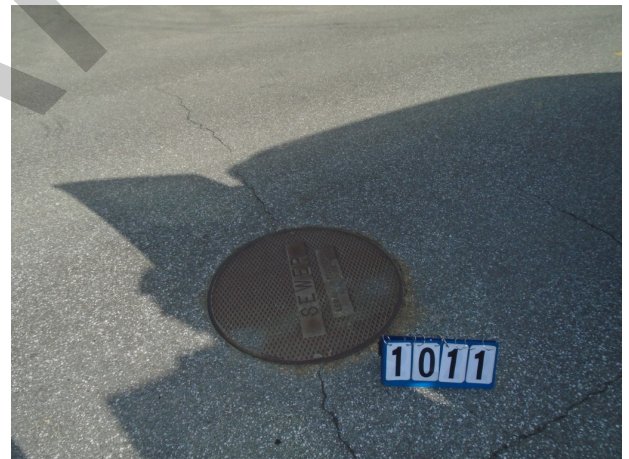
Could Not Open

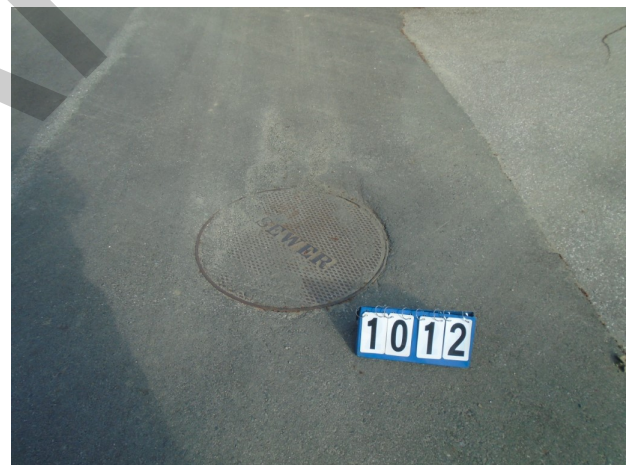
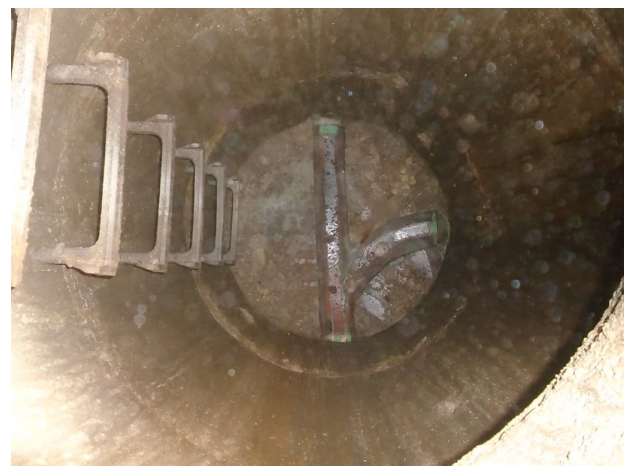
Type? Brick
 Condition? Fair
 I/I? Past Inactive
 Comments? _____

Type? Precast Concrete
 Condition? Good
 I/I? Past Inactive
 Comments? _____

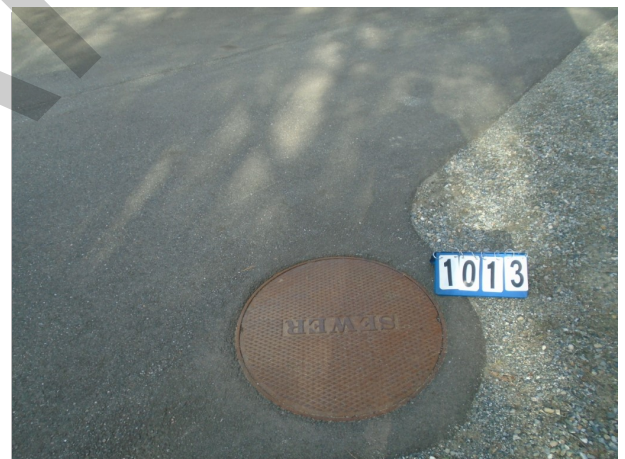
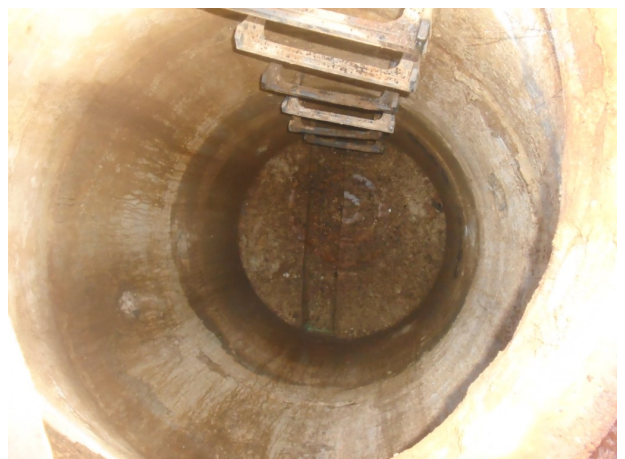
Type? Brick
 Condition? Fair
 I/I? Past Inactive
 Comments: _____

Type? Precast Concrete
 Condition? Good
 I/I? Past Inactive
 Comments: _____

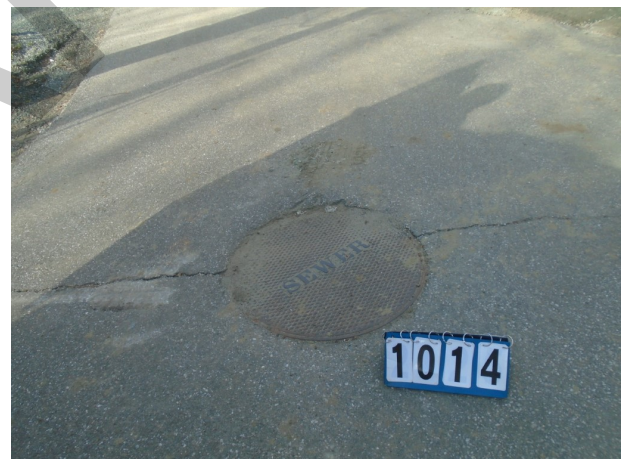
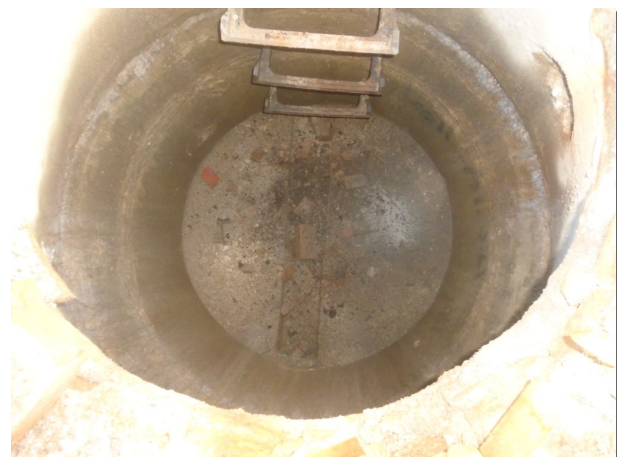
Type? Brick
 Condition? Poor
 I/I? Past Inactive
 Comments? _____

Type? Brick
 Condition? Fair
 I/I? Past Inactive
 Comments: _____

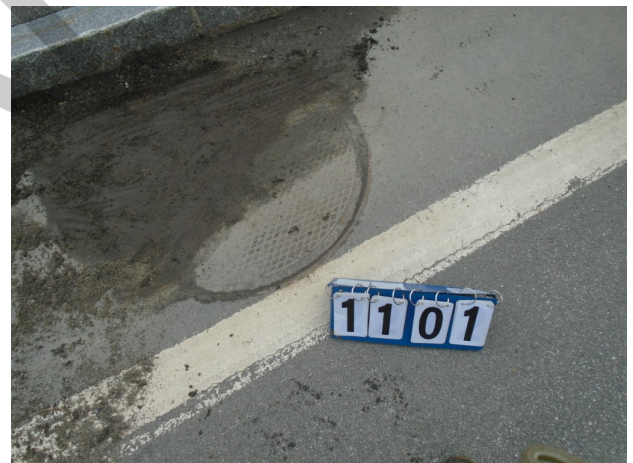
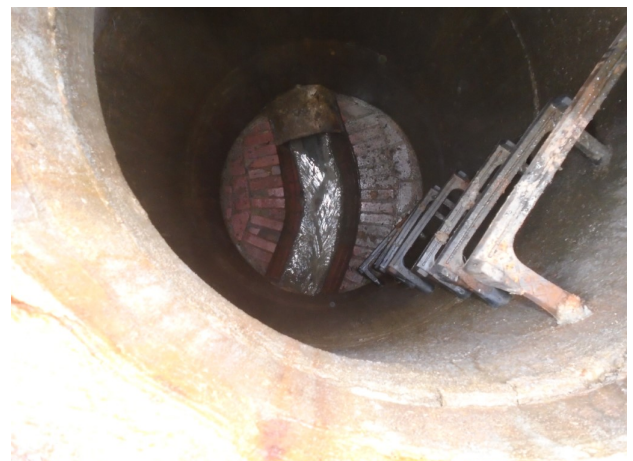
Type? Brick
 Condition? Fair
 I/I? Past Inactive
 Comments _____

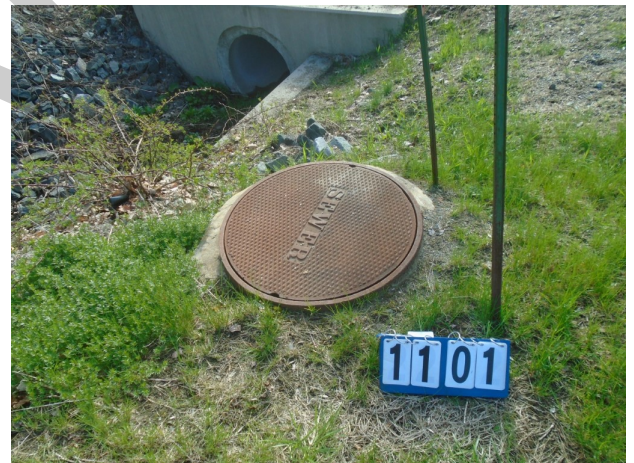
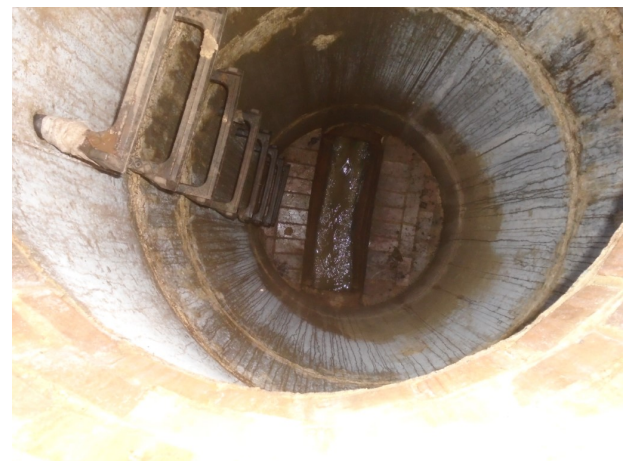
Pump Station - Enclosed Pipe

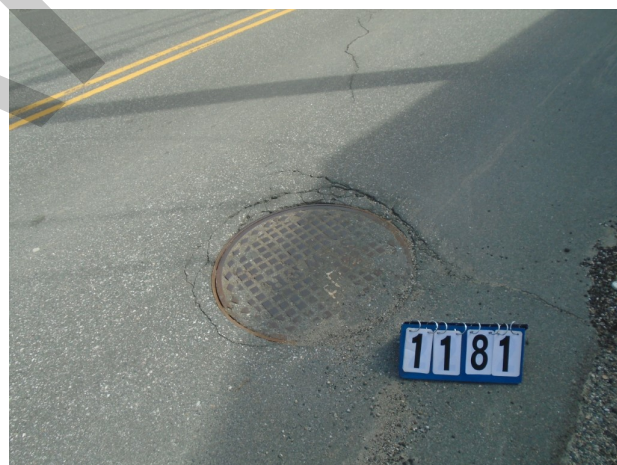
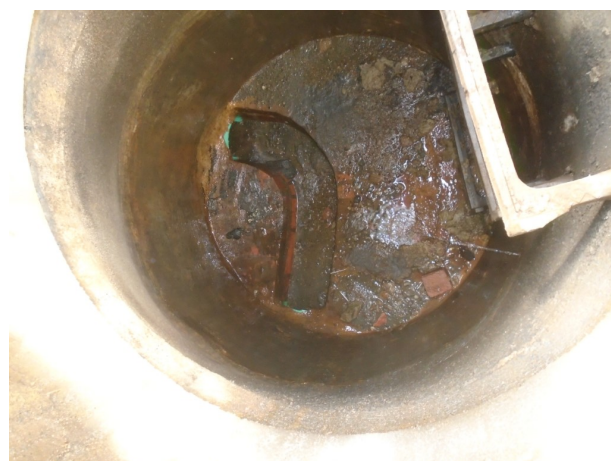
Type? Brick
 Condition? Fair
 I/I? Past Inactive
 Comments? _____

Type? Precast Concrete
 Condition? Poor
 I/I? Active Moderate
 Comments? Active Moderate I/I

Type? Brick
 Condition? Fair
 I/I? Active Light
 Comments: Active Light I/I

Type? Brick
 Condition? Fair
 I/I? None
 Comments: _____

Active Moderate I/I

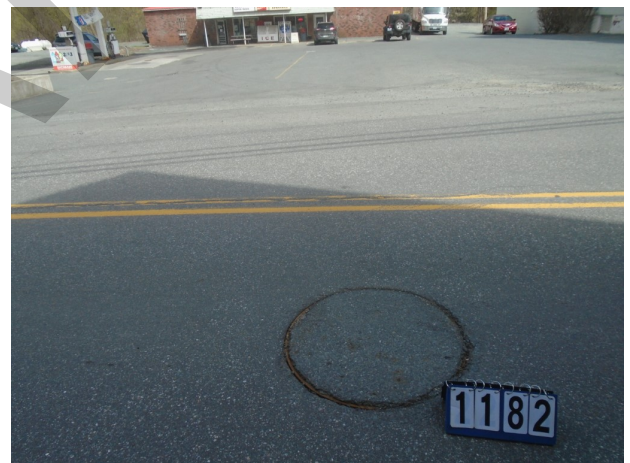
Could Not Open

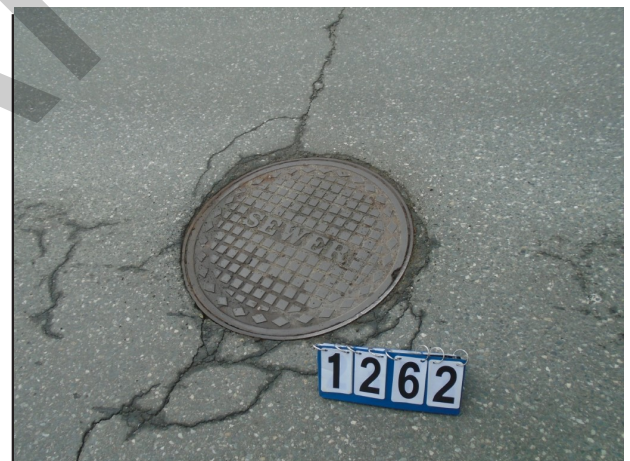
Could Not Open

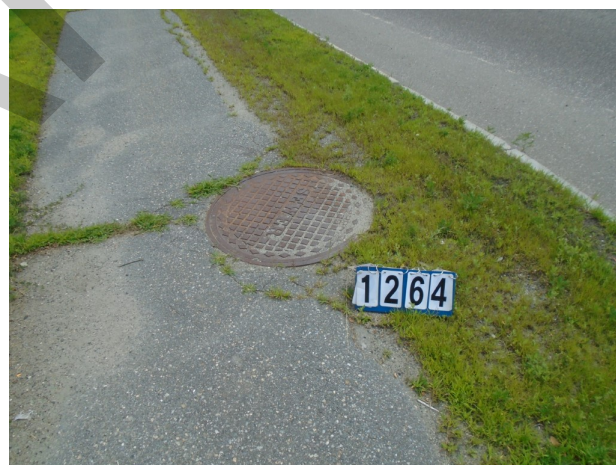
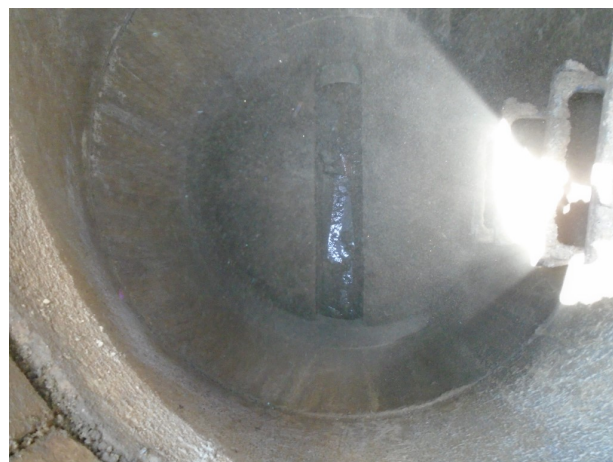
Type? Precast Concrete
 Condition? Fair
 I/I? Past Inactive
 Comments? _____

Type? Brick
 Condition? Fair
 I/I? Past Inactive
 Comments: _____

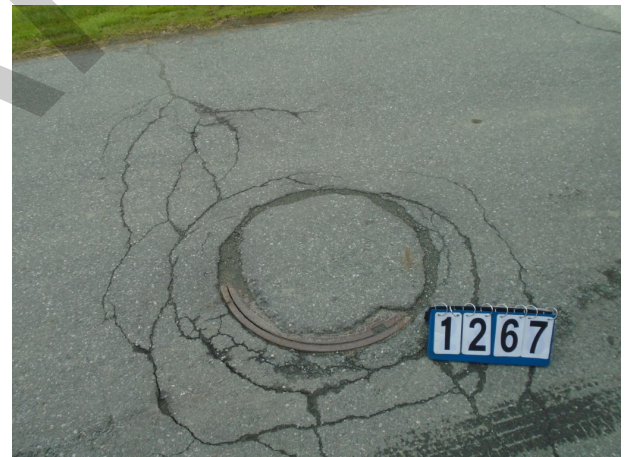
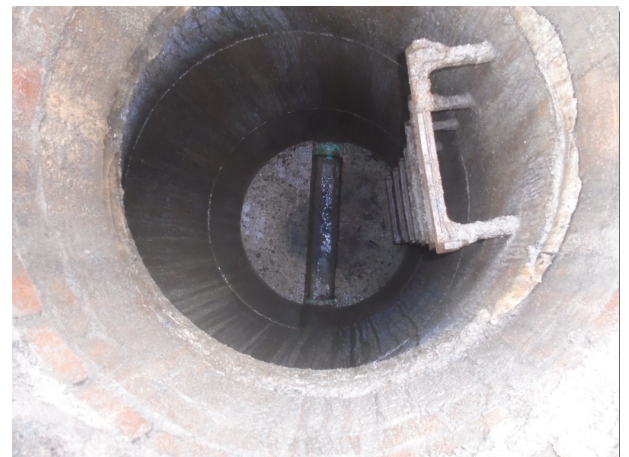
Type? Brick
 Condition? Fair
 I/I? Past Inactive
 Comments? _____

Type? Precast Concrete
 Condition? Fair
 I/I? Past Inactive
 Comments? _____

Type? Plastic Coated
 Condition? Fair
 Comments? _____

Type? Brick
 Condition? Fair
 I/I? Active Light
 Comments: Active Light I/I

Active Light I/I

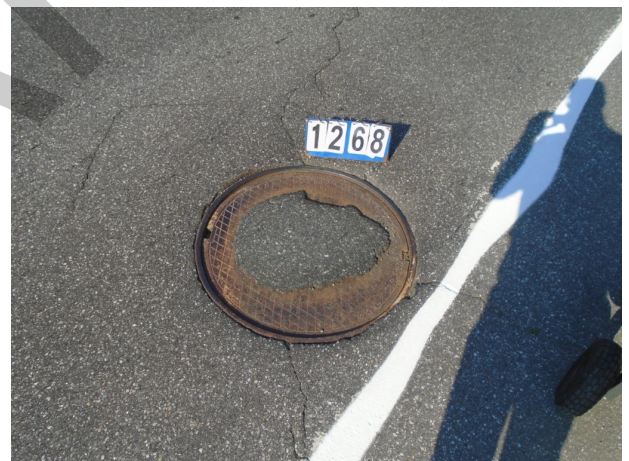
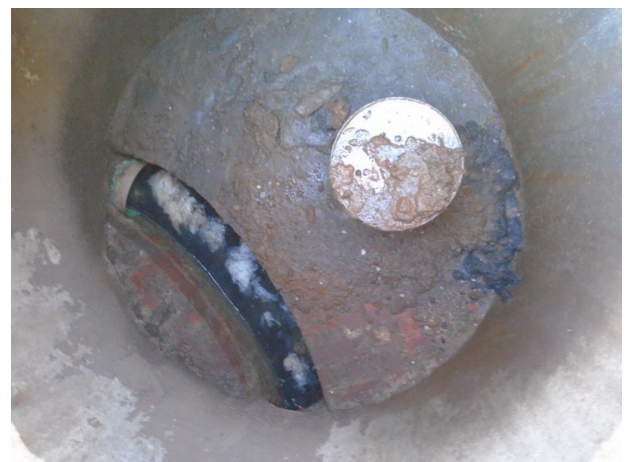
Type? Brick
 Condition? Fair
 I/I? Past Inactive
 Comments: _____

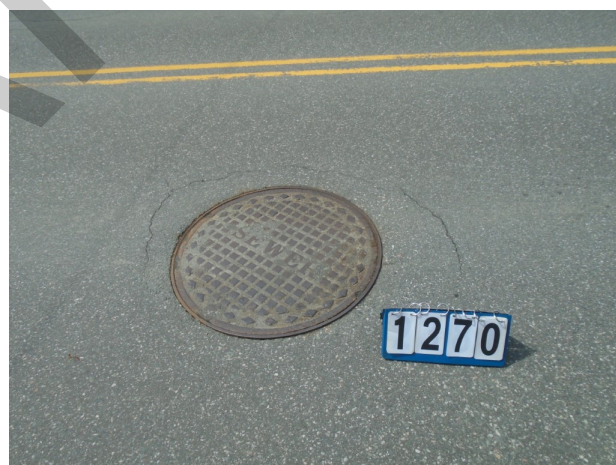
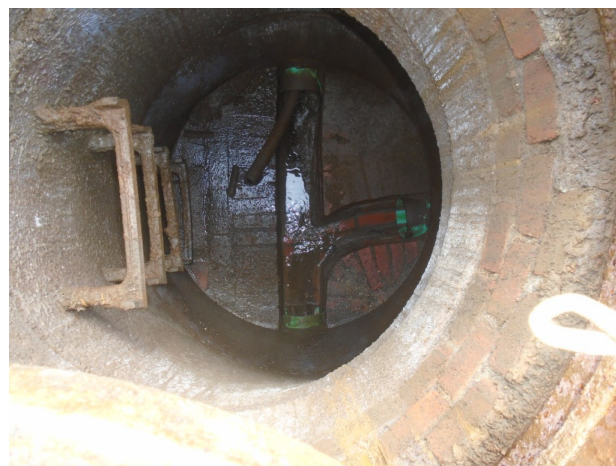
Active Light I/I

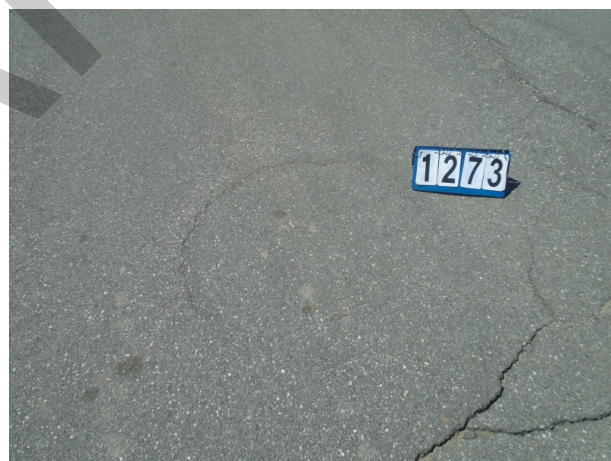
Paved Over

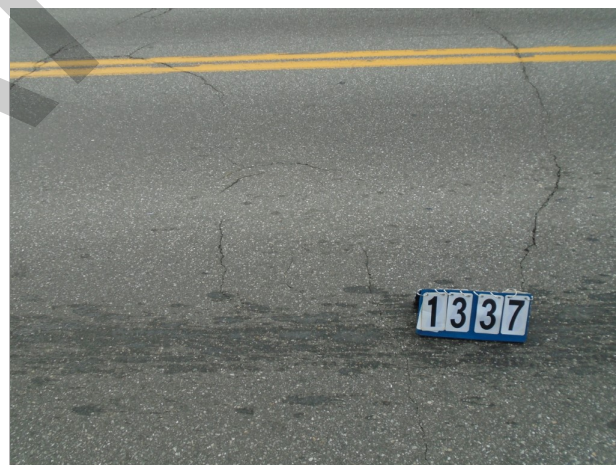
Exterior Manhole Photo

Paved Over

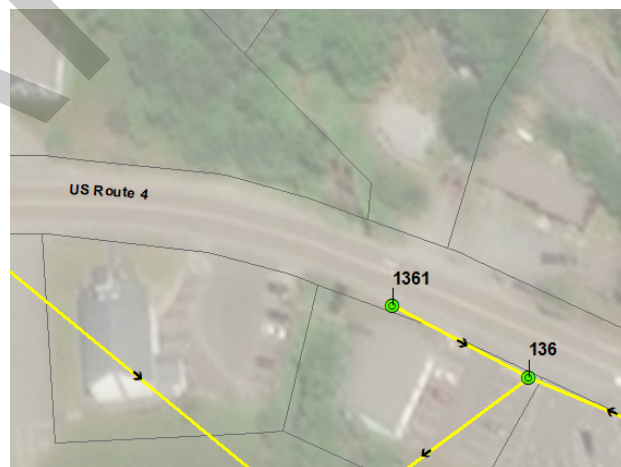
Exterior Manhole Photo

Could Not Locate

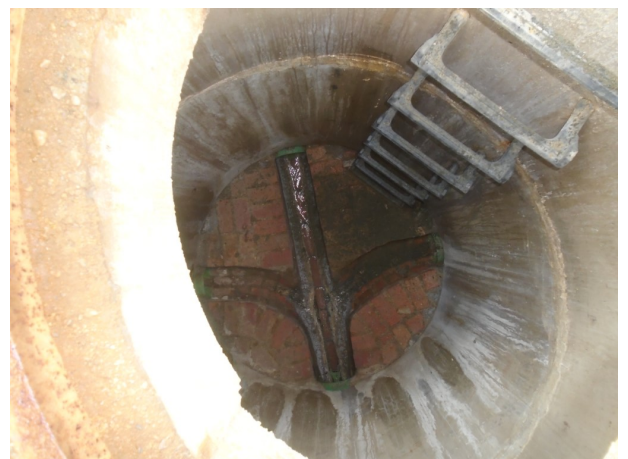
Interior Manhole Photo

Type? Precast Concrete
 Condition? Good
 I/I? Past Inactive
 Comments? _____

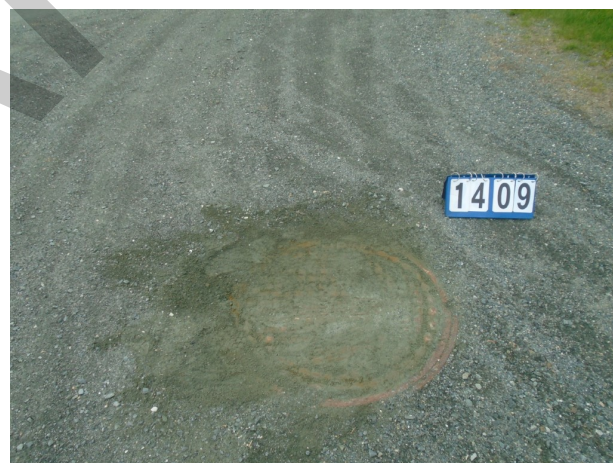
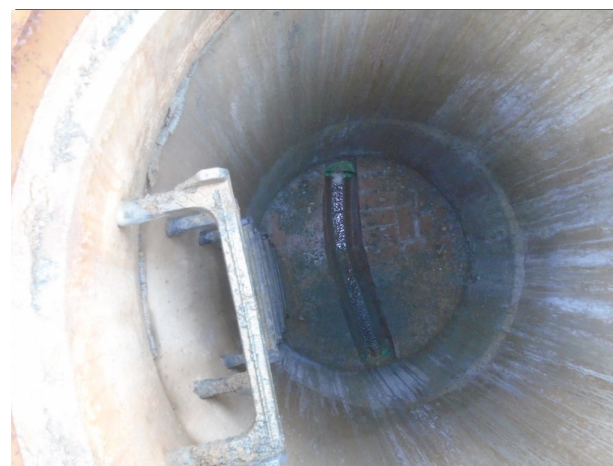
Type? Precast Concrete
 Condition? Fair
 I/I? Past Inactive
 Comments? _____

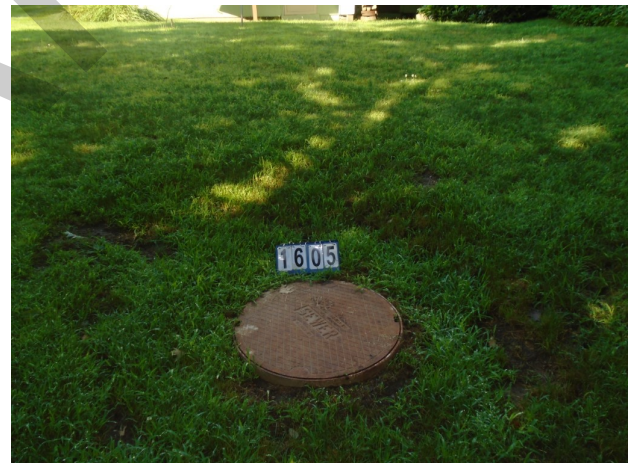
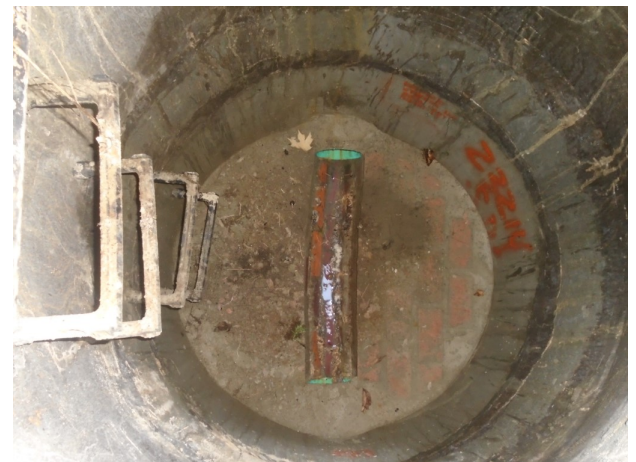
Type? Brick
 Condition? Fair
 I/I? Past Inactive
 Comments? _____

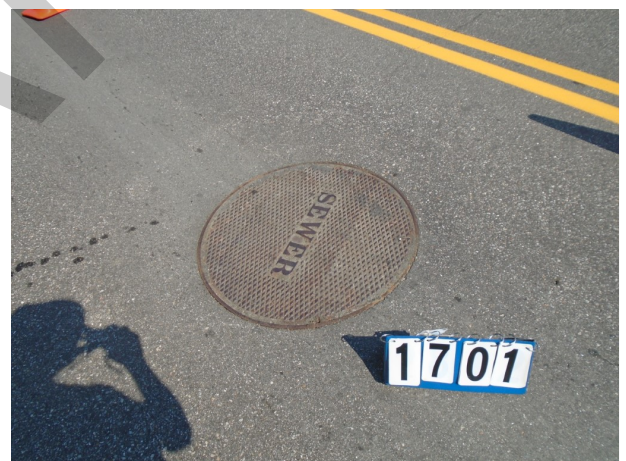
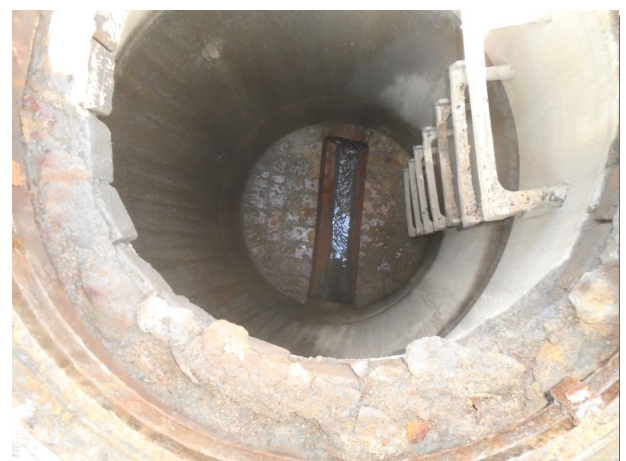
Type? Brick
 Condition? Fair
 I/I? Past Inactive
 Comments? _____

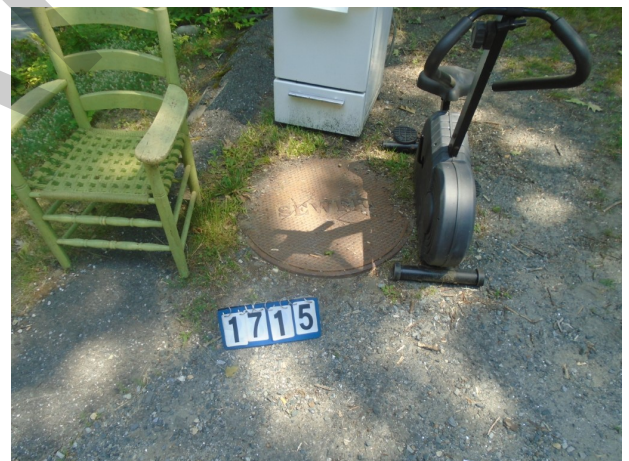
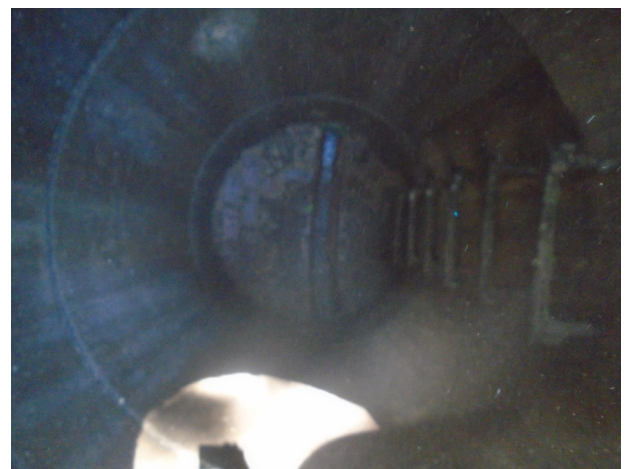
Type? Brick
 Condition? Fair
 I/I? Past Inactive
 Comments? _____

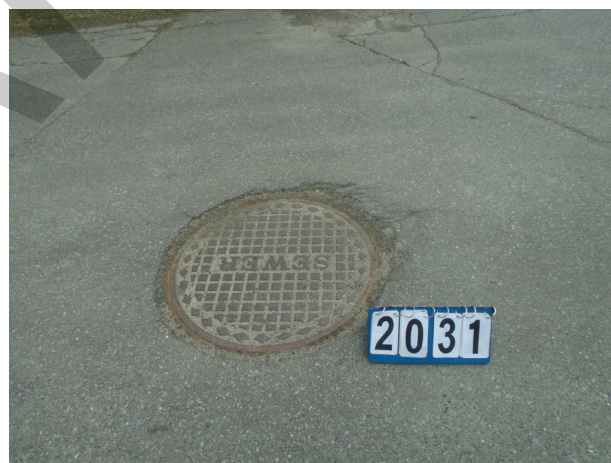
Exterior Manhole Photo

Could Not Open

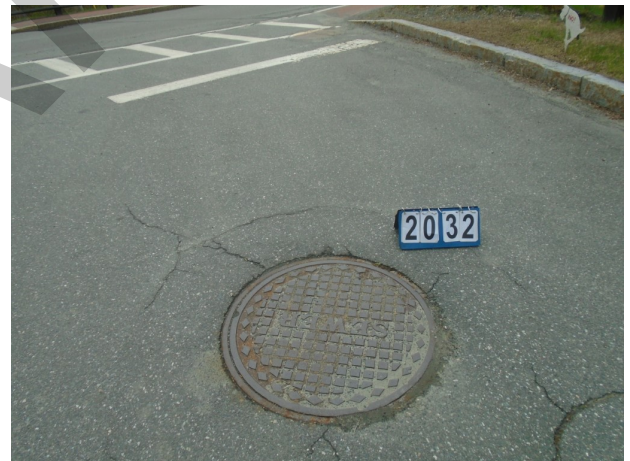
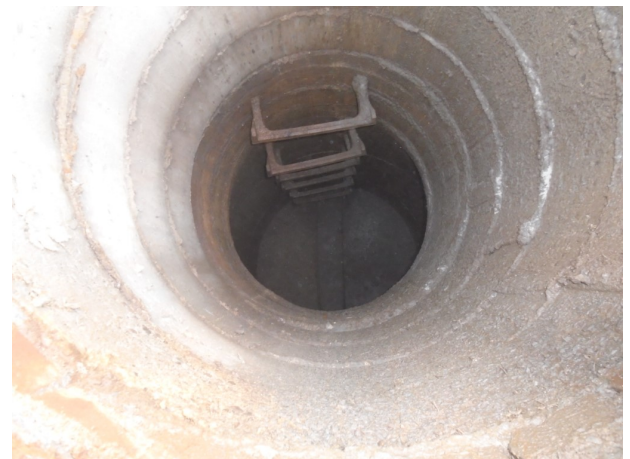
Type? Brick
 Condition? Fair
 I/I? Past Inactive
 Comments? _____

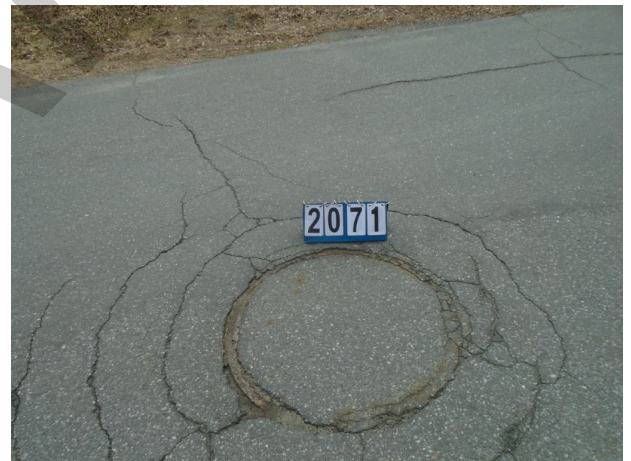
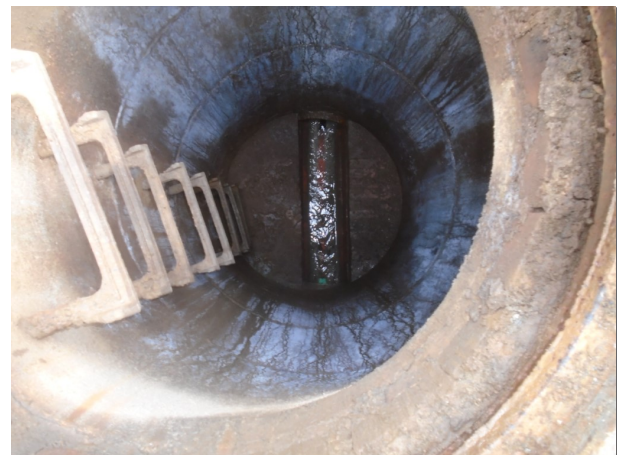
Type? Brick
 Condition? Fair
 I/I? Past Inactive
 Comments? _____

Type? Precast Concrete
 Condition? Fair
 I/I? Past Inactive
 Comments? _____

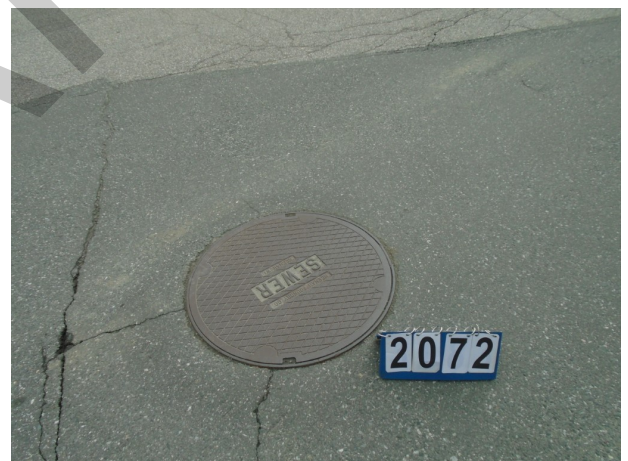
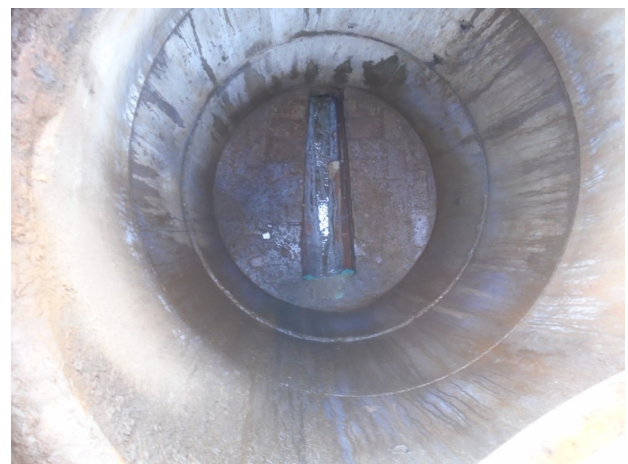
Type? Brick
 Condition? Fair
 I/I? Active Light
 Comments: Active Light I/I

Active Light I/I

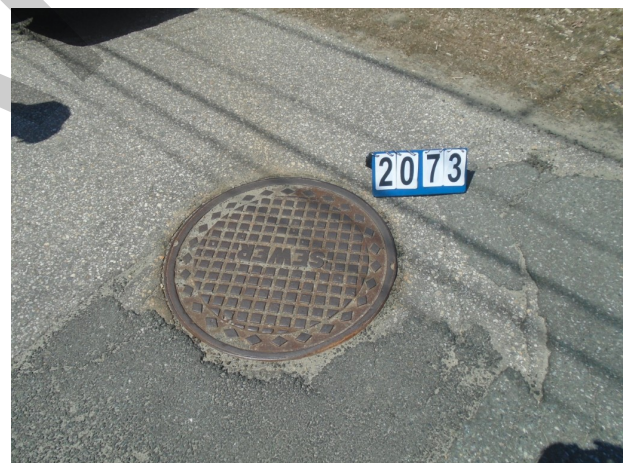
Could Not Open
