Appendix B

Manhole Inspection Summary

MANHOLE INSPECTION FORM

Client: Enfield, NH
 Date: 5/9/2019
 Time: 8:13
 Staff Initials: TH

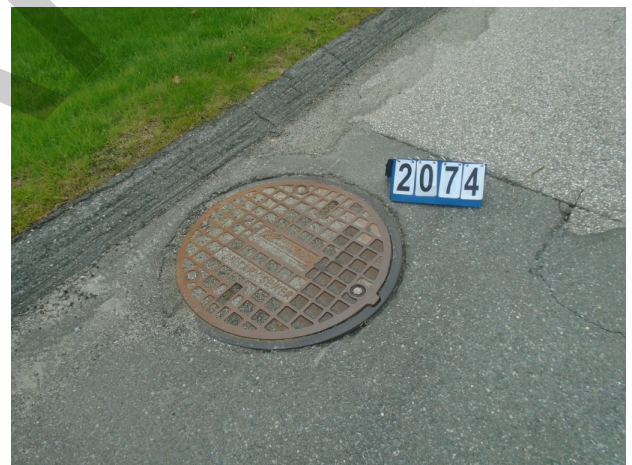
Bolted Cover

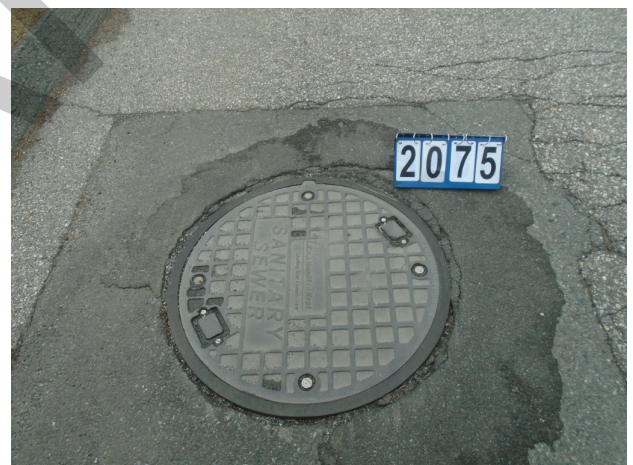
Exterior Manhole Photo

Bolted Cover

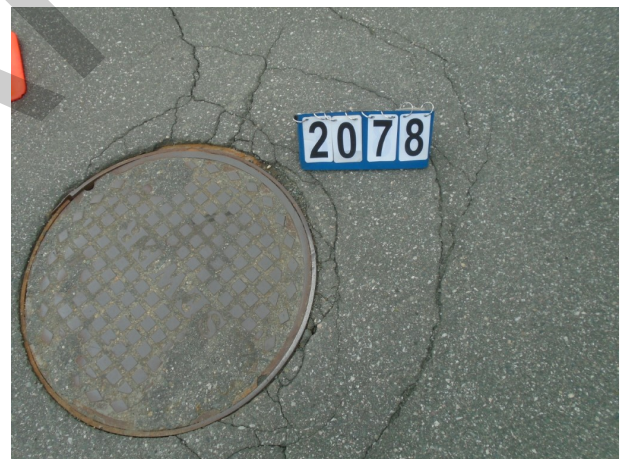
Could Not Open

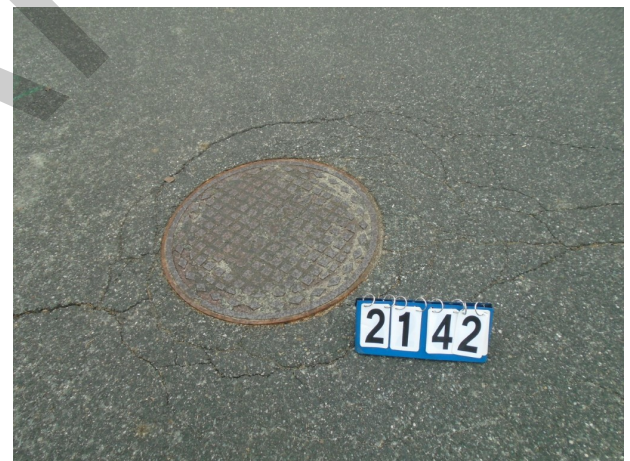
Exterior Manhole Photo

Could Not Open

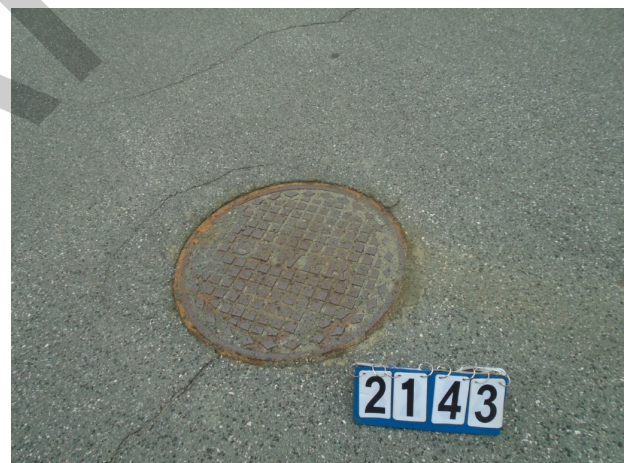
Exterior Manhole Photo

Could Not Open

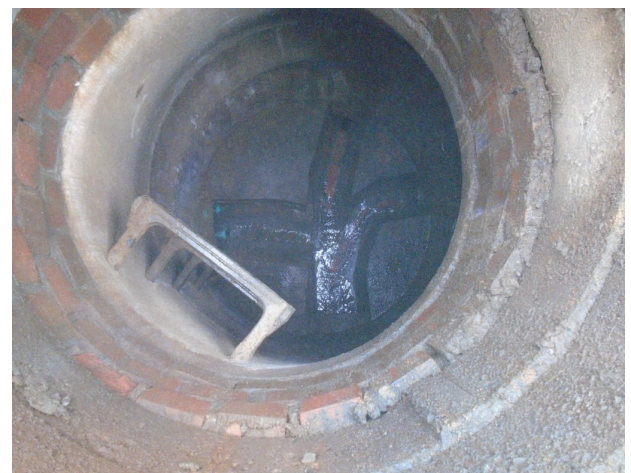
Interior Manhole Photo

Type? Brick
 Condition? Fair
 I/I? Past Inactive
 Comments? _____

Type? Precast Concrete
 Condition? Fair
 I/I? Past Inactive
 Comments? _____

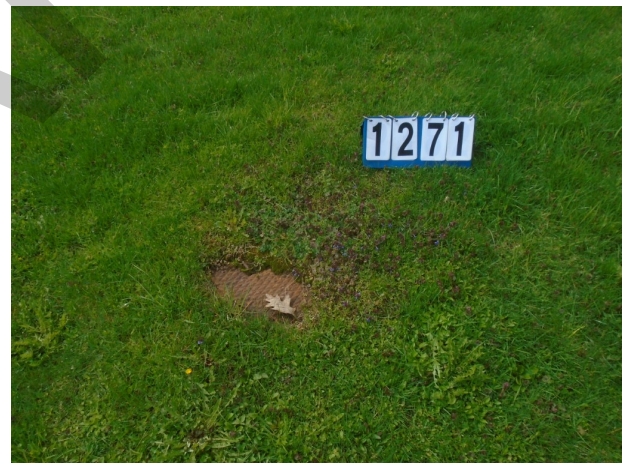
Exterior Manhole Photo

Paved Over, Exterior Photo
 Mislabeled 1271

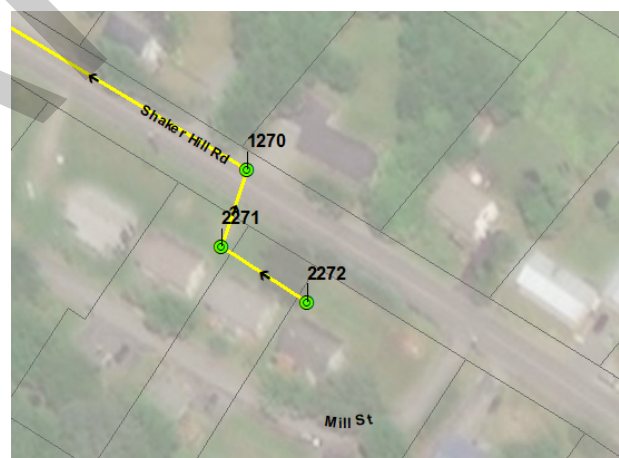
Exterior Manhole Photo

Could Not Locate

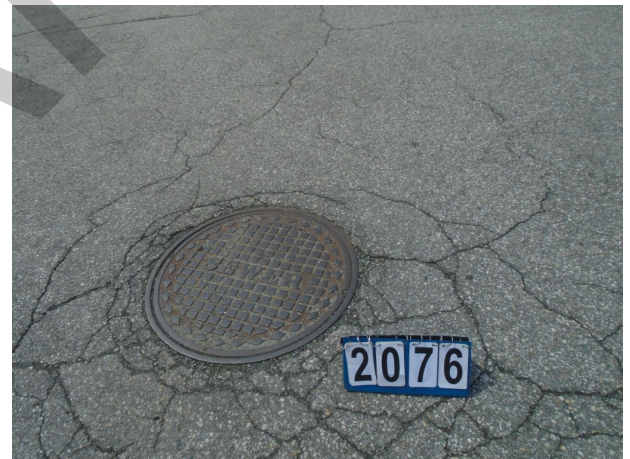
Exterior Manhole Photo

Exterior Photo Mislabeled 2076

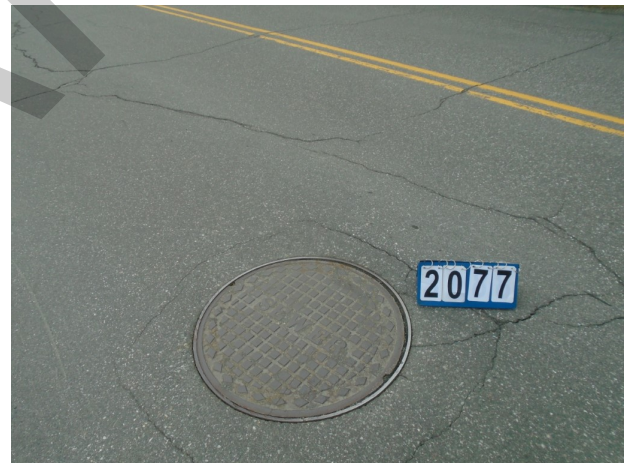
Exterior Manhole Photo

Exterior Photo Mislabeled 2077

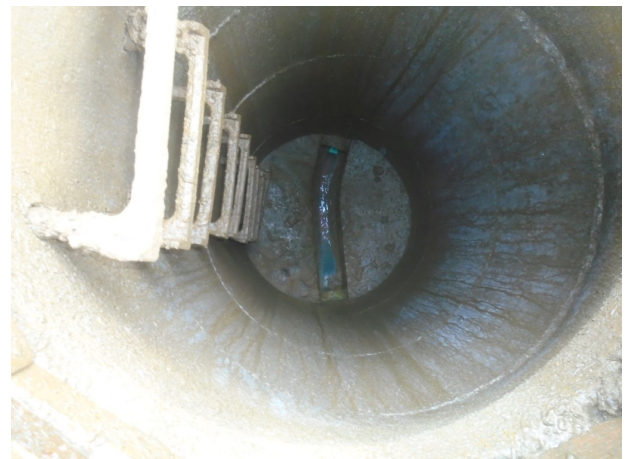
Interior Manhole Photo

Type? Brick
 Condition? Fair
 I/I? Past Inactive
 Comments? _____

Type? Precast Concrete
 Condition? Fair
 I/I? Past Inactive
 Comments? _____

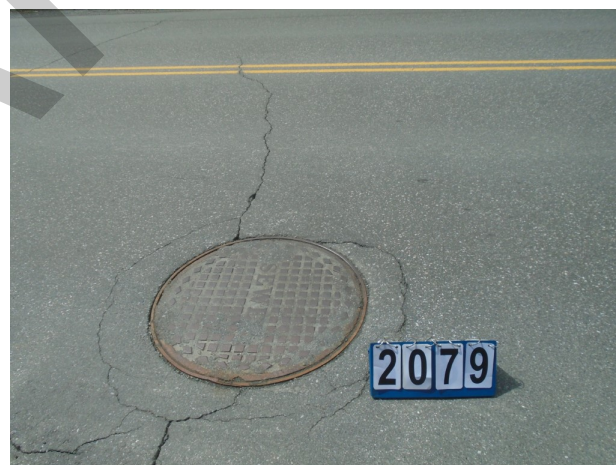
Exterior Manhole Photo

Exterior Photo Mislabeled 2079

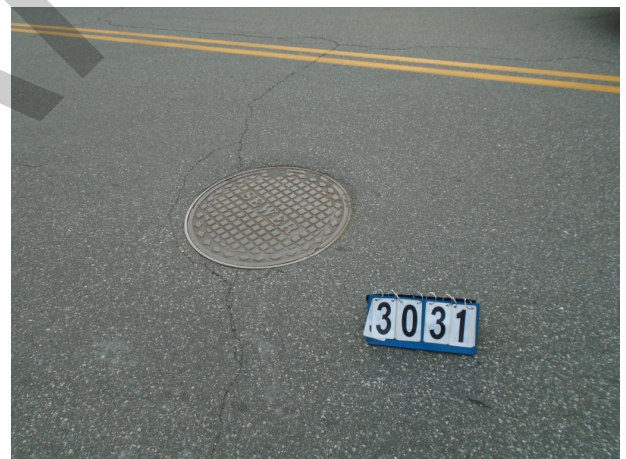
Exterior Manhole Photo

Could Not Open

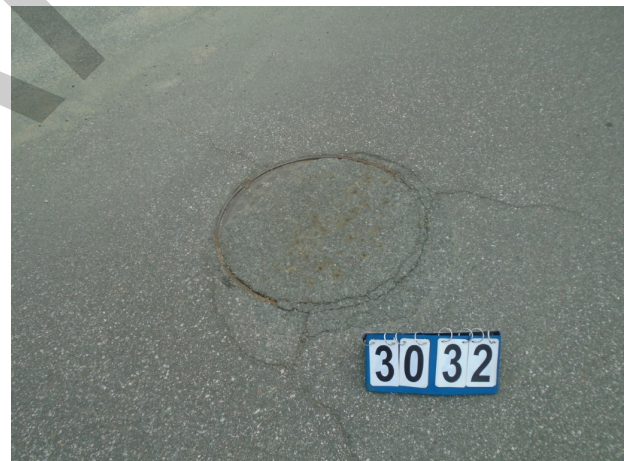
Exterior Manhole Photo

Paved Over

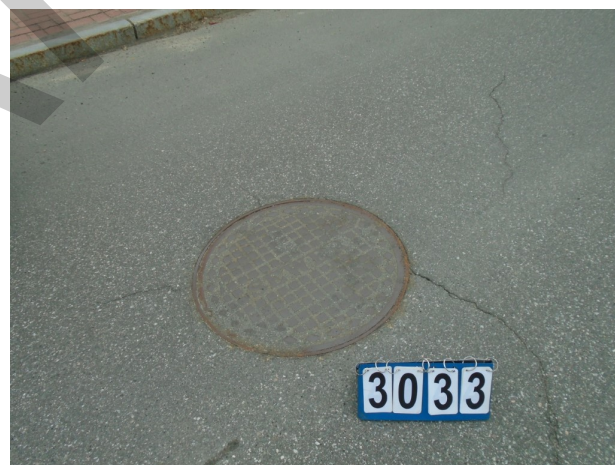
Exterior Manhole Photo

Could Not Open

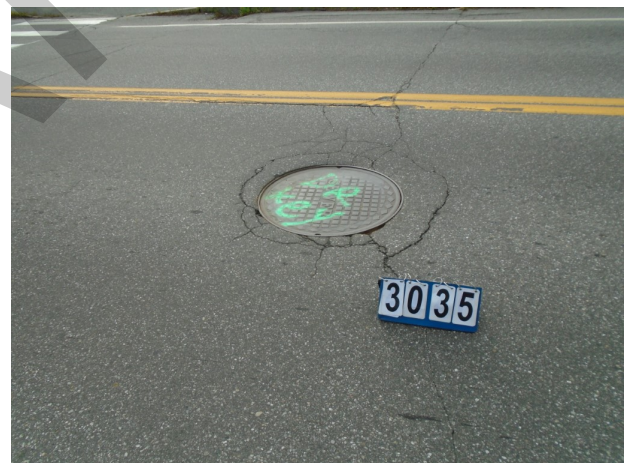
Exterior Manhole Photo

Could Not Open

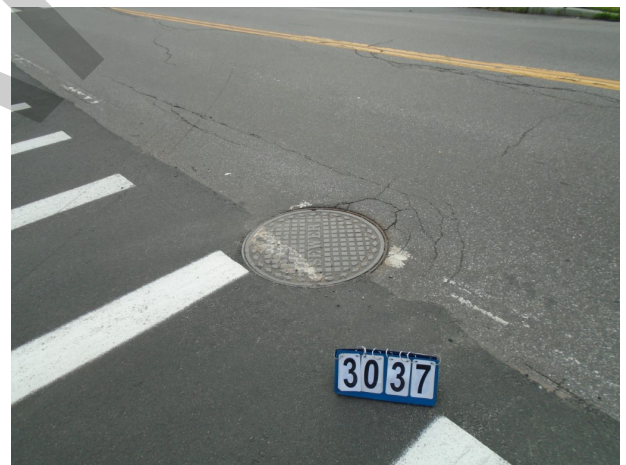
Exterior Manhole Photo

Could Not Open

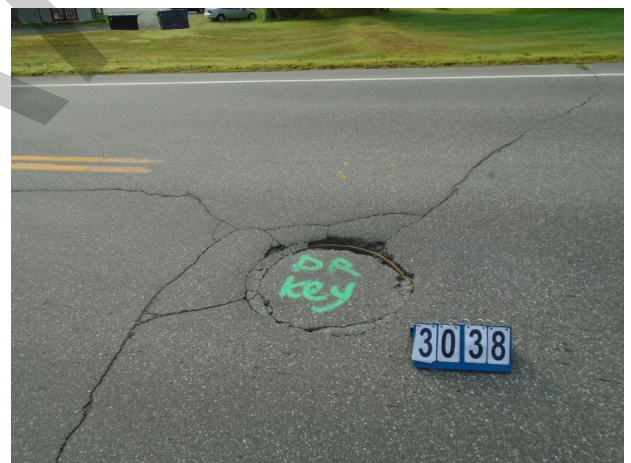
Exterior Manhole Photo

Paved Over

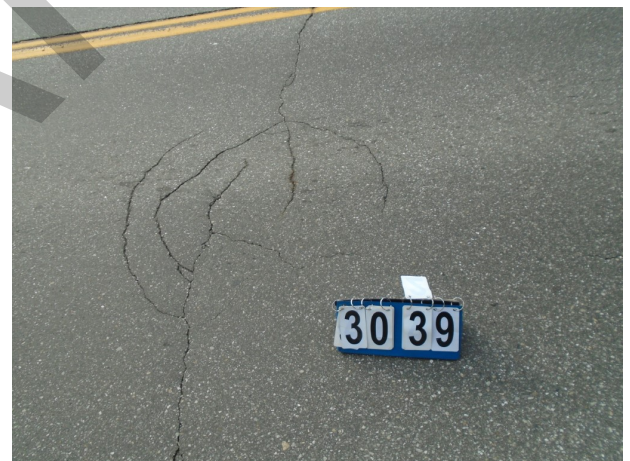
Exterior Manhole Photo

Paved Over

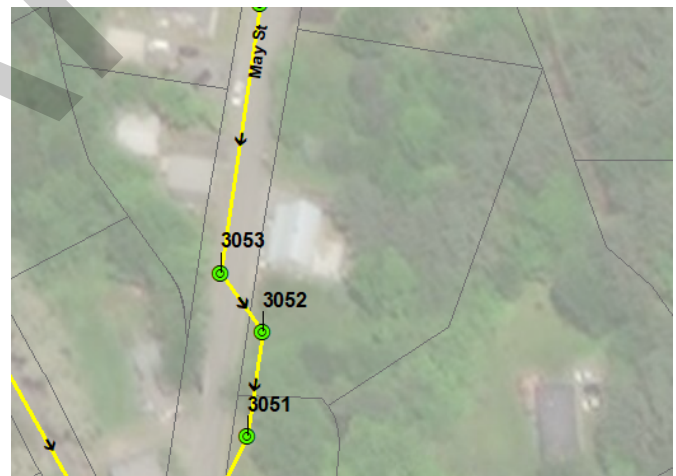
Exterior Manhole Photo

Could Not Locate

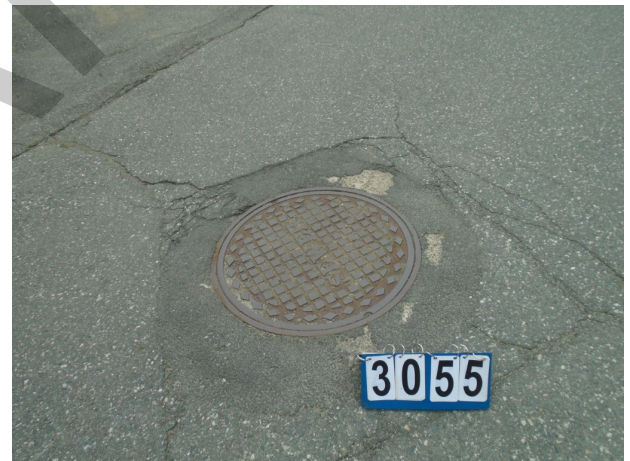
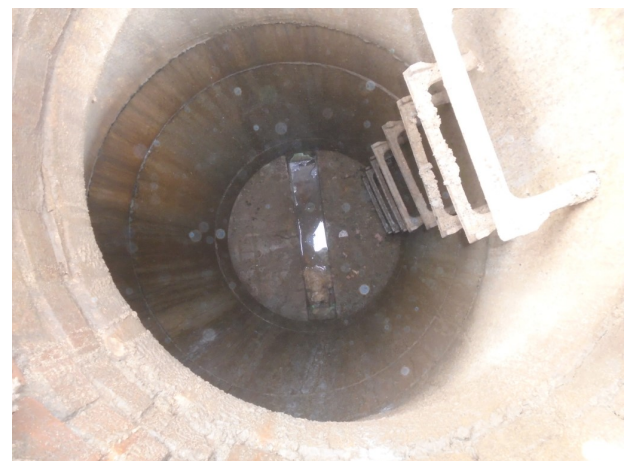
Type? Brick
 Condition? Fair
 I/I? None
 Comments: Backup/Blockage

Backup/Blockage

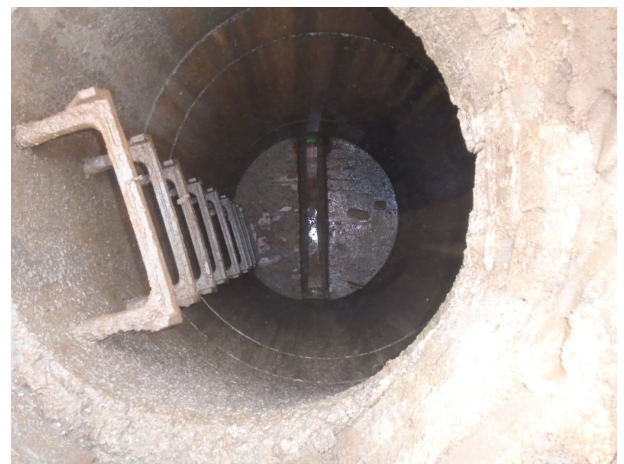
Interior Manhole Photo

Type? Brick
 Condition? Fair
 I/I? Past Inactive
 Comments? Loose/Missing Bricks from Riser

Type? Brick
 Condition? Fair
 I/I? Active Light
 Comments: Active Light I/I

Active Light I/I, Loose/Missing Bricks from Riser

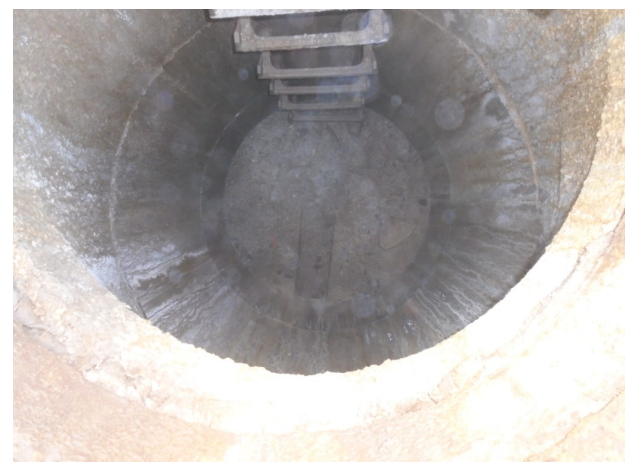
Interior Manhole Photo

Type? Brick
 Condition? Poor
 I/I? Past Inactive
 Comments? Loose/Missing Bricks from Riser

Loose/Missing Bricks from Riser

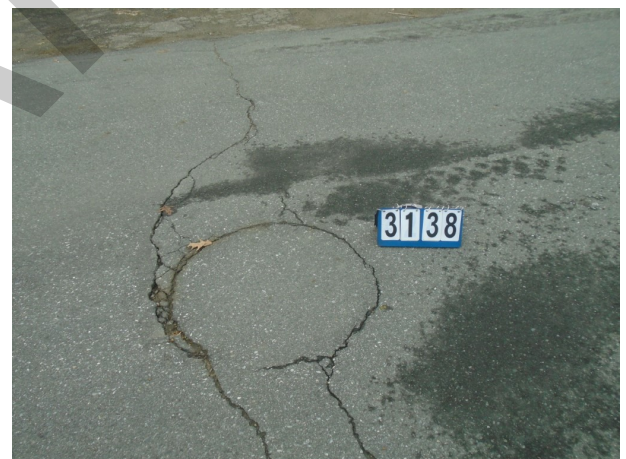
Paved Over

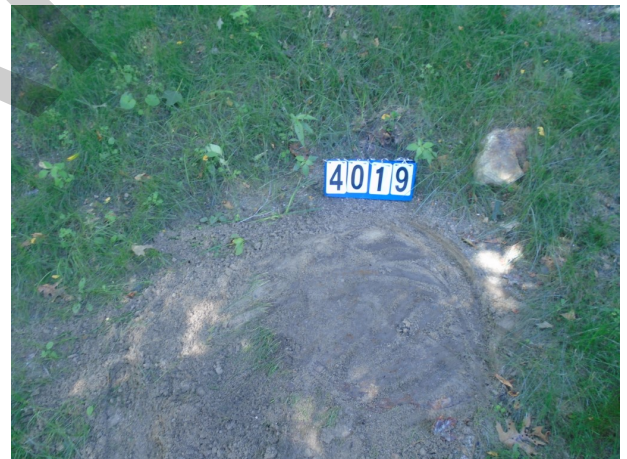
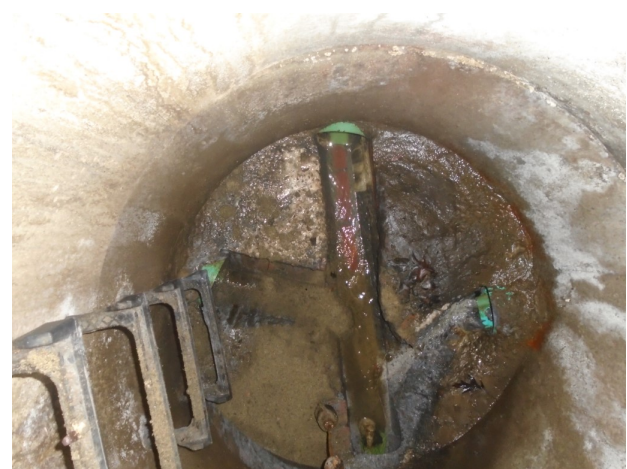
Type? Brick
 Condition? Good
 I/I? Active Light
 Comments: Active Light I/I

Active Light I/I

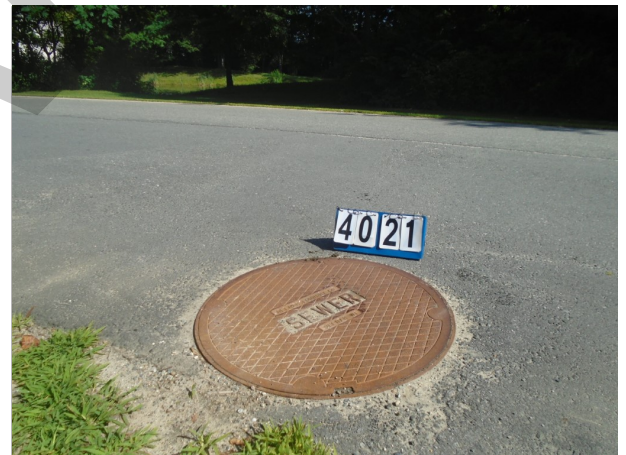
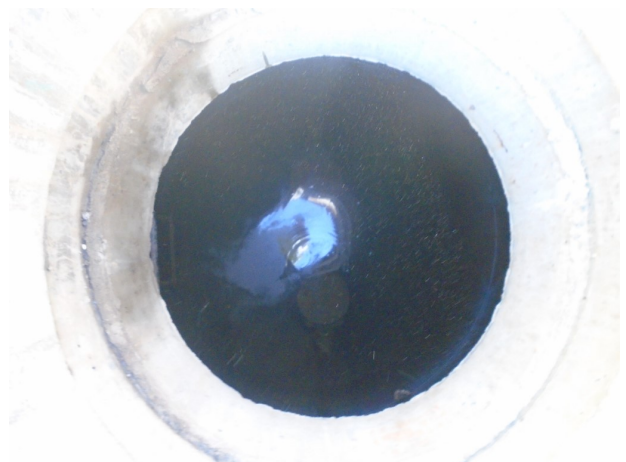
Type? Steel
 Condition? Poor
 Comments? _____

Surcharged

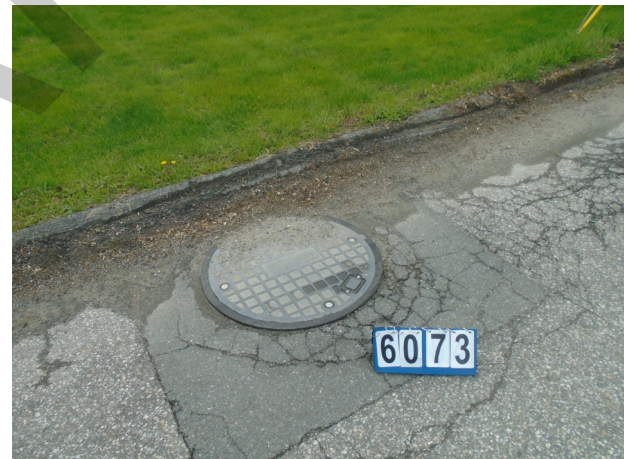
Exterior Manhole Photo

Bolted Cover

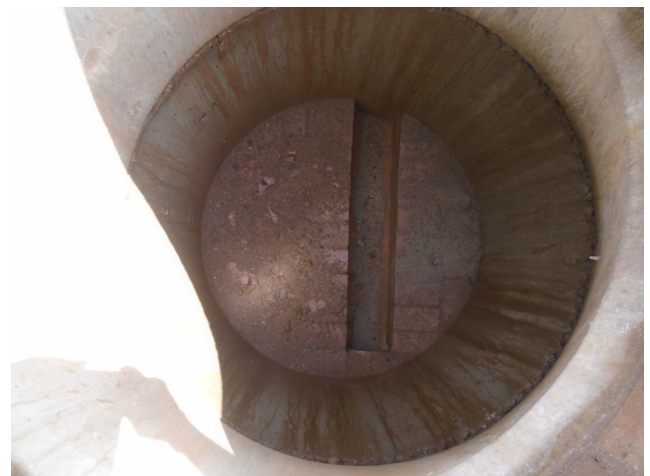
Interior Manhole Photo

Type? Brick
 Condition? Good
 I/I? Past Inactive
 Comments? _____

Type? Precast Concrete
 Condition? Good
 I/I? Past Inactive
 Comments? _____

Type? Brick
 Condition? Good
 I/I? None
 Comments: _____
